Old Keepers, Hedgerley

HISTORIC BUILDING REPORT / April 2014

Report number BAS/2014-03

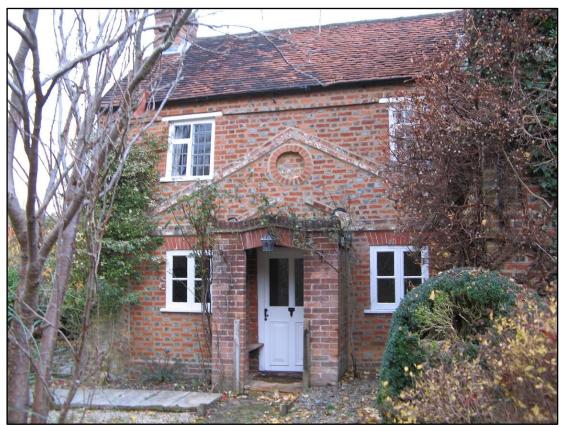
Figure 3: The pedimented west front of the north cottage.

The upper pediment is broken into by the lower corner of the first-floor northern window frame, but not by that of the smaller, southern window. The lower pediment is broken into by a strip of metal strapping which disappears behind the brickwork of the porch.

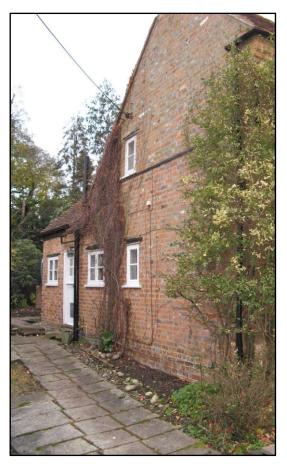
Figure 4:The north elevation. Note how the brickwork of the 1960s Kitchen extension on the left has been set to match the 1760s gable end.

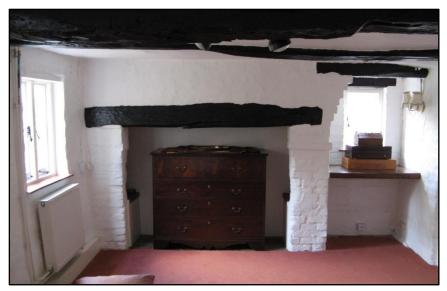
Figure 5: The open fireplace in the north cottage living room.

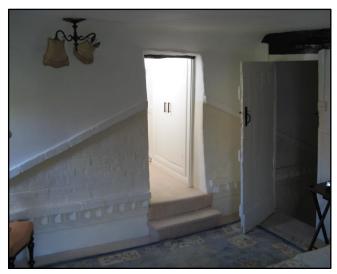
Figure 7: The 'internal pediment, cut by a later doorway.

of the later doorway into the extension. This extension also completely obscures the original outside rear wall of the north cottage, so it is impossible to see whether the pediment was mirrored there.

The brickwork of the pediment starts to one side of the 'curving wall' which was noted at the foot of the stairs, which means that the pediment itself is not centred on the present cottage. The wall itself also appears to slope gradually outwards, away from the room, as it rises. However the other side of this wall is fully obscured by the modern Kitchen extension so its thicknesses cannot be measured.

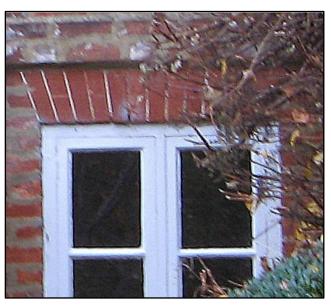
Figure 10: The finely-cut segmented brickwork over one of the windows.

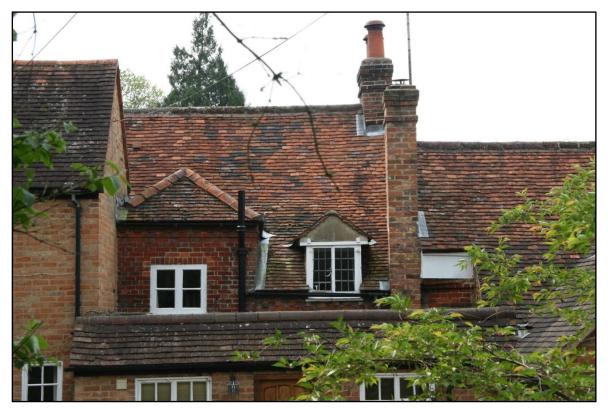
Figure 11: The east elevation, showing the two old gabled windows beyond the flat-roofed later extension.

To the south is a larger dormer set in the plane of the rear wall, built in red brick with occasional purple headers. This has a hipped dormer roof of old red tiles and half-round red ridge tiles. The eaves of the dormer rest on a line of protruding header bricks, below which there is a small double-casement cottage-style window of four panes in a modern wooden frame. Variations in the surrounding brickwork indicate that this is a recent replacement.

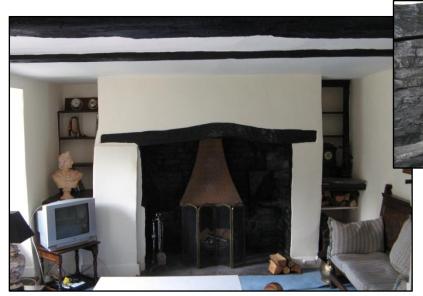
The fireplace itself is of very rough brickwork, today painted black. Within it on the right-hand (east) side are the remains of a stone shelf which once had a circular hole cut in it — this would have held an old 'copper' or basin for boiling. There is a ledge around the west and back of the fireplace, probably for pots — though the brickwork is much jumbled. The hearth is of old tiles. Inside the fireplace is a wood-burning grate and a modern copper hood. Alcoves to each side hold narrow shelves.

Figure 12 (left): The fireplace in the south cottage.

Figure 13 (above):
A close-up showing on the right
the curved stone shelf which once
held a 'copper' or basin.

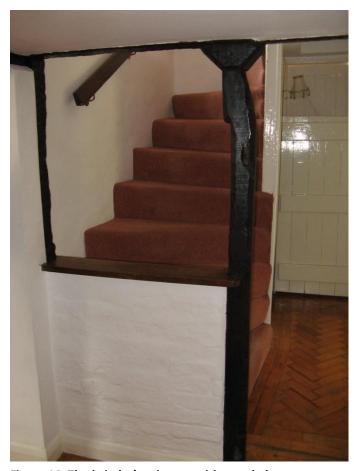
Figure 14: The 'winder' staircase, with recycled post.

A timber post at the base of the stairs has been recycled from another building, being pierced by mortise slots. Woodwork around the staircase is of reused timber, but appears to have been intentionally 'distressed' – though the timbers are genuinely old and re-used.

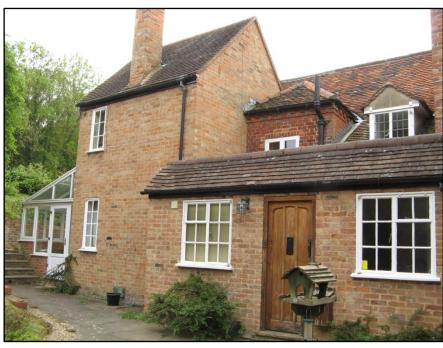
Figure 16: The modern Porch extension (right) and South-east extension (left).
