# Westbury Causeway

HISTORIC LANDSCAPE REPORT / February 2012

**Buckinghamshire  
Archaeological  
Society**

Report number  
BAS/2012-08

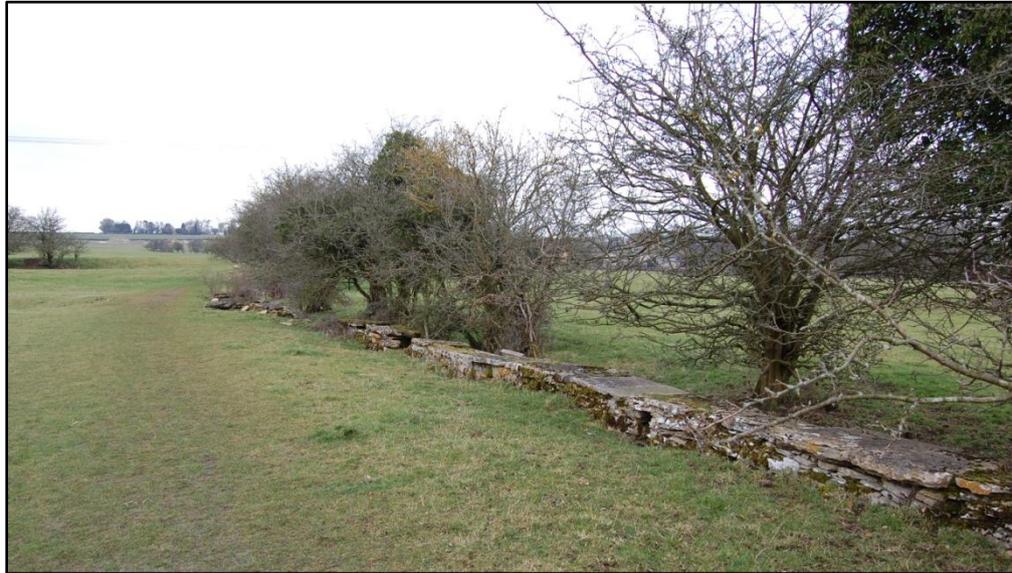
**FIGURE 1:** *The old causeway crossing the fields south-west of the former Westbury Mill.*

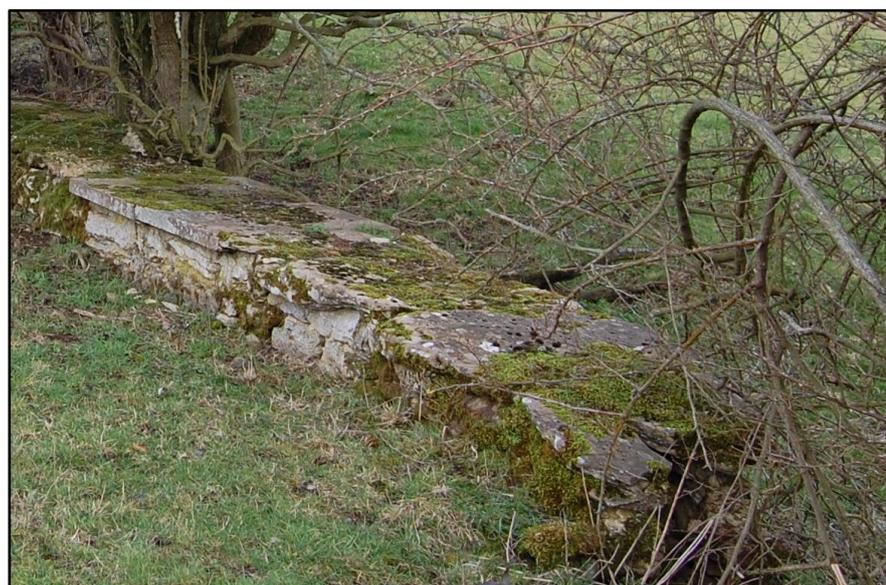
The causeway itself is no more than three feet wide. Its construction was originally of limestone slabs and cornbrash, a local form of coarse limestone (see Figure 3). This is a long-established local

**FIGURE 3: A section of the causeway showing its original construction of limestone blocks topped with limestone slabs.**

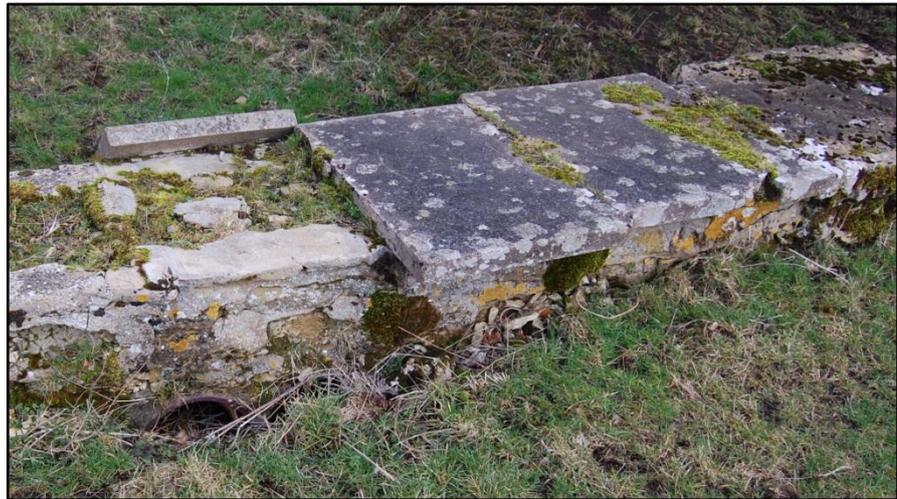
Some parts of the causeway are old, suggestive of dry-stone walling, but other parts are relatively modern because they have been repaired in concrete. It includes

paving slabs of the 1930s and, in places, vitreous drainage pipes which may also be from the first half of the 20th century (see Figure 4).

**FIGURE 4 (above): A 20th-century repair with concrete slabs and vitreous pipes.**

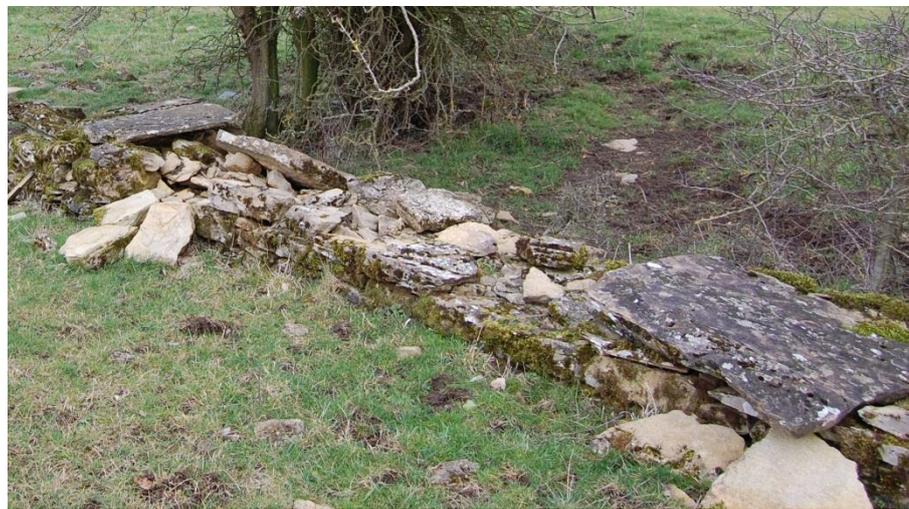
The structure is very decrepit, having suffered badly from the elements, recent neglect and possibly abuse (see Figure 5). A blown elder hedge runs along beside it suggesting a former Inclosure boundary.

**FIGURE 5: A derelict section showing neglect or, at worst, vandalism.**

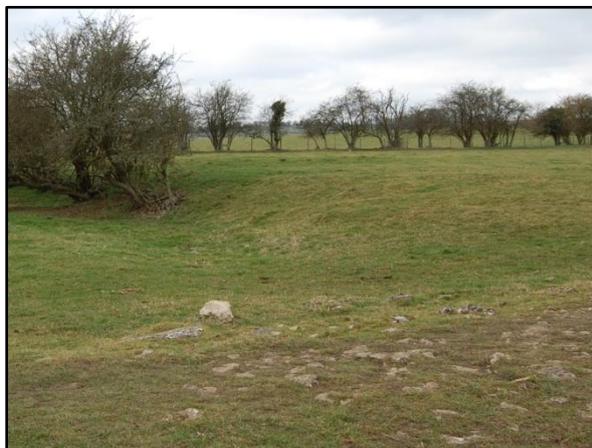
**FIGURE 6: The infilled leat and rubble deposit.**

The causeway also crosses the smaller of the two former leats mentioned above which may account in part for the drainage pipes inserted at intervals in its base. The larger leat has been filled in just before it meets the causeway by a large deposit of rubble which has given breadth and substance to the bridleway (see Figure 6).

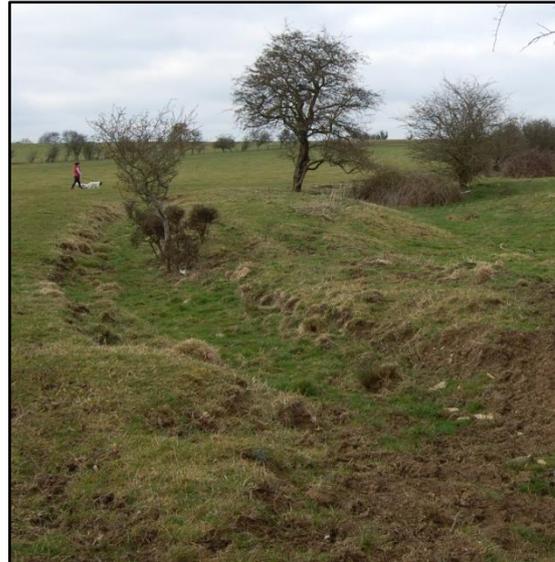
However the original mill was supplied with water from a source other than the River Great Ouse. This came from a spring situated on the hill above the mill, along which the Brackley Road now runs. The fall from this spring is quite sharp but the stream may have flowed only intermittently (see Figure 7). It was largely dry when examined.

**FIGURE 7: A section of the earliest mill stream.**

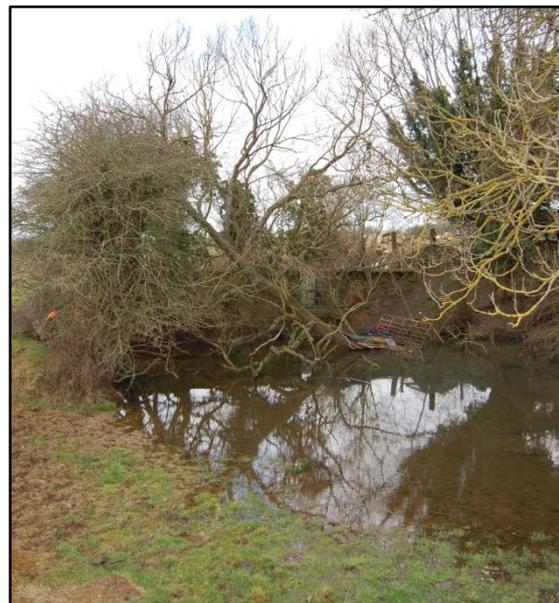
**FIGURE 8: Remains of the millpond.**

The retaining wall of the millpond was in part built up by layers of limestone slabs in the local manner but in later years it has been strengthened by brick and concrete casings. Some of these casings have fallen away and some breeze block has been recently inserted. The pond and its retaining wall now look like an abandoned site.
