MASWORTH CHURCH

AND DEDUCTIONS FROM DISCOVERIES MADE THEREIN
DURING THE WORK OF REPAIR, 1881—1906.

[BY THE REV. F. W. RAGG, M.A., F.R.HIST.S.].

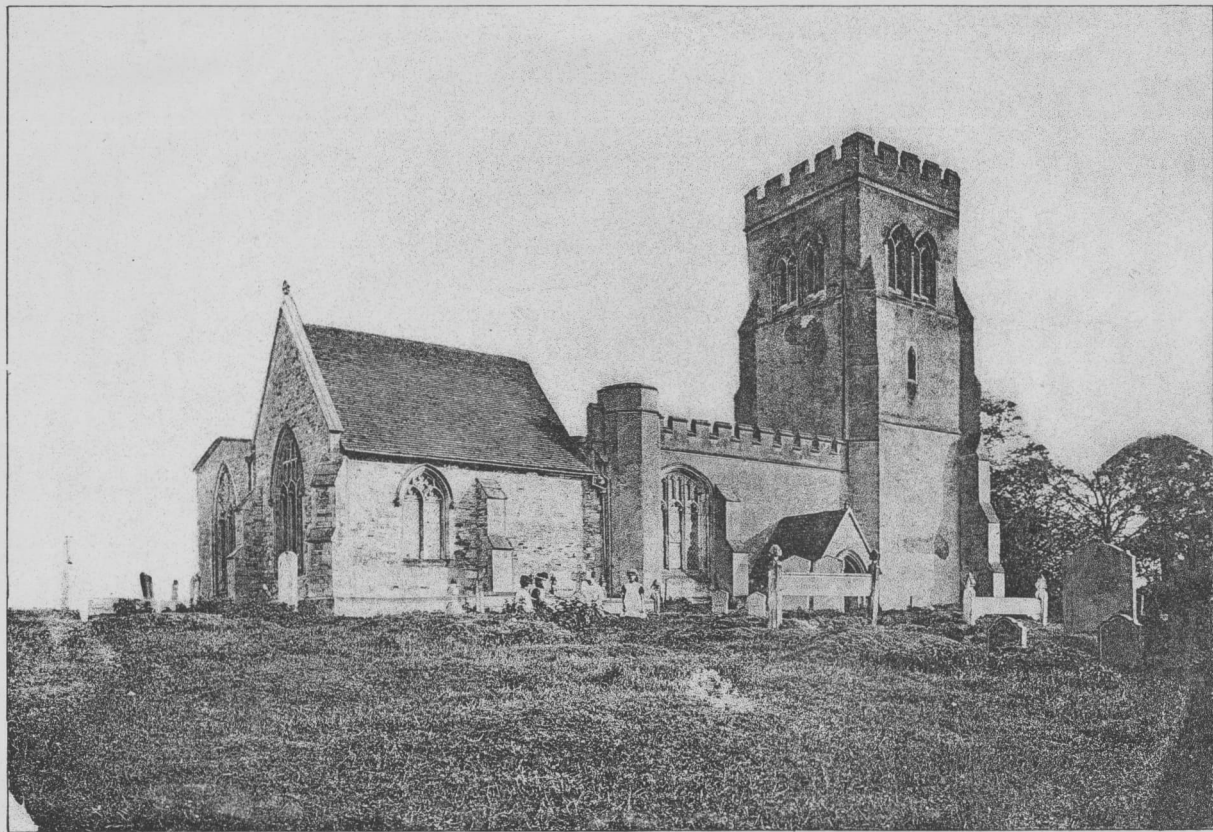
VIEW FROM N.W., BEFORE RESTORATION.

in my state of health, was sufficient, and even more. But needs must, and I began. The East window of the Chancel had been erected, as I knew afterwards, with neglect of all rules of the mason's art, and its tracery was already broken through the shoulder. The South wall was leaning outwards, and the buttresses built for its support still more so. There was a bulge in this wall in the interior which needed attention. Inside the church was an offensive odour when doors and windows were not open, and an unsoundness in portions of the platforms which upheld the seats. The "roughcast" exterior coating of the church was ineffective and unsightly, and was always giving trouble and causing expense.

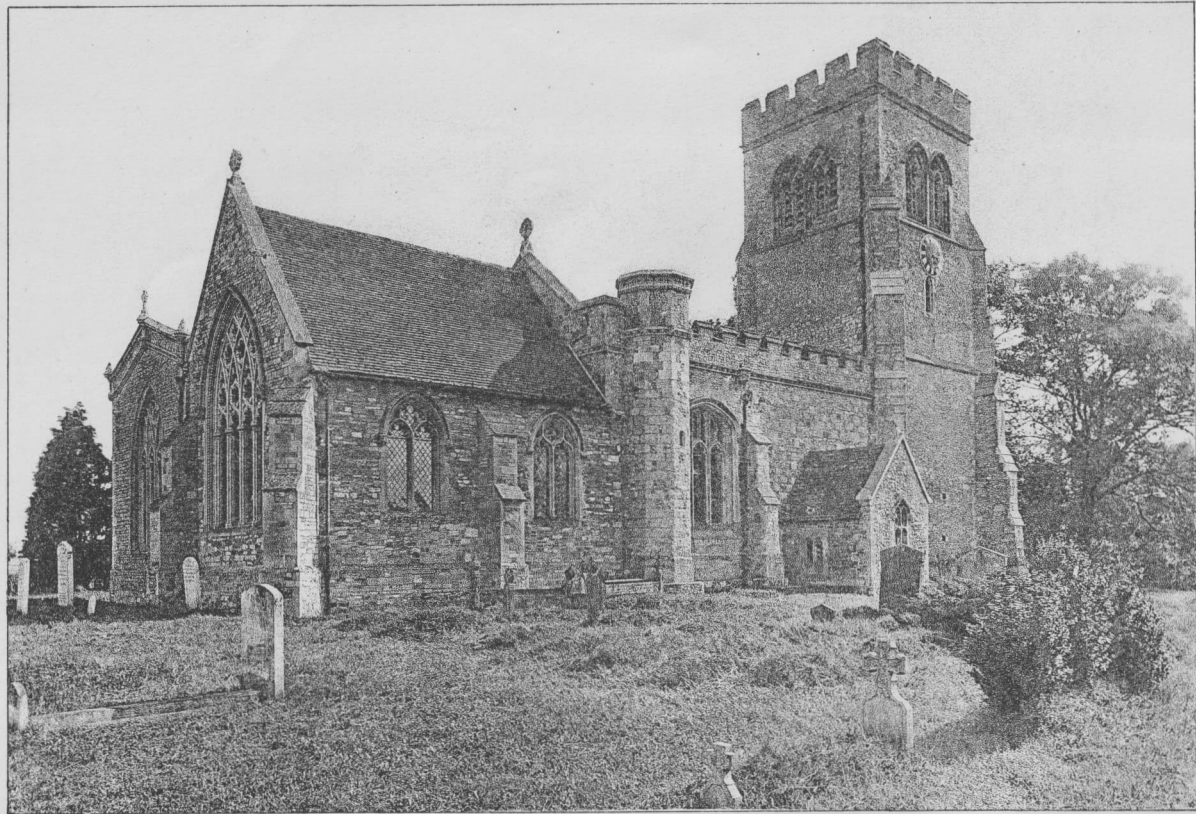
MASWORTH.
SHOWING MR. RAGG'S ALTERATIONS.

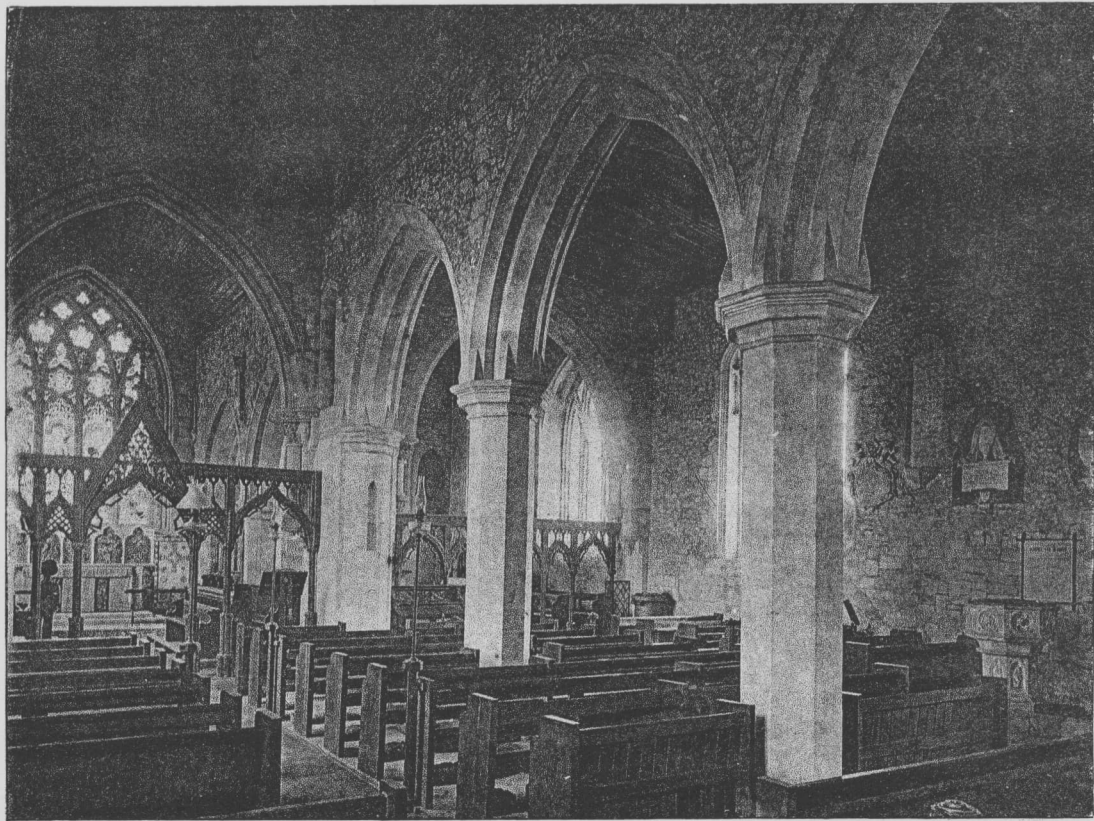
MASWORTH.
INTERIOR AFTER RESTORATION.
