The White Horse, Hedgerley

HISTORIC BUILDING REPORT / April 2014

**Buckinghamshire
Archaeological
Society**

Report number
BAS/2014-02

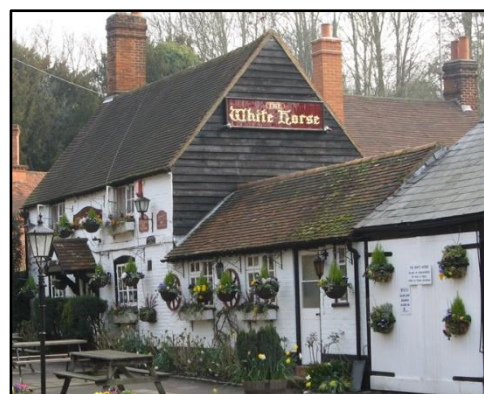
Figure 3: The west elevation

The two-storey section of the building is of brick, painted white, standing on a shallow brick plinth and with a horizontal string course of two bricks at first-floor level. The facade is symmetrical, with a central doorway flanked on both sides by a window on each floor.

The central doorway has a porch hood cantilevered from the wall on a pair of large wooden brackets. Its pitched roof carries machine-made red clay tiles. Beneath the hood the line of a former shallow brick-arched lintel is visible over the doorway. The wooden door itself is of four panels in a wooden frame.

To each side the two ground-floor windows are of twin six-pane wooden casements under shallow segmented brick arched lintels. The sills are obscured by window-boxes.

The two first-floor windows are of twin four-pane opening casements set tight under the eaves. Again the sills are obscured by window-boxes.

The roof is of plain machine-made tiles, a single span between vertical gables. At the northern gable is a tall chimney stack, set behind the ridge line, whose brickwork has a central vertical, integrated joint indicating an original single flue to which a second rear flue has been added at a later date. The brickwork of the front flue appears older than that of the rear flue. Each carries a single pot.

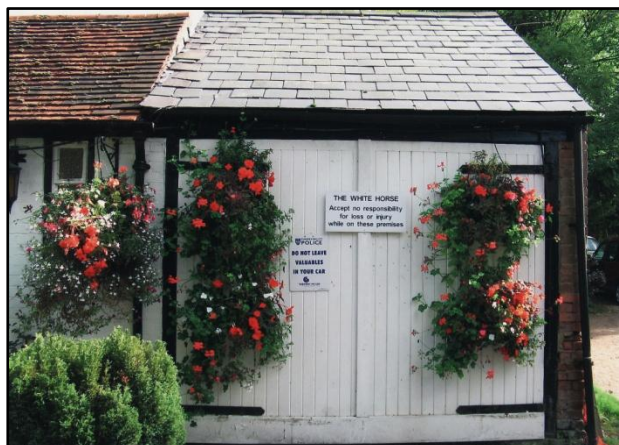
Figure 4: The garage in its summer finery.

At the southern end of the range is a single-storey building with large wooden double garage doors. This has a pitched slate roof, again in-line though with a shallower pitch.

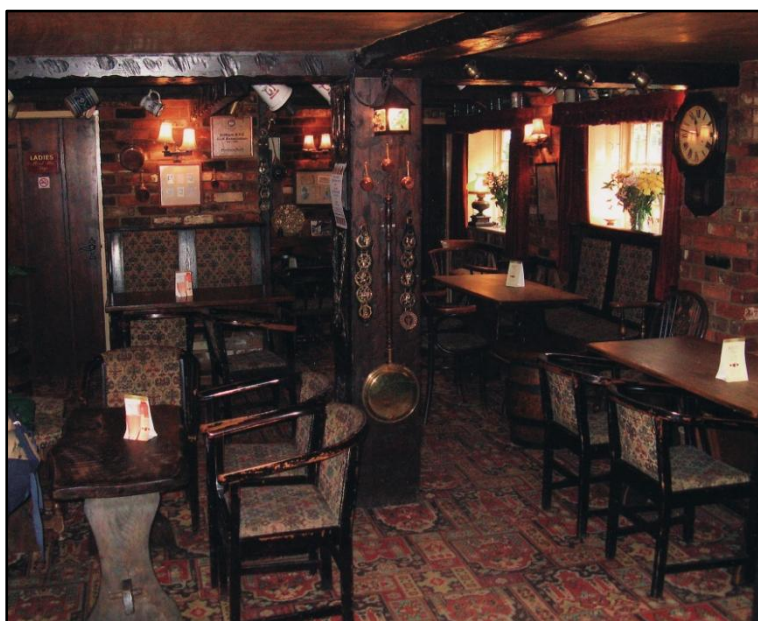
Figure 8: The main bar, looking through to the 1980s extension. It is heavy with polished wood, but how much of this is old?

The cross-beam and post where the south wall has been removed are obviously recent additions: steel beams clad in boarding which has been 'hacked' to give a false impression of age.

Measured wall thicknesses vary but are consistent with a single build of the two-storey main building. That of the front (west) wall is 390mm, matched by the width of the modern crossbeam supporting the end gable (382mm) and the eastern wall (430mm, but including later tongue-and-groove panelling). The wall between the main bar and Public bar, on the other hand, is original stud-and-plaster only 148mm in thickness.

The fireplace in the eastern wall, with its external chimney stack, is a later addition. The woodwork of doors and windows carries 'false aging' marks.

The wooden pillar and crossbeam that have replaced the original south wall of the main bar, for instance, are in fact structural steel joists to support the gable-end wall above, clad in boarding which has been ‘hacked’ to give a false impression of age.

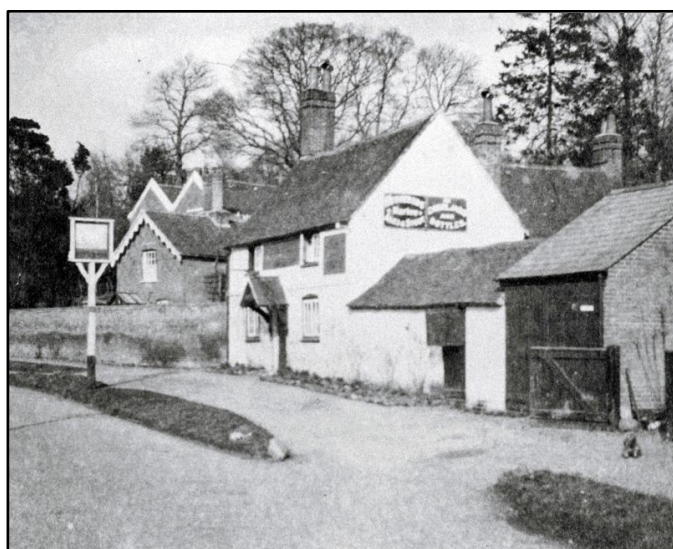
Figure 11: The White Horse in the early 20th century.

The old photograph (Figure 11) is probably from the early 20th century. It shows the main building of the White Horse with its rear-wall chimney stack and rear wing. In the foreground on the right is the garage now used as a Bar Store. In between there is a stable with a two-part stable door. Comparison with a modern photograph shows that the roof of the stable is set about a foot lower than that of the Bar Extension which has today taken its place.

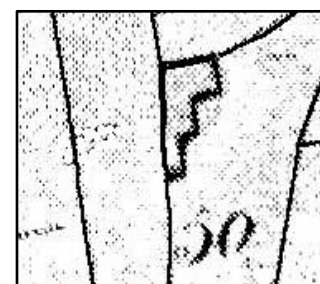
Figure 12: The White Horse on the 1842 Tithe Map..

The outline of the White Horse on the 1842 Hedgerley Tithe Map⁷ (Figure 12) shows the main building beside Village Lane with a large square rear wing. This concurs with the account of an addition in the 1830s in the records of Wethered Brewery.

Attached to the south is a small, narrower building. This is most likely the stable shown in the old photograph. In the 18th and 19th centuries a stable would be a necessary part of any country public house
