# Wingrave Historic Buildings Workshop / 9 October 2011

## SUMMARY REPORT

### A ONE-DAY WORKSHOP

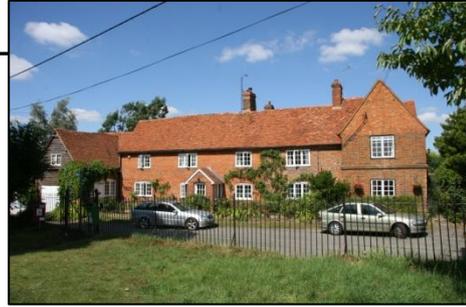
## Church Farmhouse

This is right in the middle of Wingrave, next door to the church. Only the front elevation was viewed, and only externally.

- A four-bay brick-fronted building with central chimney stack, off-centre front door and later porch.
- To the right is a two-bay cross-wing, also built in brick, with front-facing gable and prominent string-course between ground and first floors.
- The base plinth indicates a very old building, but what is visible appears to date from the 17th or 18th centuries.

*[ In fact the rebuilding of the front elevation in brick, partly dated 1793 and 1828, disguises an original building from the late 14th and 15th centuries. Internal examination would have revealed three incomplete cruck trusses and two surviving 15th-century bays, one of which was part of an open hall.]*

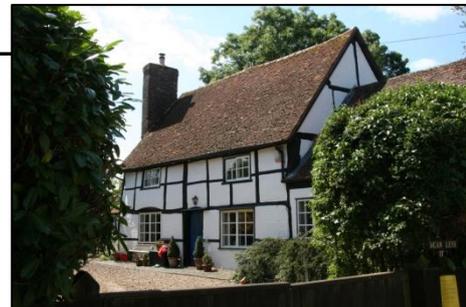
## Dean Leys

This was the first house to be viewed internally. Features noted were:

- The chimney on the left-hand gable has a stone base, early brickwork and is built outside the timber frame of the building. This indicates that the chimney is a later addition.
- The stairs are not original, though their original position is uncertain.
- Discussion focused on a possible open space in the centre of the building: did this indicate an open hall with central fireplace? With no smoke-blackening in the roof space this was considered unlikely.
- A wall-painting which included a quotation from the Coverdale Bible of 1535 might indicate a date in the 16th century - for the wall-painting. But the building itself might be earlier.

Thirteen samples were taken of which the tree-ring sequences in six cross-matched to show that the oak trees from which these timbers were taken had been growing between the years 1431 and 1493. The six samples all came from timbers of the frame itself – two from truss tiebeams, two from posts, one from a wallplate and the sixth from a curved brace.

None of the six samples included bark, so felling dates were calculated from sapwood samples. This produced a felling date between 1495 and 1527. Because medieval builders used oak when it was still ‘green’ and easier to work, this means that the main frame of Dean Leys was most likely built in a single phase at some time between 1495 and 1527.

This is interesting. As Andy Moir points out: ‘This dating [for Dean Leys] is a century earlier than previous estimates based on stylistic features.’

Dean Leys has a Queen Strut roof and full gable ends, both of which are usually taken to indicate a date after 1600. Perhaps the dendrochronology is suggesting that the dating of these features in Buckinghamshire should be reconsidered?

Likewise, domestic buildings of 1495-1527 usually had open halls, with a central hearth, no upper floor and no chimney - resulting in smoke-blackened roof timbers. But if Dean Leys was originally an open-hall house, as this dating suggests, then why are its rafters not smoke-blackened?

Well, Dean Leys has clearly had major repairs during the past 500 years. Perhaps the roof was replaced? Or perhaps it was originally an unheated agricultural building? Or perhaps it always had a chimney, in which case the dendrochronology results are suggesting that chimneys, usually considered to appear around 1580, were around earlier than that – in Wingrave at least!

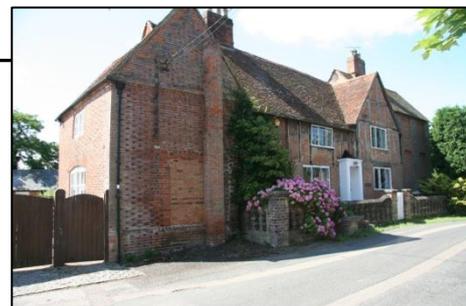
## Floyd's Farm

- Originally a two-bay timber-framed farmhouse.
- Differences in the timber framing indicate that the front-gabled cross-wing to the right was added later.
- The framing has relatively narrow vertical panels known as 'close studding'.
- Possibly 17th-century?

*[ The listing suggests 16th-17th century, with 18th-century alterations. ]*

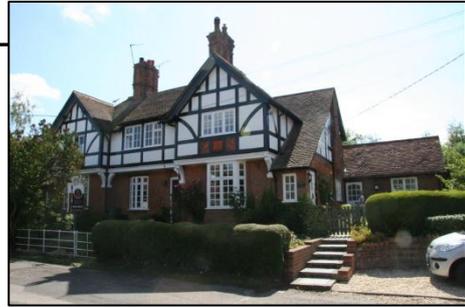
## Ivy Cottage

In some buildings timber framing can be deceptive, but no one was fooled here: the stone plaque on the front stated plainly 'HR 1876'.

- The decorative style is clearly what used to be called 'mock Tudor', with plenty of vernacular features: black-and-white timbering, but with a couple of brick-infills for variety; 'catslide' roof to the side; multi-paned windows with a square bay on the ground floor.
- In fact the building is a terrace of three dwellings, but built in an imposing style to impress the viewer. These are 'estate cottages' built by local landowner Hannah Rothschild, of the banking family.
- An interesting feature is the capped-off side chimney, an indicator of redundancy caused by 20th-century central heating.

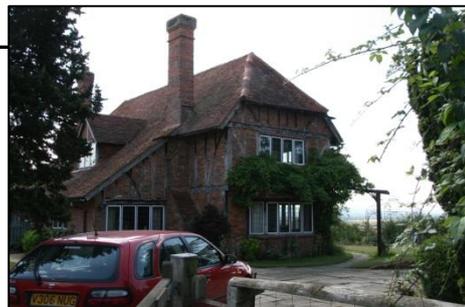
## Little Manor

This house confused several people, which is why it was included on the list.

- It has considerable timber framing, a half-hipped tiled roof, a 'cat-slide' side extension and tall chimneys. Might these indicate a 16th or 17th-century building?
- But there are other clues: the even ridgeline, the regularity of the windows, what appears to be an unpegged and rather sparse timber frame for such a large building, and some rather strange corner joints reveal the truth.
- In fact 'Little Manor' is less than 50 years old, being constructed in 1964 by a Mr Marks, a teacher from Amersham who used old timbers and recycled bricks from Whitchurch.

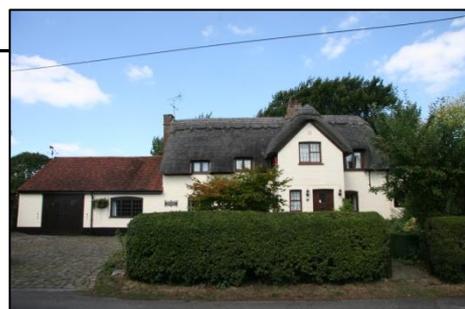
## Mollard's Cottage

This is the third Wingrave house that was open for internal viewing during the workshop, and is an example of how external and internal views can differ.

- From outside we see a thatched cottage, but one that appears to be entirely brick-built and with modern wood-framed and leaded-light windows.
- The only immediately visible sign of age is a short, central, tapering brick chimney stack.
- To each side is a tile-roofed single-storey extension, that on the left with a narrow garage door, probably indicating a 19th-century date. The central two-storey porch, in tidier brickwork than the main wall, also appears to be a modern addition.
- Careful examination reveals some thin timbering in the walls to the right of the porch, then the hint of a collar-beam in the left-hand gable.
- Go inside and everything changes. This is a three-bay 'lobby-entry' house, with its front door immediately opposite the central chimney stack.

- Inside, sections of timber frame are visible in the walls. The spine beam is finished and chamfered, with rolled end stops. Curved windbraces date the house as 16th-century.
- The chimney stack to the left is something of a puzzle, as it serves not the main house but the left-hand extension. This probably indicates that this was originally a workshop.

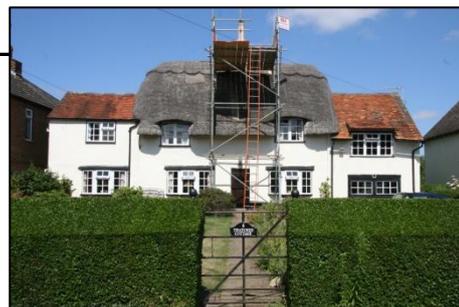
### Thatched Cottage

Unfortunately this cottage was partially obscured by scaffolding as its central chimney was being repaired. Features identified were:

- The central thatched building is symmetrical, with front door and chimney flanked by matching windows on two storeys.
- If there is timber framing, this is obscured by white-painted render. The not-quite-matching tiled-roofed extensions on each side might be 20th-century.

General consensus: little could be deduced from viewing the front elevation alone.

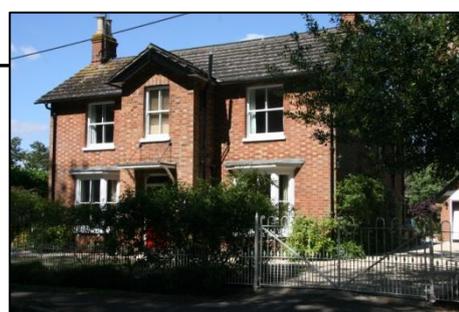
### The Hollies

This was the second building which could be viewed internally. Features noted:

- Symmetrical brick-built frontage with ground-floor bay windows and sashes, indicating a classic Victorian building, possibly 1860 or later.
- Internal joinery and fireplaces are plain.
- The porch is a later addition, but accords well with the original style – perhaps indicating that the building ‘went up in the world’ soon after construction.
- An old photograph in the house shows a pitched-roof single-storey outbuilding at the rear in use as a stable. Today this is two-storey, and its chimney and first-floor fireplace show that it was added for domestic use.

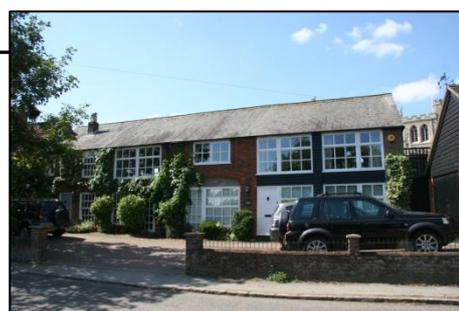
### The Old Post Office

At the heart of the village, this house is the left-most in a row of several formerly separate buildings. (in our picture it is hidden by trees!) The row backs on to the churchyard, so is clearly on an old site, but the buildings themselves have been renovated.

- The house is built of brick in a pattern of red stretchers and blue headers, set on a brick plinth topped by a brick moulding.
- The roof is tiled with a central chimney. The six-panelled door has a flat wooden hood.
- The attached building, now also residential, has large glazed windows, at both ground and first floor levels, indicating a former workshop. In the centre the outline of a brick archway, now filled and with an inserted window, indicates the former entrance archway for a rear yard. Its low-pitched slate roof indicates 19th-century.

[ The house is listed as late 18th-century, the workshop as 19th. ]

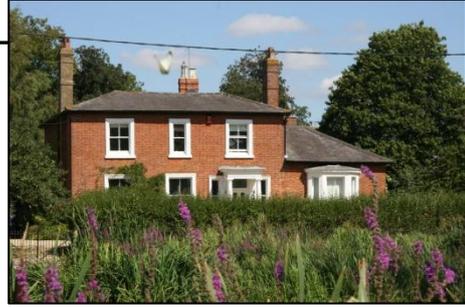
## The Old Vicarage

In a comparable position to Windmill House (see below), this house is close to the village centre facing across the main village pond. Although of high status as the vicarage, a comparison of the two houses makes it clear that this is the lower of the two in the social hierarchy.

- A semi-symmetrical brick-built house with plain window and doorframes, but with its front door set to the right with a pillared open porch and unusual narrow windows to each side.
- The slate roof is fully hipped, with a low pitch, and tall chimneys to each end wall.
- To the right is a single-storey extension, whose later addition is made plain by irregular brickwork where it joins the main building. This too has a slate roof, but with a steeper pitch. Its front-facing bay window does not match those of the main house.

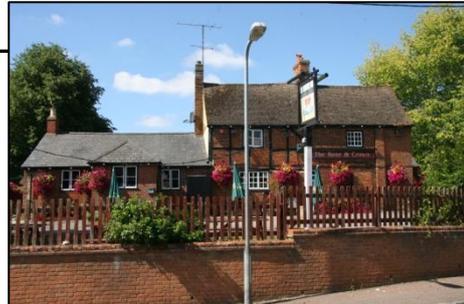
## The Rose and Crown

The village pub.

- Partial timber framing, with tiled roof showing an irregular ridgeline.
- Windows in the main building are also irregular; one is a horizontal sliding sash.
- The single-story extension to the side is later, with lower-pitched slate roof.

*[ Listed, with 17th-century framing in the first-floor of the left-hand bay, where the ground floor was rebuilt in brick in the 19th century. The right-hand bay is 18th-century in chequer brickwork. ]*

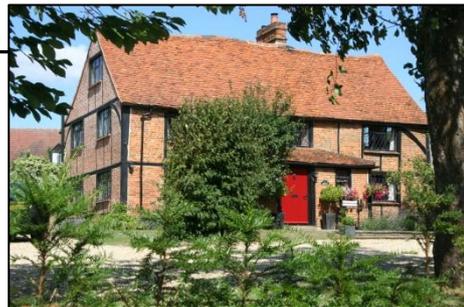
## Waterloo Farmhouse

This building, like 'Little Manor', was included as a warning, and this time no one fell into the trap. It was noted that:

- The left-hand gable has been rebuilt, with regular windows.
- There are a lot of potentially old timbers, but these display many void slots.
- Was it a former farm building, recently converted?

*[ The truth, revealed at the workshop by local historian Prue Goodwin, is that documents from 1798 show a house on this site, but it was abandoned in the 19th century and a ruin by 1935. The Home Guard used this for training exercises during the Second World War and the rest was demolished by local kids. The present house was built in 1968 using left-over materials. ]*

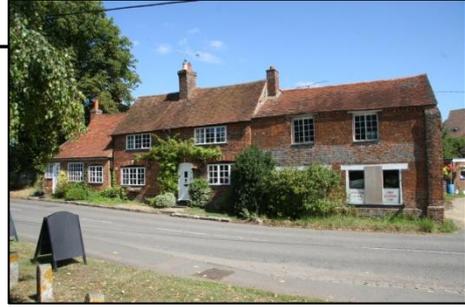
## Wheelwright's

A brick-built cottage with single-storey extension to the left and two-storey workshop to its right. It was felt that:

- The right-hand workshop was probably the oldest part of the range.
- Interesting that the name indicates a certain continuity of use: from the workshop of a wheelwright, maintaining and repairing carts and carriages, the workshop had become a garage in the 20th century. It is now empty, seeking a buyer.

*[ Late 18th and 19th-century rebuilding and alteration to an older building, of which some timber framing remains in the left gable end and to the rear. ]*

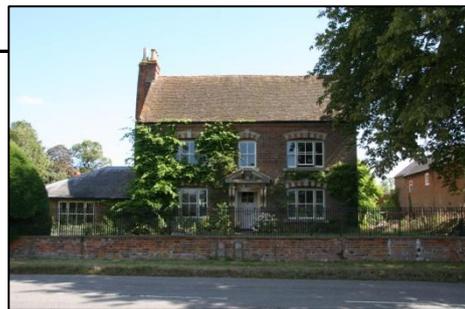
## Windmill House

A high-status building, built to impress on the main village street.

- A square-fronted, symmetrical brick building set around a central front door with architrave and broken-pediment hood on stone brackets.
- Full-gabled roof with two end chimney stacks. Large windows with decorative, arched segmented lintels and triple sashes.
- Sun Insurance plaque.
- Single-storey side extension with low-pitched slate roof and windows to match those of the main house.
- At the rear, multiple later extensions.
- Style dates the main house to the late 18th or early 19th century, while slate dates its side extension to not much later than this.

*[ The listing says it was built in 1742 and enlarged in 1819. ]*

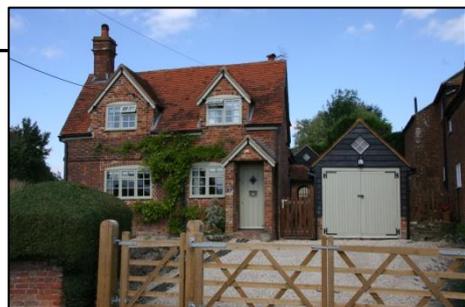
## 3 Castle Street

A cottage, extensively renovated in the 1990s, that is known to have an internal timber frame and old fireplace.

From an external viewing of the front elevation, it was judged that:

- the two front-facing gabled windows were modern insertions,
- the steep roof indicated that earlier thatch had been replaced with tiles,
- and that a division in the brickwork might show that the right-hand section of the cottage was a later addition.

On balance it was felt that the cottage was dated pre-1700.

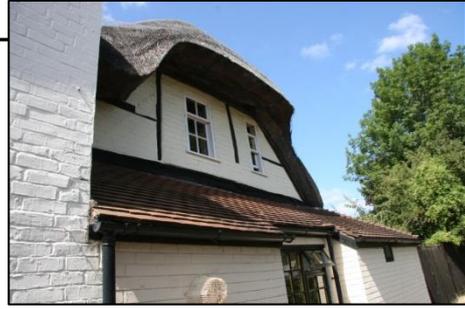
## 28 Nup End Lane

This small cottage was the fourth to be viewed internally – and cores were also taken for dendro-analysis. It has:

- A thatched roof with low eaves, a half-hip at one end and full gable at the other.
- A single-storey outshut wraps around two sides. This is of brick with a tiled roof and is most likely a 20th-century addition.

- The full gable end abuts on to a public lane, while the fourth side is a shared party wall with the adjoining house, one of a row of small early 19th-century cottages. The two houses share a chimney stack, set into the dividing party wall. This is most likely a replacement for an earlier chimney in the same position.

- The cottage has an oak frame, but the roof is elm. The roof space is open to the thatch, with heavy common rafters and no principals
- At first sight this appears to be a single-bay dwelling, but examination of the framing at the pitch of the full gable indicates that this is in fact the central truss of a two-bay building, which has been infilled with brick. The second bay has been demolished.

- Moreover, smoke-blackening and the lack of principal rafters indicate that it was originally a hall house with central hearth, dating it to before 1550.

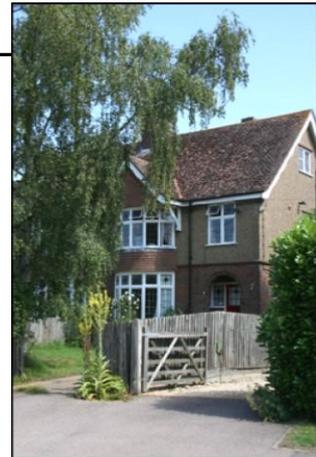
## 30 Winslow Road

Sometimes identifying old buildings means eliminating the new. This is the best-preserved in a small row of 1920s/1930s semi-detached houses in Wingrave and exhibits some classic features of the period:

- Pebble-dash rendering.
- Part-circular bow windows on both floors, with multiple 'leaded-lights'.
- Arched open front porch with panelled front door and domestic stained glass.

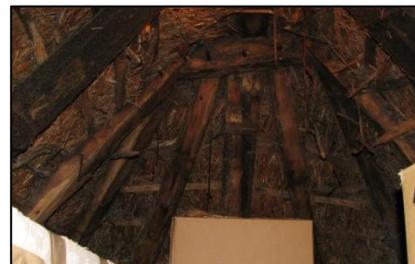
Smoke-blackened rafters at 28 Nup End Lane.  
Photo: Mike Farley

The roof timbers are impressive, with heavy rafters, open to the thatch and smoke-blackened (see photograph). But these turned out to be elm, so not suitable for dendrochronology.

The smoke-blackened rafters, however, do indicate that 28 Nup End Lane is at least 16th-century and possibly earlier. A more exact date may result from the planned survey of the building – *see Section 10 below*.
