St Mary's House, Twyford

HISTORIC BUILDING REPORT / June 2011

Buckinghamshire Archaeological Society

Report number BAS/2011-01

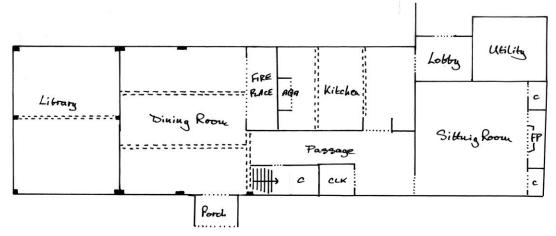
St Mary's House today is a single 23-metre range facing east and set at right angles to the church. Its walls are timber-framed to the south and brick-clad to the north, with a main tiled roof hipped at both ends around a massive central chimney stack. Attached to the north of this is a lower building with tiled roof and a stone-built gable end.

Figure 3: Ground-floor plan of St Mary's House, May 2011.

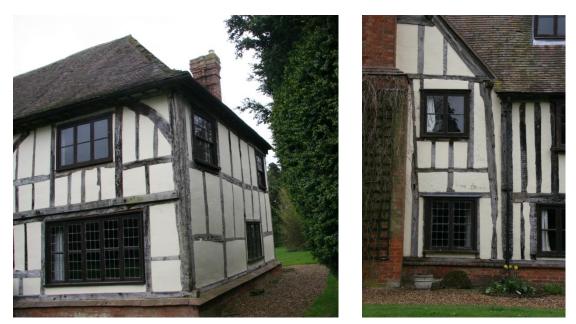
Figure 6: The second medieval hall (left) and (right centre) the corner posts of the two frames, side-by-side.

Immediately abutting the main hall, to the south and facing the church, is a second medieval open hall (Figures 6 and 8), whose frame, in contrast to that of the main hall, is more workmanlike, with wider panels and little if any decoration in its roof structure.

Although this second hall abuts directly on to the main hall range, the two frames are independent of each other. Alterations to its frame show that this second hall was originally erected elsewhere, then dismantled, moved to its present position and shortened to match the width of the main hall.
