# GRANGE FARM, WIDMER END

IAN JOHNSON and PAULINE FENLEY

## INTRODUCTION

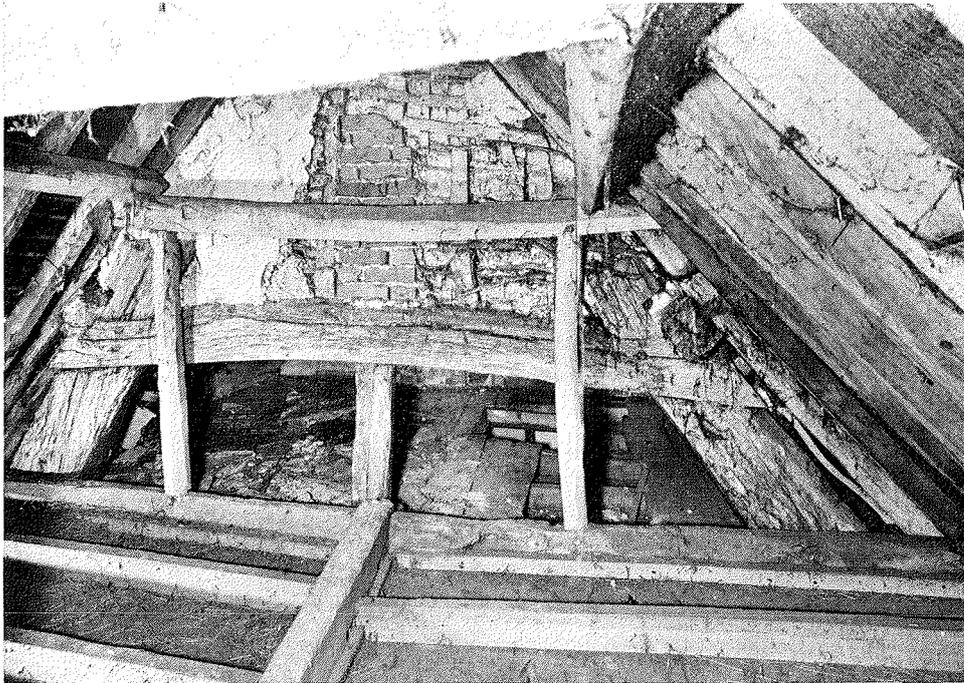
PLATE IIIb. Cruck structure of main roof space, looking S from roof of extension and showing original end wall and top of cruck blades in truss a-a'.

Returning to the hall, we note that, in all three trusses, the cruck blades end just above the collar-beam. As already indicated, the outer roof consists only of common rafters. Each pair is halved and pegged together at the apex. Smoke-blackened rafters occur in bay ab, and probably also in bay bc, where the poor condition of the roof made examination difficult. There is unmistakable smoke-blackening on the cruck blade to the E. of the stack, but this could be accounted for by the fact that an aperture about a foot square has been made in the stack, probably to create some sort of smoke chamber at first floor level. It is possible too that what appears to have been an aperture in the gable at the N. end, and now filled in with brick, was a vent to draw off the worst of the smoke. Blackening occurs in cracks in the plaster infilling, in the same general area.

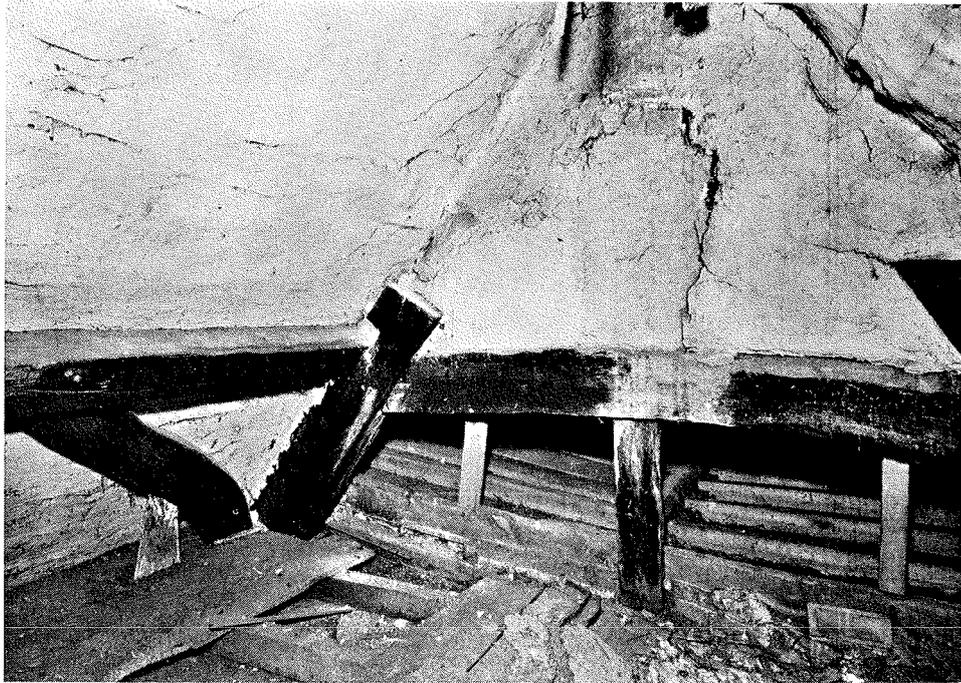
PLATE IVa. Main roof space looking N showing top of cruck blades in truss a-a'.  
*Crown Copyright*

Grange Farm conforms to neither pattern. We did wonder whether this could simply be the result of alterations or repairs to a cruck roof which had started life in a more usual form. In support of this view is the odd way in which the blades in Truss a-a' have been cut off at different angles. But we could find nothing else to suggest alterations of any consequence. Viewed as a whole, the roof timbers give the impression that the original structure has not been interfered with.<sup>5</sup>

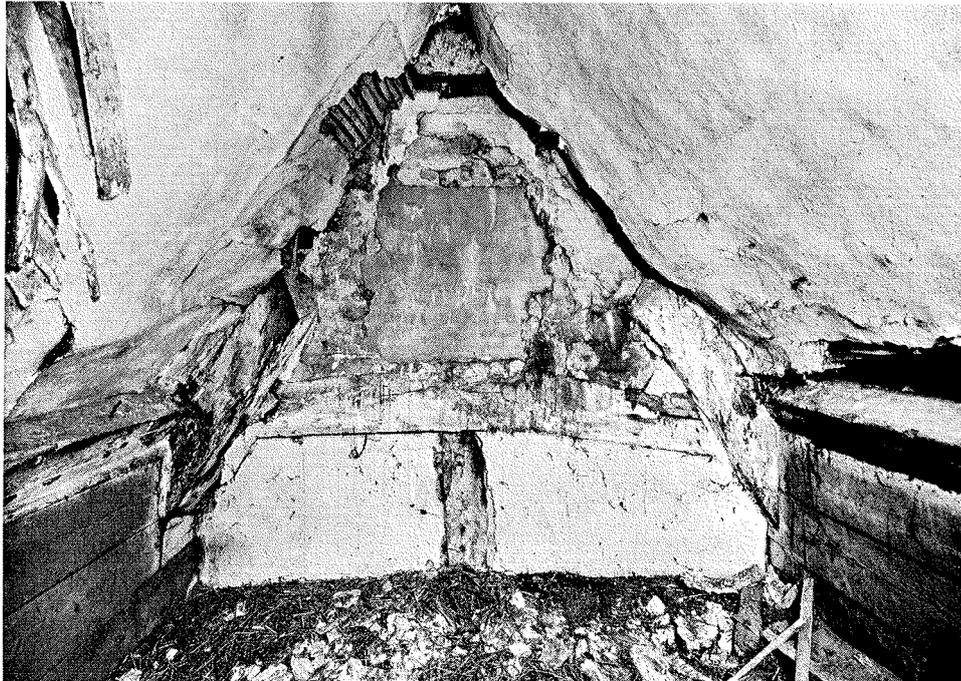
PLATE IVb. South roof space looking S showing top of cruck blades in truss c-c'.  
*Crown Copyright*

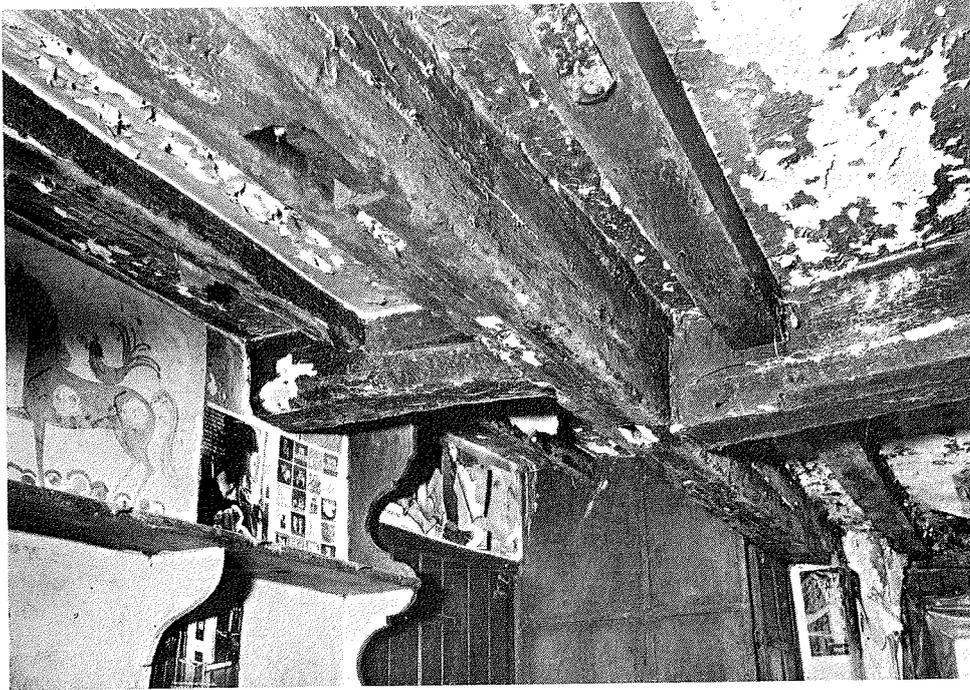
Plate Va. Original end wall beam with mortises. Ground floor N room.  
*Crown Copyright*

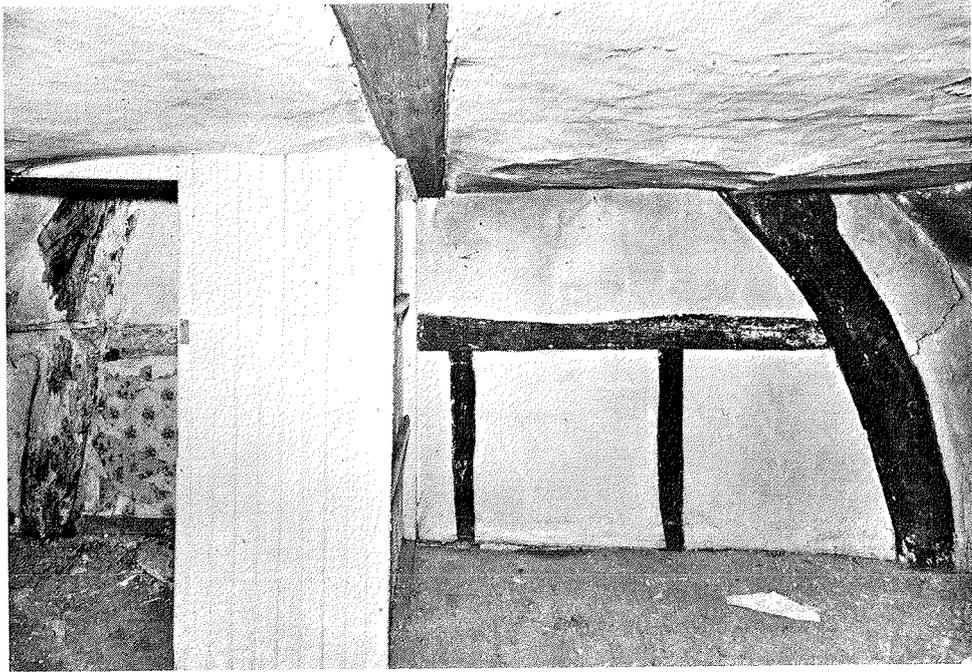
Plate Vb. S room looking S, showing cruck-framing in truss c-c'.  
*Crown Copyright*

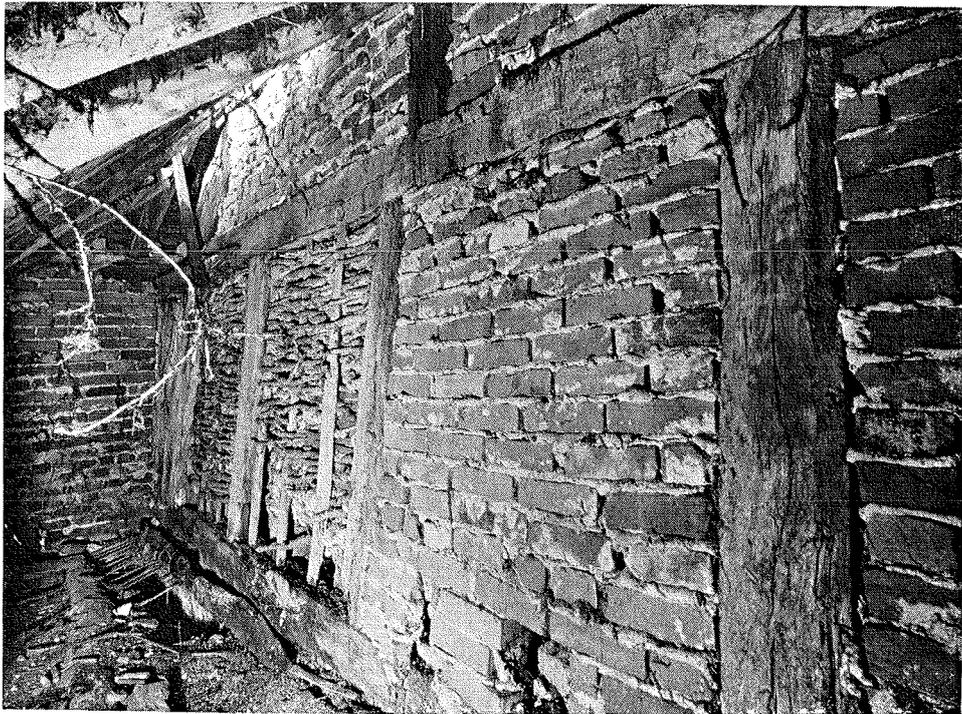
PLATE VIa. External framing on S end wall, from inside lean-to.

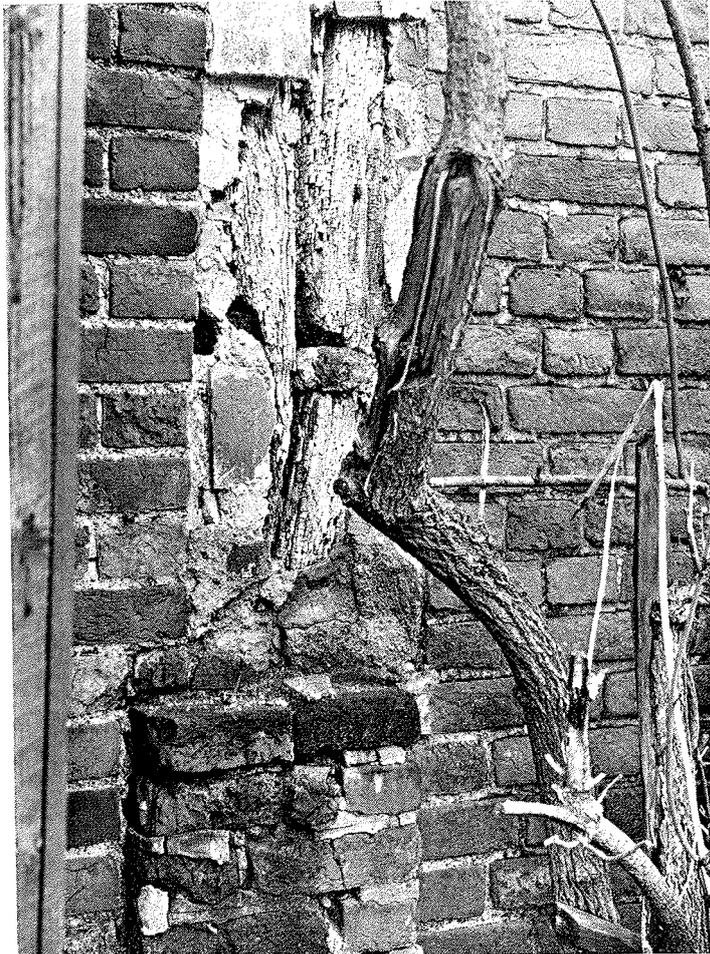
PLATE VIb. Front (W) elevation. Detail of cruck b-b' with  
brick pier.

The main features should be clear from the drawings. Three cruck trusses define the two bays of the hall (marked ab, bc on the plan). Both bays are of exactly the same length. In all essentials, the outer trusses are identical. The central truss is very similar to its neighbours, unless the lower rail—now supporting a ceiling—was not original to the structure. But the blades are narrower here, typically about 10 inches wide, as against 12-15 inches in both outer trusses. All the blades are about 9 inches thick, and have been underbuilt in brick. A sarsen stone is ledged under the W. end of Truss a-a' and a similar stone lies 6 feet from the W. end of Truss b-b'. No other large stones lie under, or near, cruck blades.
