BRADWELL ABBEY, BUCKINGHAMSHIRE RESEARCH AND EXCAVATION, 1968 TO 1987

D.C. MYNARD, P. WOODFIELD AND R. J. ZEEPVAT

Mr. Mynard was the head of the Milton Keynes Archaeology Unit until it was disbanded early in 1994. He and two colleagues here review all the evidence for the layout and function of the conventual buildings of Bradwell Abbey, Milton Keynes and assemble a complete reconstruction and structural history. A surprisingly large proportion of the standing buildings turns out to be medieval, or have medieval elements. The once prevalent view that the chapel on the site is a seventeenth-century structure built with old materials is finally laid to rest, and the chapel is shown to have been the centre of the healing cult of Our Lady of Bradwell. Its important wall paintings are fully described.

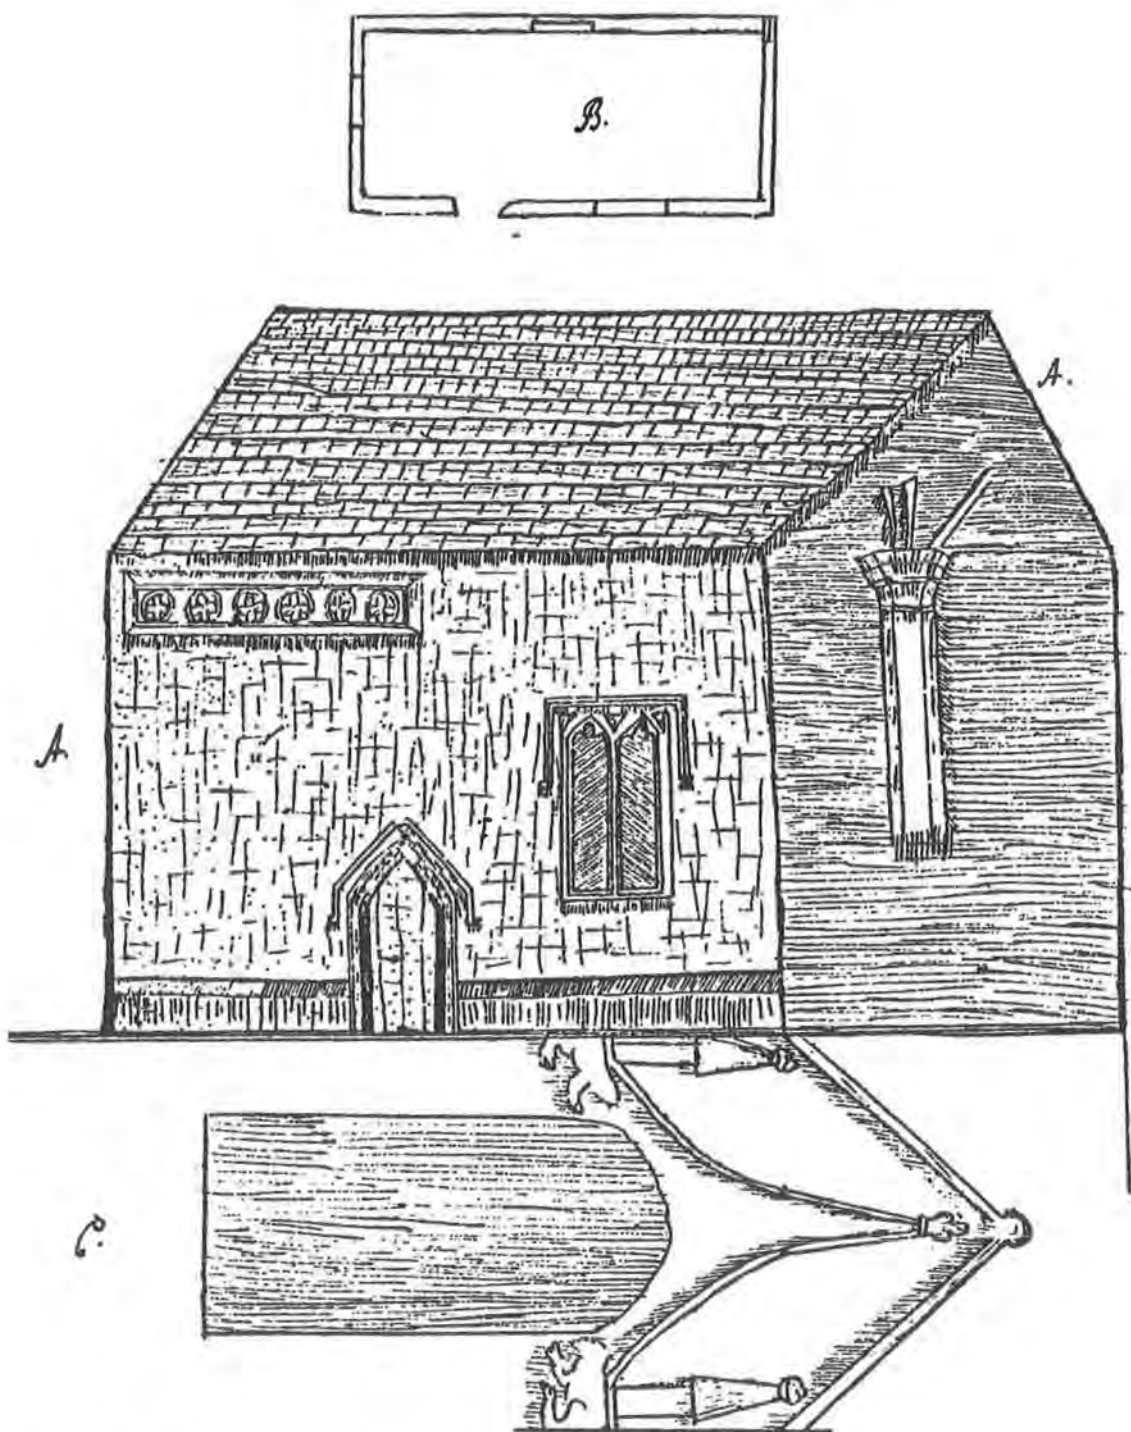
Fig. 8 The Browne Willis drawing of Bradwell Abbey chapel circa 1730.

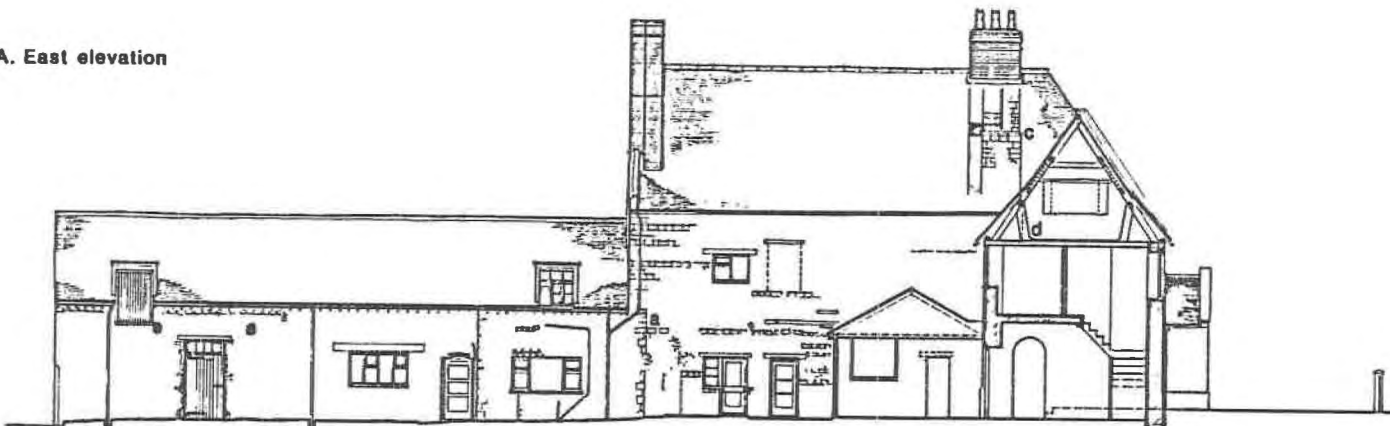
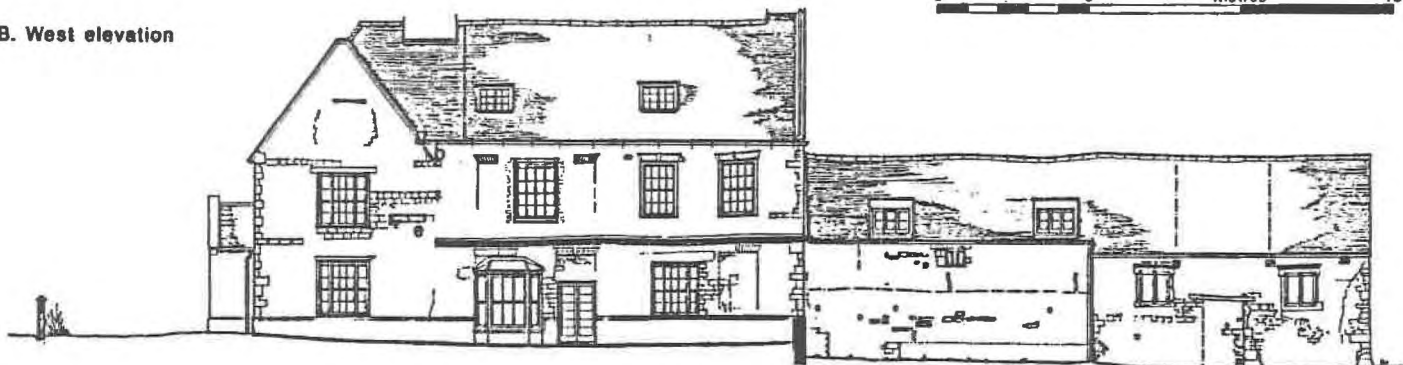
A. East elevation

B. West elevation

Fig. 10 The east and west elevations of the Farmhouse.

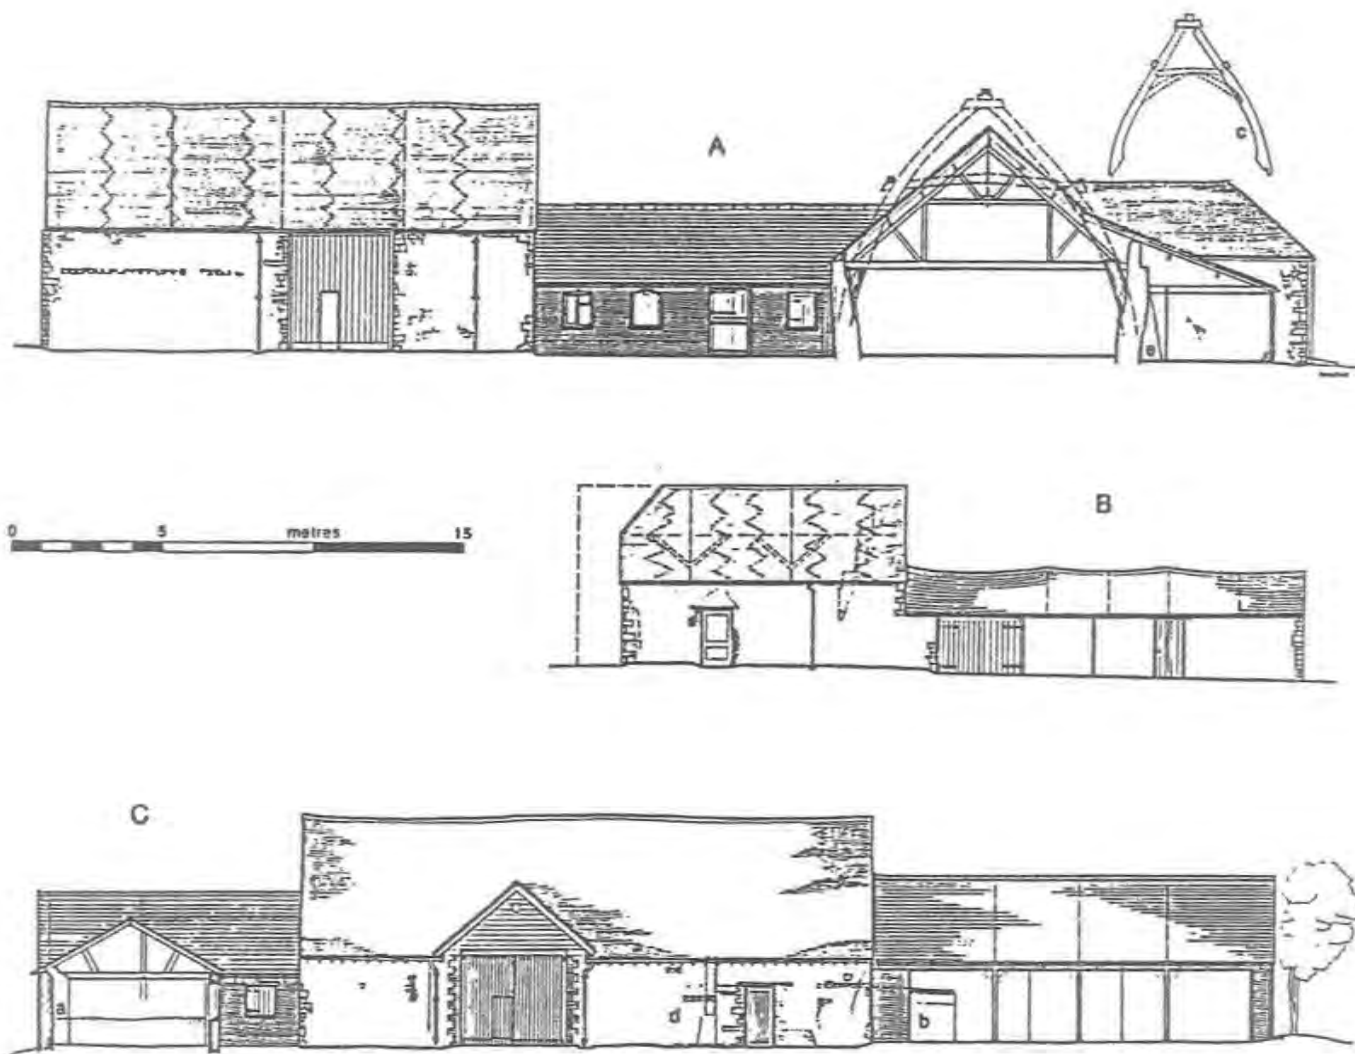
Fig. 11 A: The west elevation of the Stone Barn. B: The west elevation of the Bakehouse range. C: The north elevation Cruck Barn range.

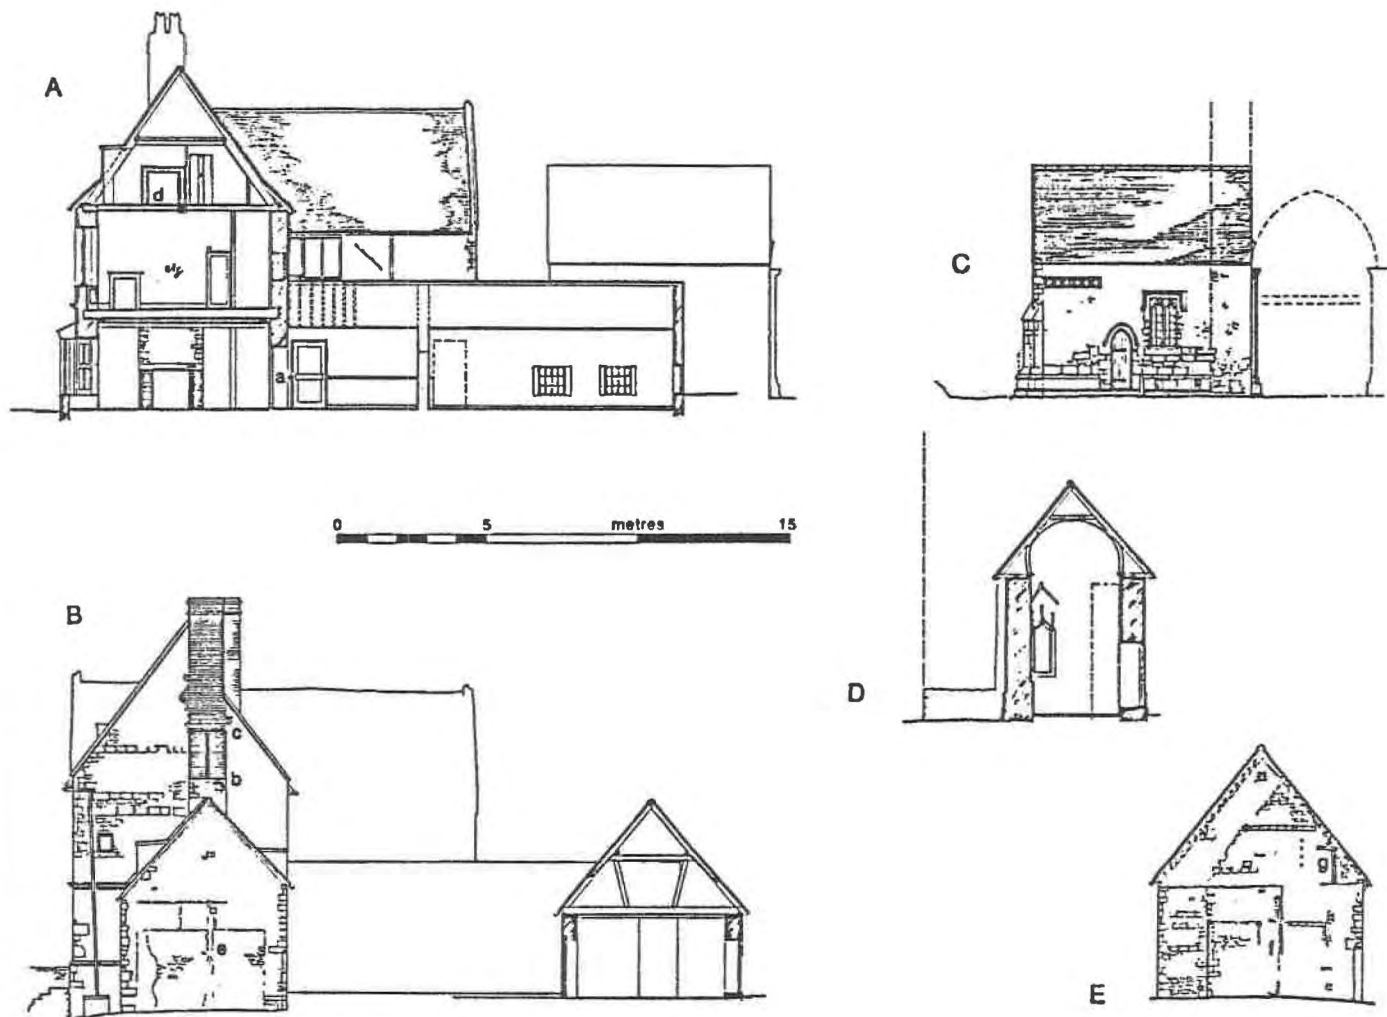
Fig. 12 A: Section through the Farmhouse. B: The south elevation of the Farmhouse and a section through the Bakehouse. C: The south elevation of the Chapel. D: Section through the chapel facing east. E: The north elevation of the Stone Barn.

The south gable of the whole range (Fig. 12B) clearly clasps earlier masonry, the top of which aligns well with the upper courses of the postulated medieval work, and is not unlike it in character despite recent clumsy pointing. Thus the medieval structure appears to have extended for 18.7m, the full length of this range. The extra thickness of the gable wall, and particularly the west wall, tends to confirm this. On the west face there is no explanation for a short course of gritstones at low level (Fig. 10B, f) which may, like some of the brick at ground level, represent repairs. The upper stage with the timber window then appears to be a post-medieval heightening of the range to provide a loft. Unfortunately the eastern elevation cannot cor-

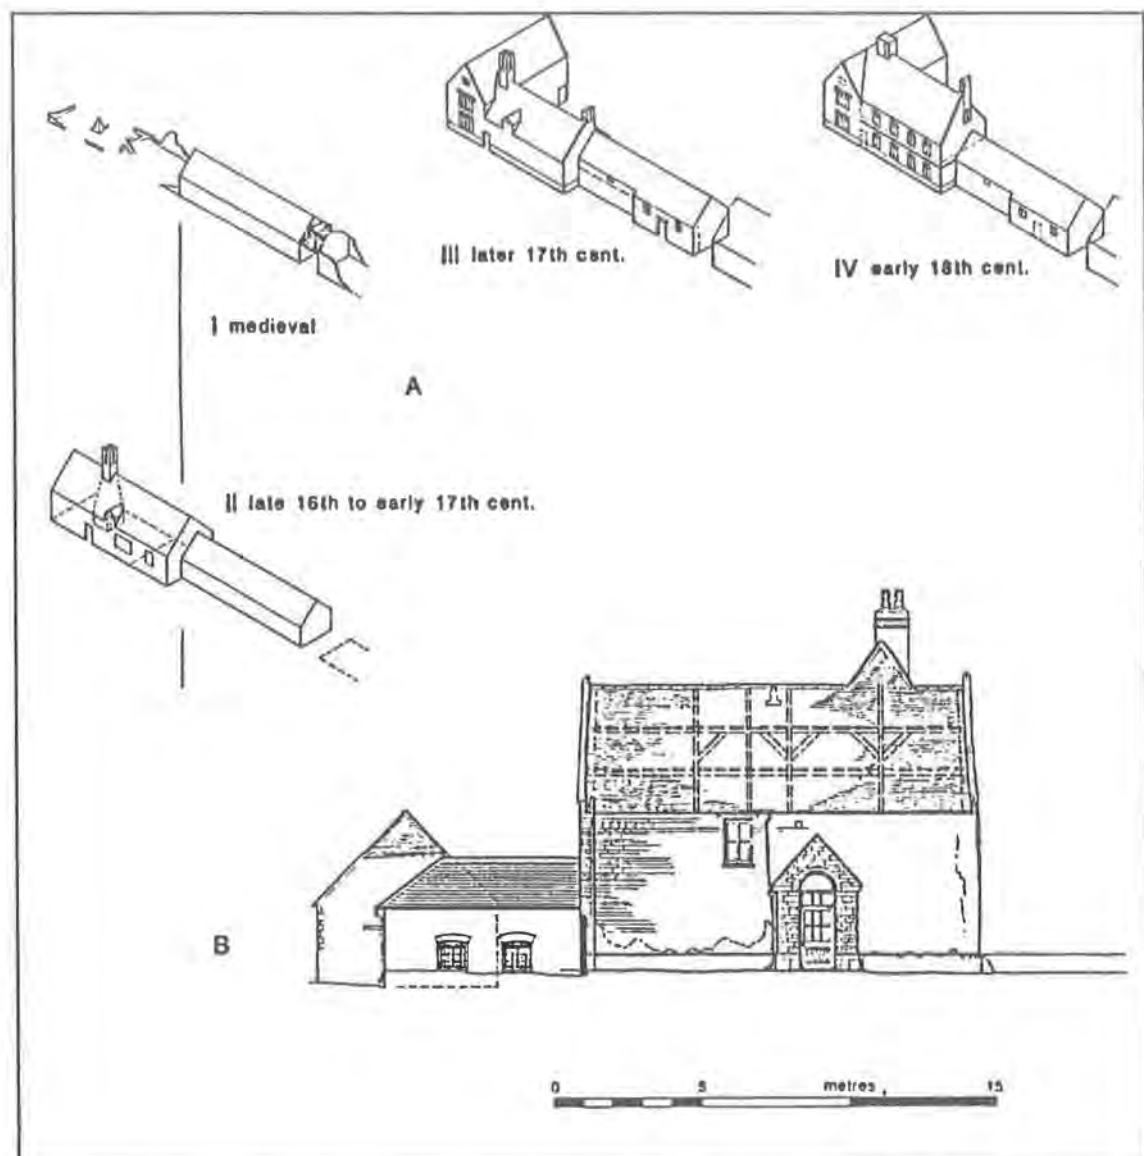
Fig. 13 A: The phases of development. B: The north elevation of the Farmhouse.

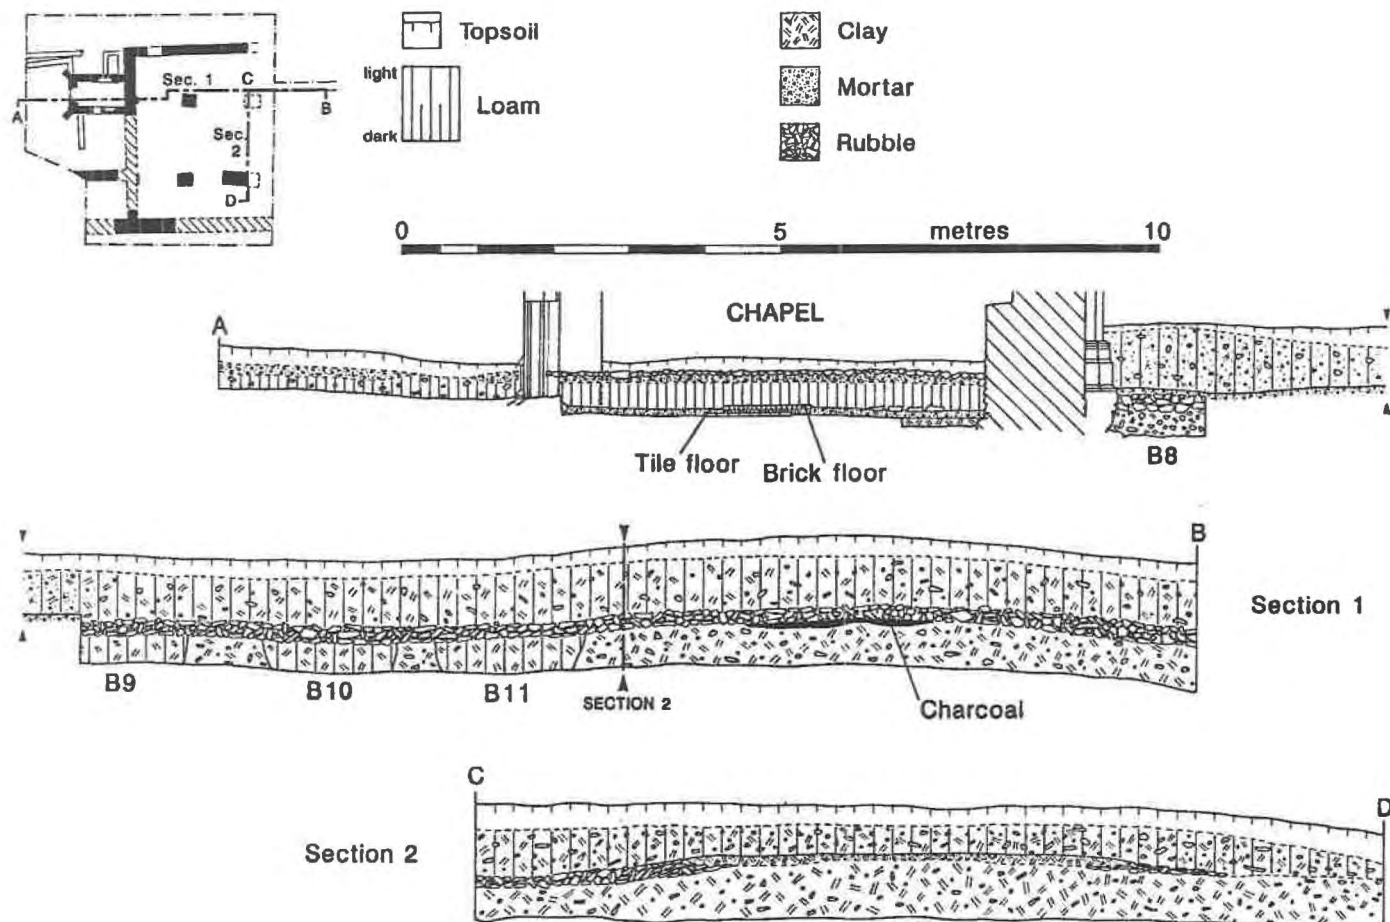
Fig. 15 Sections 1 and 2 through the Chapel and the west end of the Priory Church.

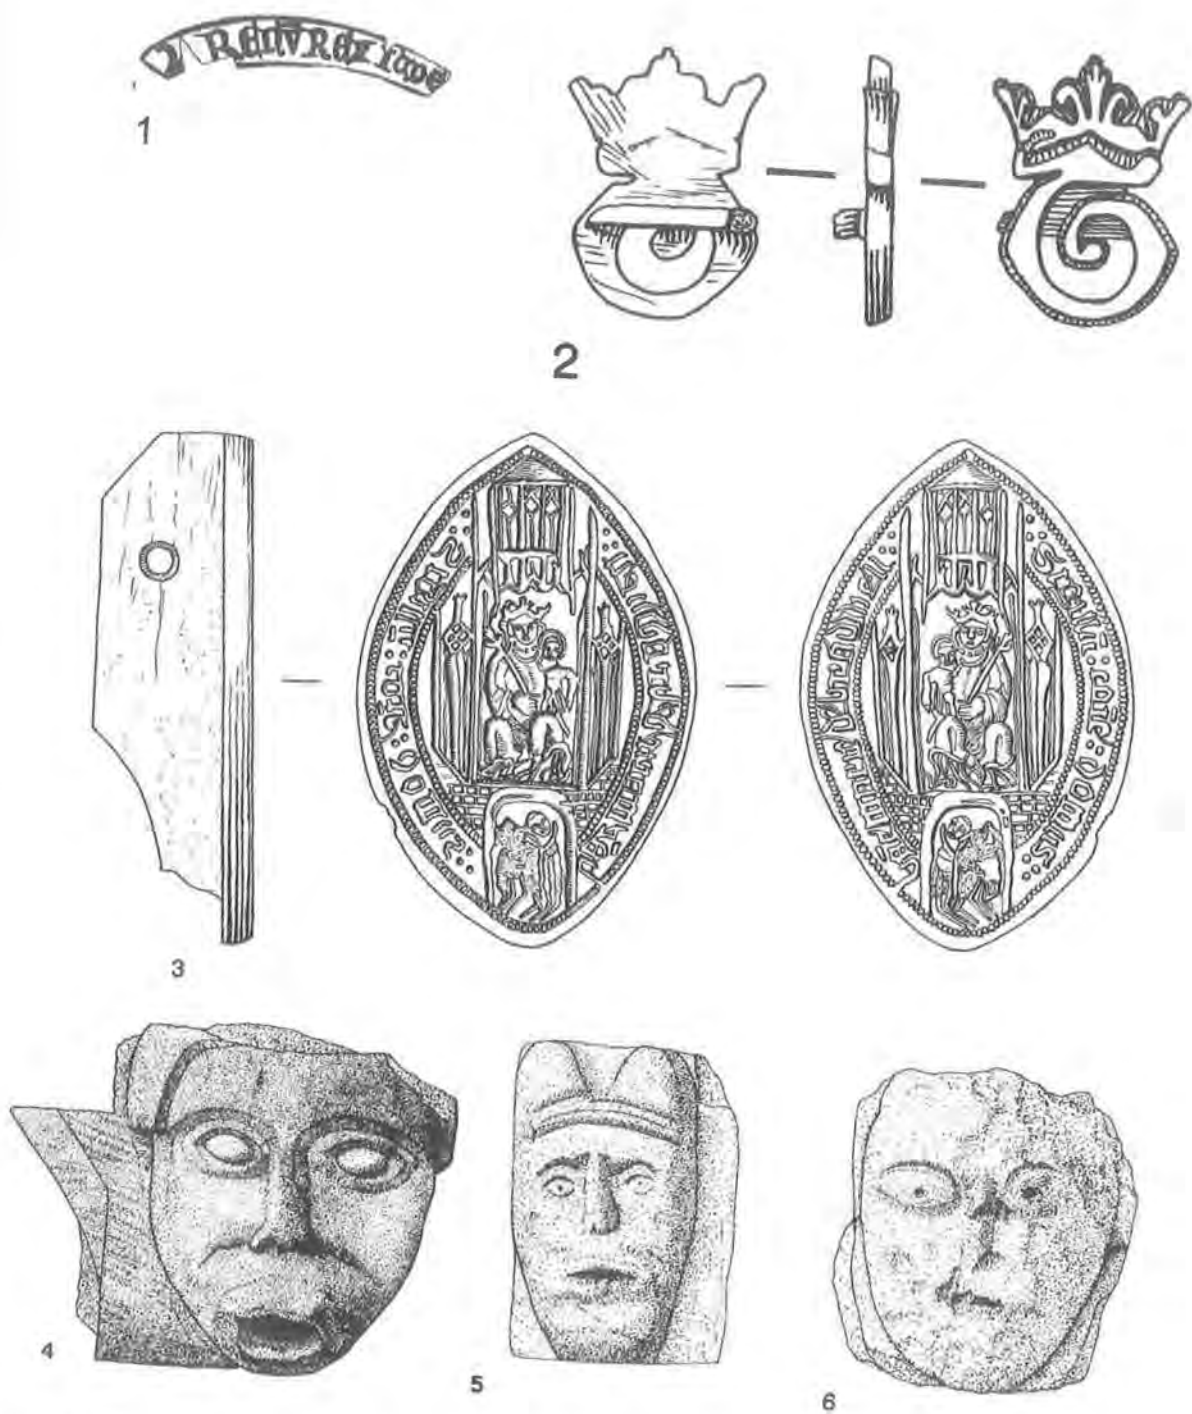
Fig. 19 1. The window glass, scale 1:2; 2. pilgrims' badge, scale 1:1; 3. The Seal of the Priory, scale 1:1; 4-6. Architectural stonework, scale 1:4.
