# AN EIGHTEENTH-CENTURY DOVECOTE AT STEWKLEY

*An octagonal brick dovecote of high quality dated 1704 survives at Stewkley in unusually good order; its features are described and interpreted.*

## *The site (SP 851 256)*

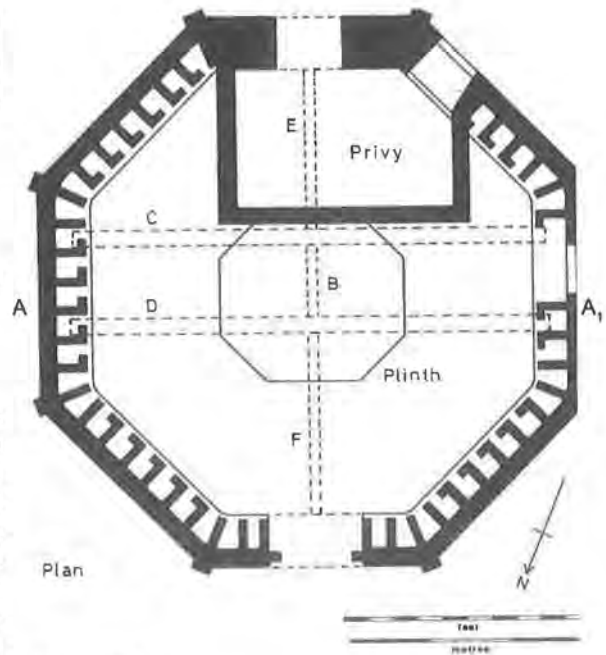
Figure 3. Plan.

The walls are lined with eighteen tiers of brick nest-boxes, starting 8 inches above the present brick floor. Most of them are 10 × 10 inches in plan by 8¾ inches high, with an entrance passage 5½ inches wide; less regular shapes are formed in the angles of the octagon and beside the door (Figure 3). A course of headers projects 2 inches to form an alighting ledge below each tier (Figure 8). The nest-boxes are carried over the door by a hardwood lintel 16 × 3 inches which continues the adjacent alight-

The insertion of the west window has destroyed or blocked 24 nest-boxes. Part of the interior was partitioned off in the nineteenth century to form a privy. 24 more nest-boxes were destroyed by the insertion of its south door, and another 16 by the insertion of its south-west window. Within the privy the nest-boxes and alighting ledges are blocked and plastered over to form flat wall surfaces, but they are still present within the plaster. Above the privy ceiling, 9 feet high, most of the

nest-boxes remain unaltered. Effectively some 80% of the original complement of nest-boxes remain unaffected by later alterations.

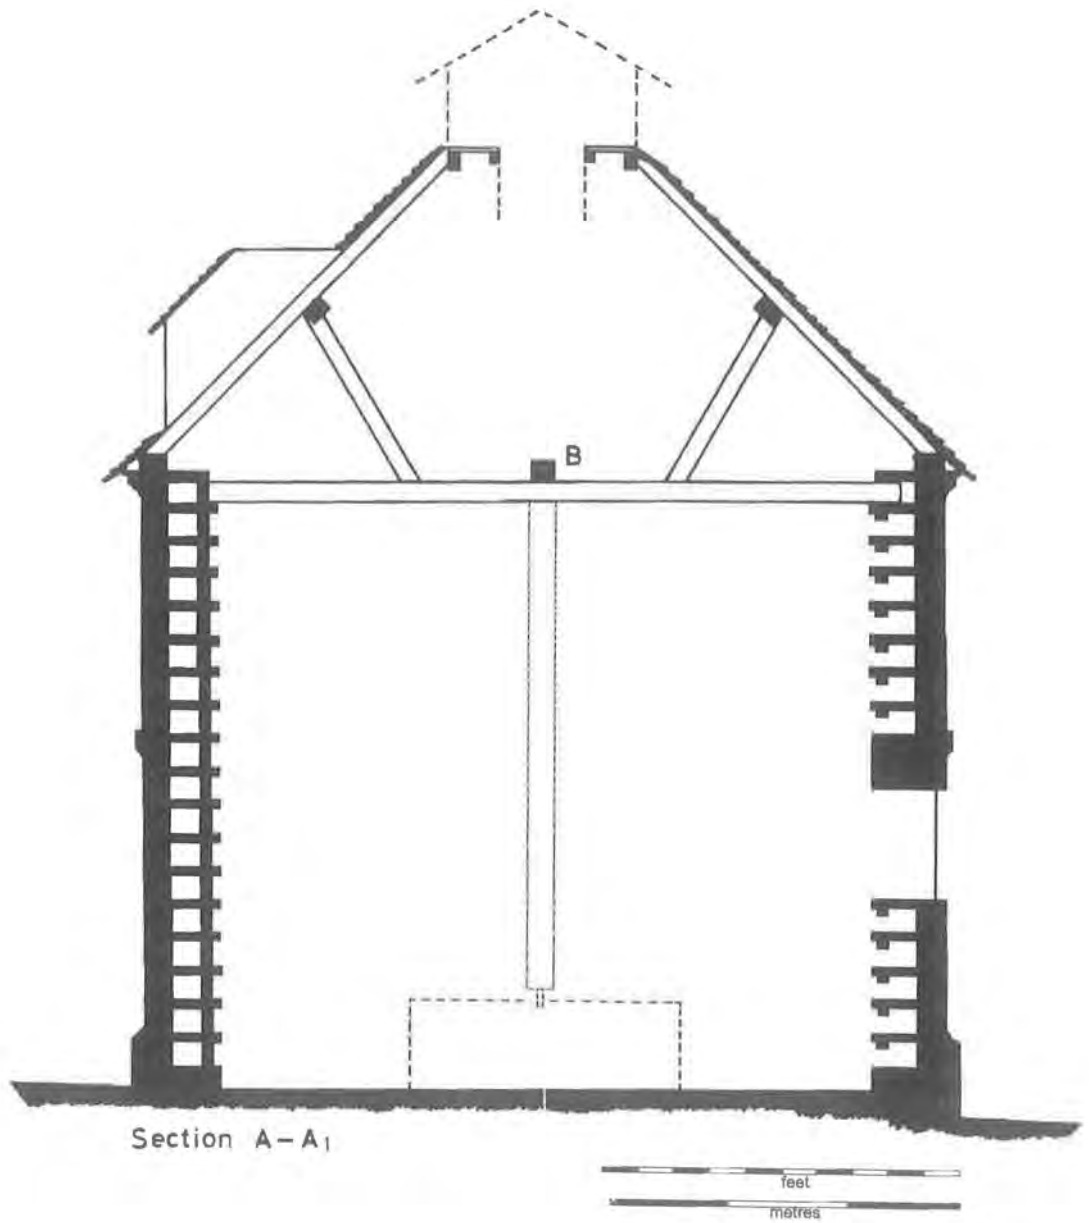
When examined the interior was obstructed by stacks of boxes and other lumber. Partly concealed in a corner against the inserted privy was the axis of a former *potence*, the revolving structure which carried a ladder on bracketed arms (Figure 4 and 9). Its purpose was to enable the pigeon-keeper to search the nest-boxes continuously, without having to descend to move his ladder. It is of oak, octagonal in section, bound at the end by a wrought iron ring, with an iron pivot. The upper bearing is still present, an iron plate spiked to a beam in the roof structure (B in Figures 3 and 4). The octagonal brick plinth which formerly supported the lower bearing has been demolished down to floor level, but it is still perceptible in the brick floor laid round it (Figures 3 and 4).

The present roof is original, of typical eighteenth-century carpentry, but it was augmented by a lower supporting structure at an early date (Figure 9). Principal rafters of 5 x 3 inch vertical section rise from the corners of the octagonal wallplate to an octagonal frame which formed the base of the louver. Purlins which vary in size are nailed below them a little below half-height. In each facet of the pyramid seven common rafters about 3 x 3 inches (some of re-used timber), are butted and nailed to the principals and upper frame. The later supporting structure comprises two oak beams C and D aligned east-west, to which two subsidiary beams E and F are butt-cogged, with wrought iron plates spiked across the joints (Fig. 4). Raking struts mounted on these timbers support the principals and purlins of the original structure.

**Figure 4.** Vertical section A - A<sub>1</sub>. The pecked lines indicate the former positions of features now missing or displaced - the louver and its roof, the 'pipe' which protected the entrance against sparrow-hawks, the axis of the former potence, and the plinth on which its lower bearing was mounted.

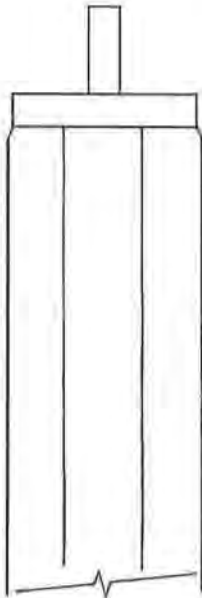
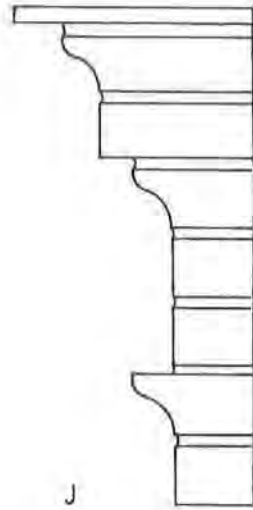
**Figure 5.**

- B Upper bearing of the former potence  
 G & H The axis of the former potence in plan and elevation  
 J Profile of a capital

- K Profile of the string course  
 L A cyma reversa moulded brick in elevation  
 M A convex-moulded brick in elevation  
 N A weathered brick in elevation

All other elaboration of the brickwork is ingeniously contrived from purpose-moulded bricks of three shapes. The cornice, the capitals, the lowest course of the string, and the border round the datestone are formed from bricks moulded to a cyma reversa profile (L in Figure 4). A small surplus of these bricks was used to form the ornamental heads of the top tier of nest-boxes. Where the cornices and string course return round the pilasters the moulded bricks were axed and rubbed to the same profile. Rubbed bricks of plain shapes were used in the pilasters, in the plain courses of the string and cornice, and in the arch of the north doorway. Softer bricks containing more sand were used for rubbing; the material exposed was of a more orange-red colour than the remainder. Bricks of simple convex shape were moulded for the ornamental heads of the nest-boxes (M in Figure 4).

The top-most course of the plinth is made partly from simple weathered bricks (N in Figure 4), and partly from cyma reversa bricks. The latter start at the west side of the original doorway and continue round four of the eight faces; then the plinth is continued with simple weathered bricks as far as the east side of the doorway. It would be tempting

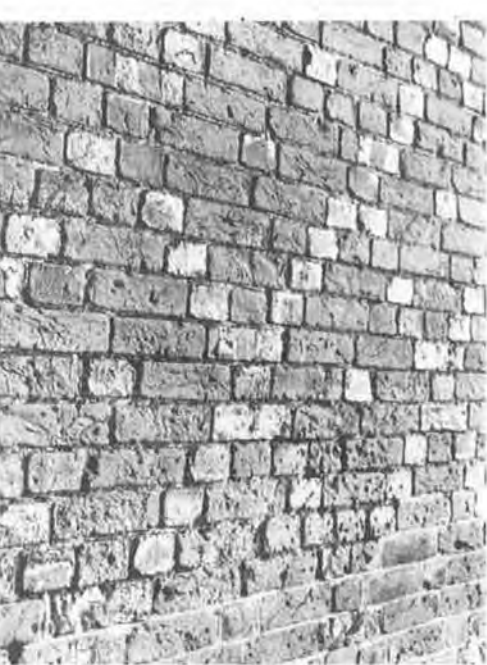
**Figure 6.** A section of the brickwork with the sun glinting on the vitrified blue bricks which form the diaper pattern. The nail-holes near the bottom indicate that fruit has been grown against the wall.

The blue bricks used were of the same clay, and made by the same process as the normal red bricks, but because the temperature in the kiln or clamp was uneven some bricks would emerge under-fired, others over-fired. The under-fired bricks were discarded or used for inferior purposes. The over-fired bricks could be selected for decorative use. Many of them were so overheated that the surface has literally turned to glass (Figure 6). Both headers and stretchers are used in the diaper patterns here.

In the first edition 1/2500 Ordnance Survey map surveyed in 1880 the dovecote is shown still within a garden south of the house. Numerous nail-holes in the brickwork up to half-height show that fruit has been grown against it. None of the farm buildings now used for the egg-packing business were then present, so the dovecote was over fifty metres from the nearest building. Whenever practicable dovecotes were sited well away from other buildings and large trees so that the pigeons could see birds of prey approaching.<sup>5</sup> In 1880 there was a rectangular pond 65 metres to the west-south-west, still perceptible as a patch of marshy ground. Dovecotes were always sited near water because the adult birds had to carry water to their young in their beaks,

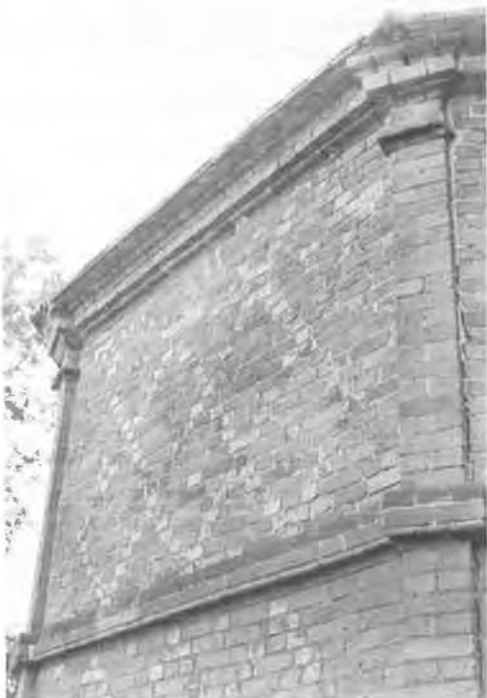
**Figure 7. (below)** The pilasters, capitals, eaves cornice, string course and diaper-patterned brickwork.

The dovecote is octagonal in plan, with a weathered plinth standing seven to eleven courses above the sloping concrete. A full-height pilaster at each angle has a simple capital integrated with a moulded eaves cornice, and a moulded string course encloses the pilasters (Figure 7). The pyramidal roof is clad with hand-made plain tiles and hipped with lead with a hipped dormer facing east. The former louver where the pigeons entered has not survived; its leaded roof is now mounted directly on the main roof, and bears a wrought iron weathervane.

The red bricks are  $8\frac{1}{2} \times 4 \times 2\frac{1}{4}$  inches, laid in Flemish bond with lime mortar, four courses rising 11 inches. The flat panels of brickwork are embellished with diaper patterns of flared blue bricks (Figure 6 and 7), omitted on the north face where the space is limited by a doorway and datestone. The patterns are interrupted by an inserted doorway in the south face and inserted windows in the west and south-west faces, all characteristic of the nineteenth century. The north doorway is original and

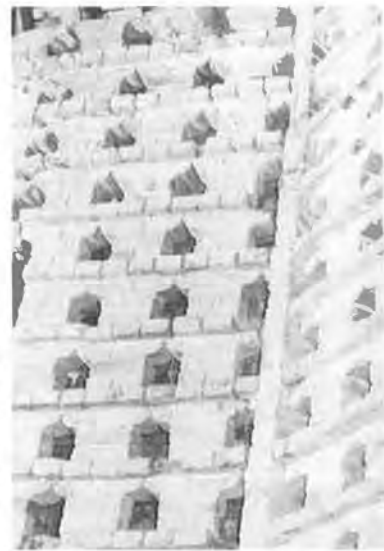
**Figure 8. (right)** The nest-boxes, with ornamental heads each formed by two moulded bricks, and an alighting ledge to each tier.

ing ledge. The four lowest tiers of nest-boxes have plain heads, but those above all have ornamental heads, mostly formed by bringing together the convex ends of two purpose-moulded bricks (Figure 8). The top tier is exceptional in that the heads are formed with cyma reversa bricks. Originally there were 56 nest-boxes in each complete tier; allowing for those omitted at the door there were 987 in all. Examination of the construction shows that the pilasters and external 8½-inch walls were built first, and rendered inside. The inner brick structure comprising the nest-boxes is mounted on the same plinth but was built independently, apparently not keyed to the outer wall. In accordance with traditional practice the interior has been limewashed,

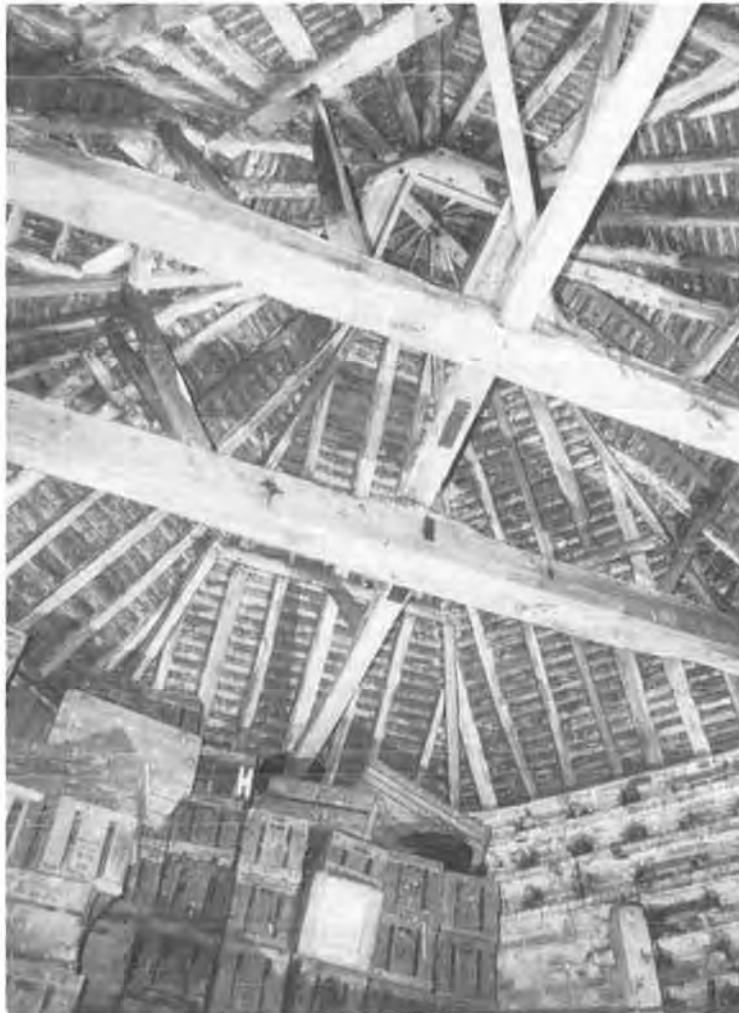
**Figure 9. (below right)** The roof structure and western walls above the inserted privy, showing the square aperture through which the pigeons entered. The axis of the former potence is at bottom right, and its upper bearing is at the Centre.

The dormer is glazed with leaded rectangular panes. The glazing itself has been renewed, but there would have been glazing or a protective grill here from the outset. The pigeons entered by the louver at the highest point of the roof, passing through narrow entrance slots which kept out the larger birds of prey. From the base of the louver the pigeons descended into the interior through a framed aperture 2 feet 2 inches square. Where a dovecote has retained all its original features - a

The alteration to the roof is a familiar phenomenon. Owners of dovecotes wanted the roof space to be free of tiebeams and other projections, partly to allow the pigeons free circulation space, but primarily to avoid providing perching places for any bird of prey which might penetrate to the interior.<sup>4</sup> Unfortunately in this desire they often failed to tie the roof sufficiently against expanding forces. It is quite common in historic dovecotes to find that additional tiebeams have been inserted after the original construction to check the strain on the wall heads. Here the beams C and D are set into the top tier of nest-boxes, blocking four of them. The short member which holds the upper bearing B of the former *potence* is laid over them and spiked down, which proves that this structure was inserted while the dovecote was still in use.
