PEASANTS, PEERS AND GRAZIERS: THE LANDSCAPE OF QUARRENDON, BUCKINGHAMSHIRE, INTERPRETED

PAUL EVERSON

The medieval and later earthworks at Quarrendon, surveyed by staff of the former Royal Commission on the Historical Monuments of England (now English Heritage), are described and interpreted. They reveal a sequence of major land-use phases that can be related coherently to topographical, documentary and architectural evidence. The earliest element may be the site of St Peter's church, located alongside a causeway. The evidence for its architectural development and decline is assembled. The site of a set of almshouses in the churchyard is identified. In the later medieval period, there were two separate foci of settlement, each similarly comprising a loose grouping of farmsteads around a green. It is argued that these form components of a form of dispersed settlement pattern in the parish and wider locality. Following conversion for sheep, depopulation and engrossment by the Lee family, merchant graziers of Warwick, a 16th-century moated country mansion was created, with accompanying formal gardens, warren and park. This was one of a group of residences in Buckinghamshire and north

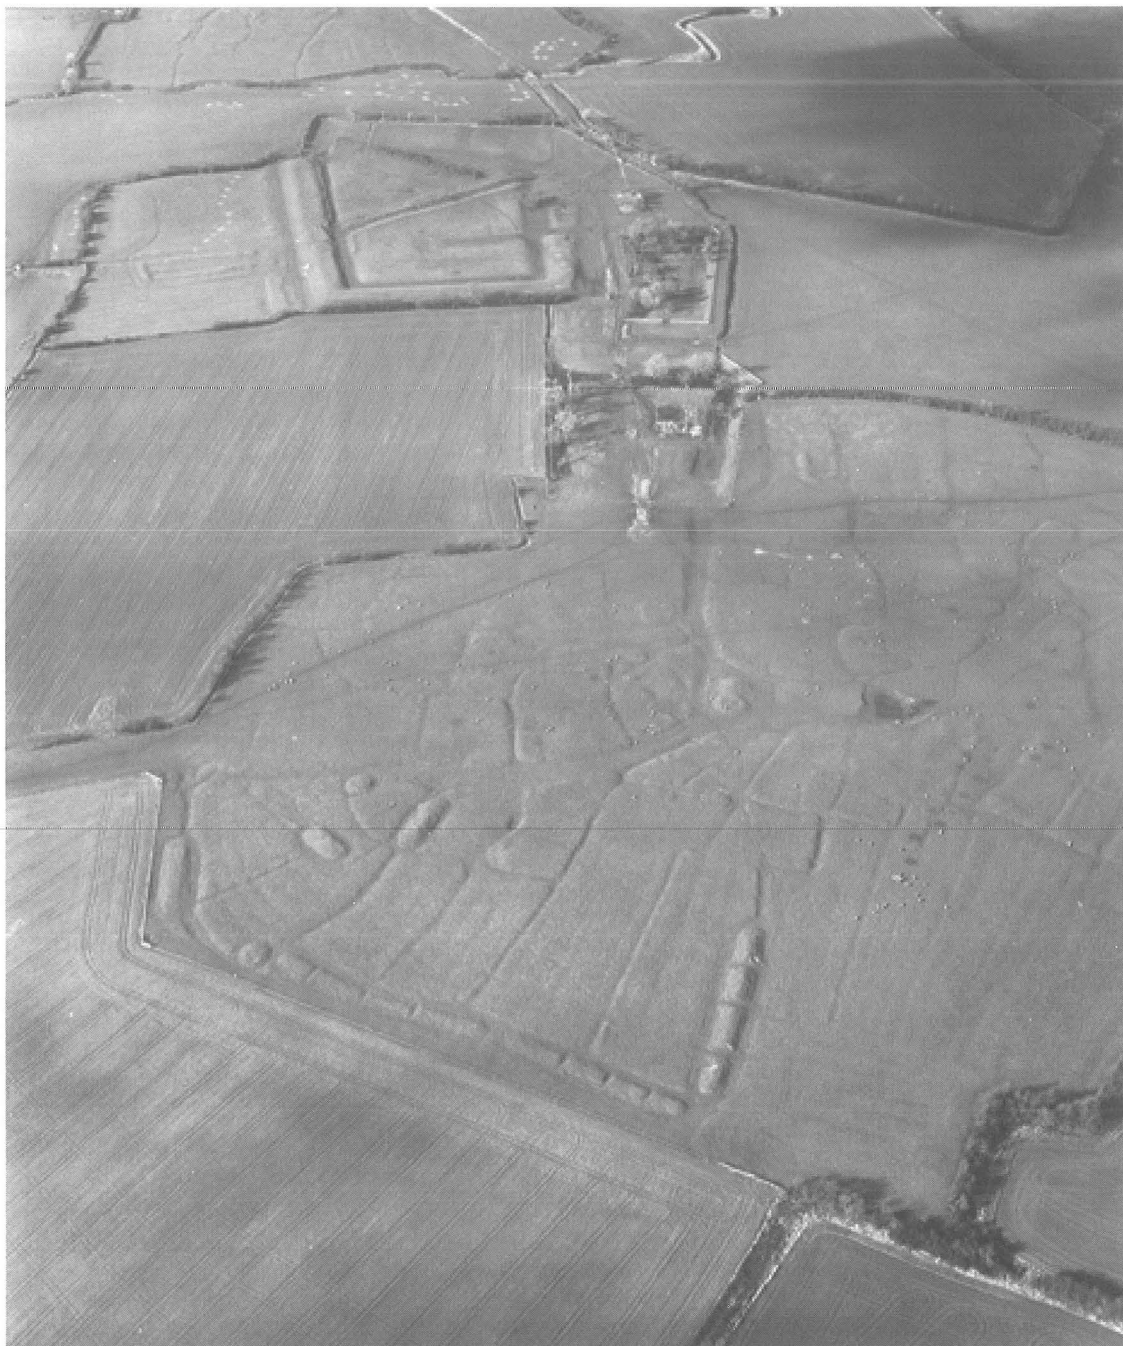
FIGURE 2 Aerial photographic view of the earthworks at Quarrendon from the east, showing the Warren and 'Quarrendon I' settlement remains in the foreground, the moat in centre picture, formal garden terraces and church ruins beyond, and 'Quarrendon II' settlement remains top left beyond the stream (NMR SP 8015/78; © Crown copyright.NMR)

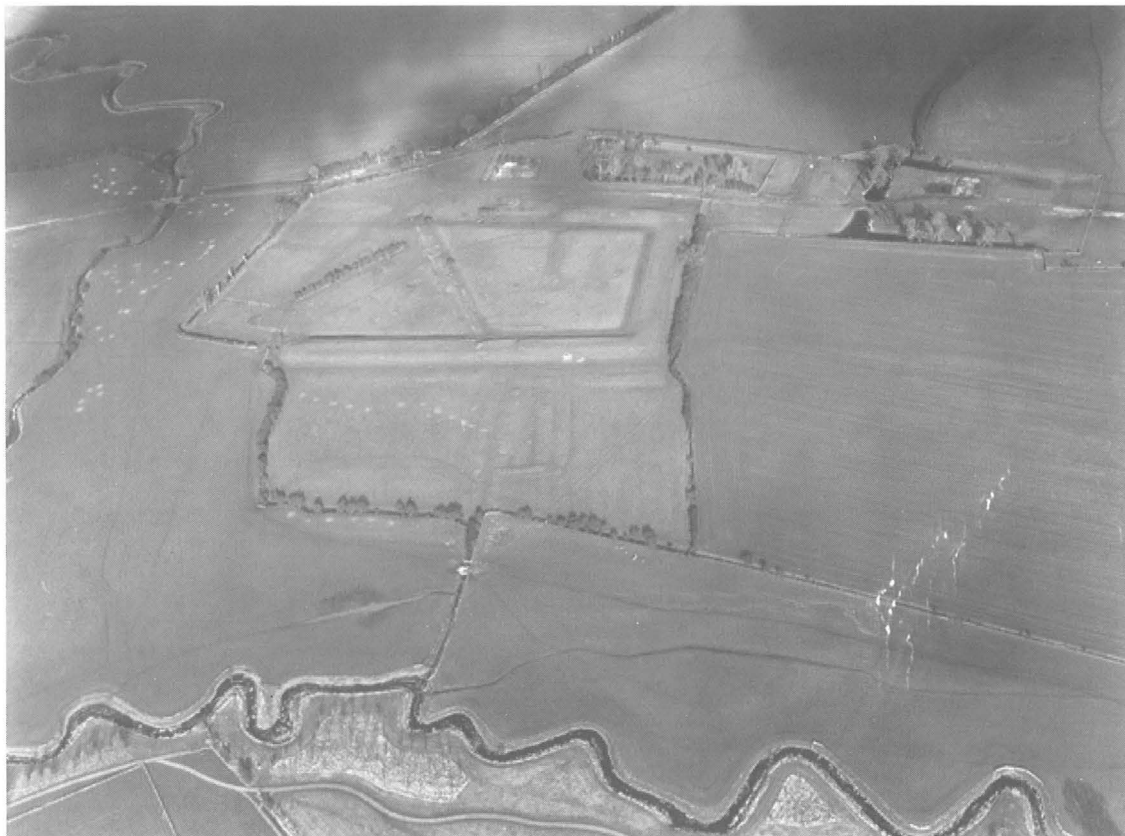
FIGURE 3 Aerial photographic view of the moated 16th-century house site and formal gardens from the south; River Thames in the foreground (NMR SP 8015/76; © Crown copyright.NMR)

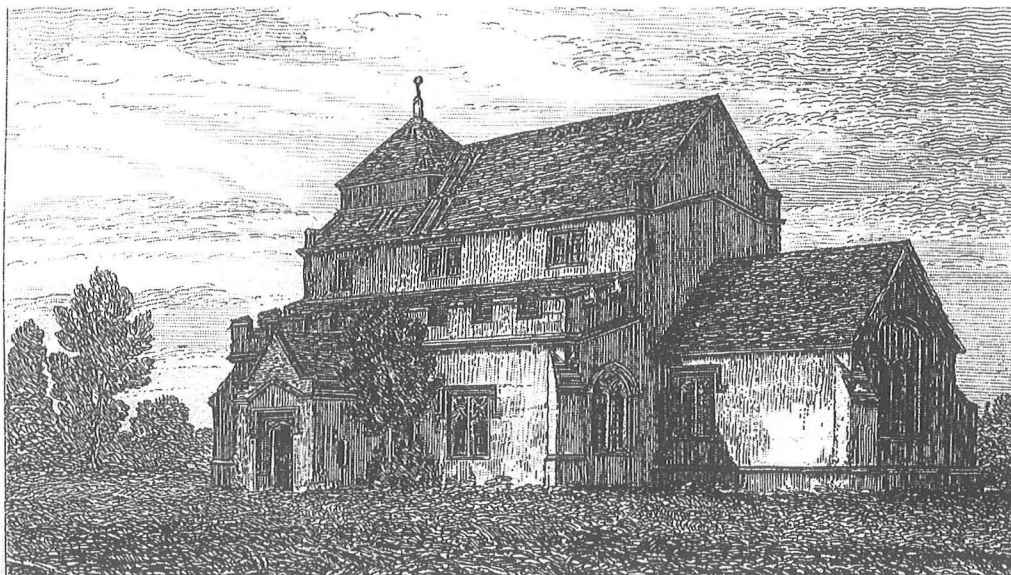
FIGURE 4 Engraved view of St Peter's church at Quarrendon in 1815 from the south-east, reproduced from Bickersteth 1859-62

Figures 4 and 5). Lipscomb, the county historian and one of the pseudonymous authors of the contributions to the *Gentleman's Magazine*, consolidated these descriptions in his county history (1847, II, 406). The engravings were reproduced in support of Archdeacon Bickersteth's rallying call to members of the newly founded Buckinghamshire Architectural and Archaeological Society to care for what remained of the building (Bickersteth 1859-62), following renewed expressions of concern at the way it was being robbed of dressed stone (Anon 1854-8a). Three further published engravings – two perhaps of 1828 (Figures 6 and 7) and the third of the 1850s (Figure 8) – though of

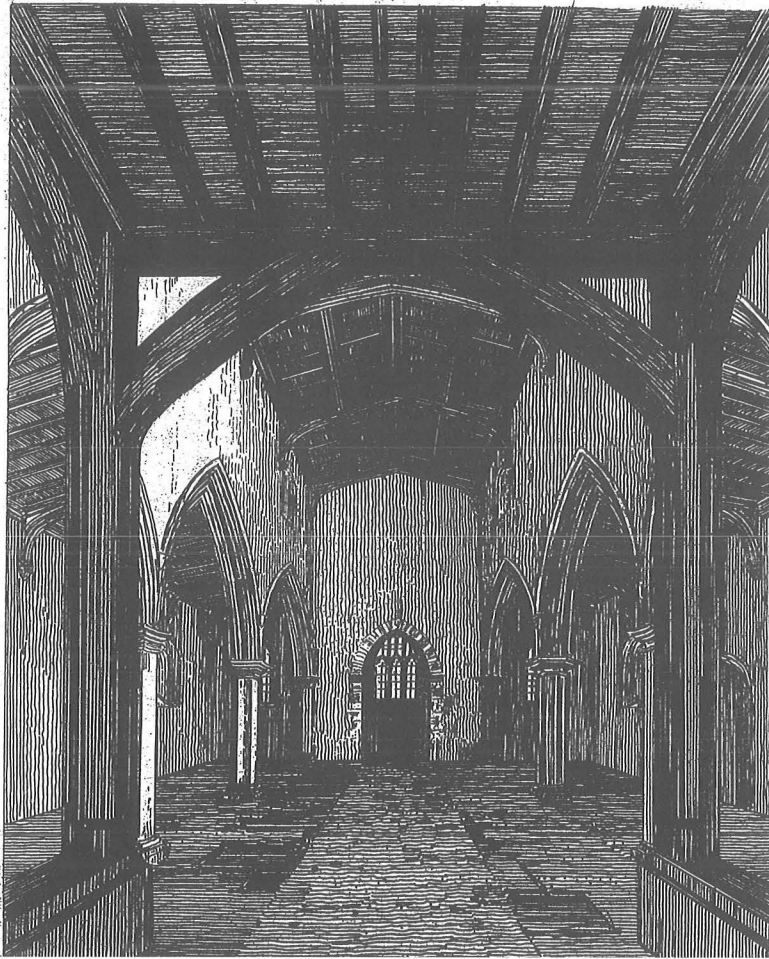
FIGURE 5 Engraved internal view of St Peter's church at Quarrendon in 1815 looking east, reproduced from Bickersteth 1859-62

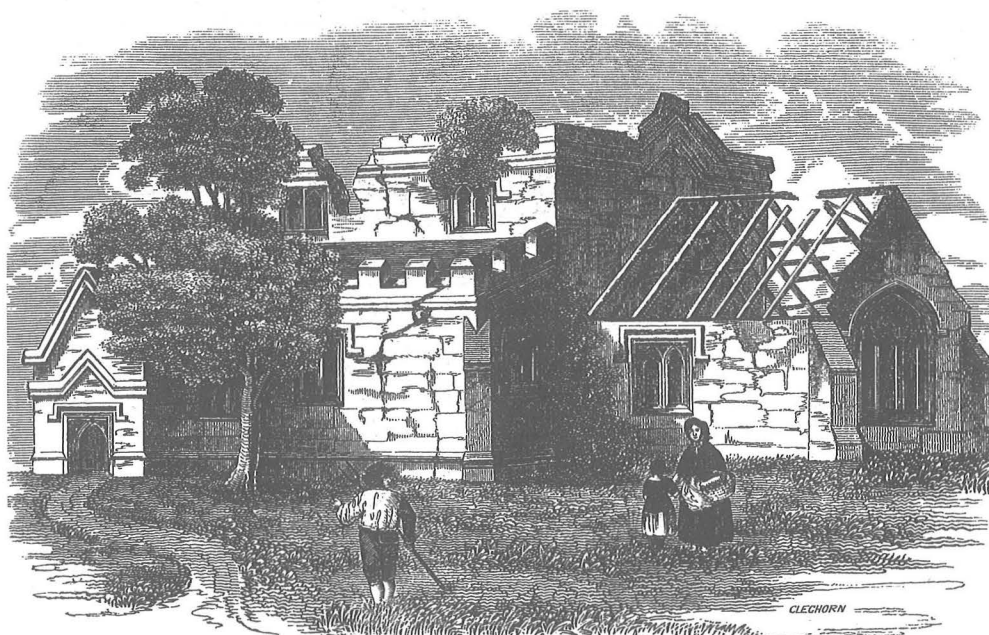
FIGURE 6 Engraved view of St Peter's church at Quarrendon in 1828 from the south-east, reproduced from Anon 1864, Plate 14

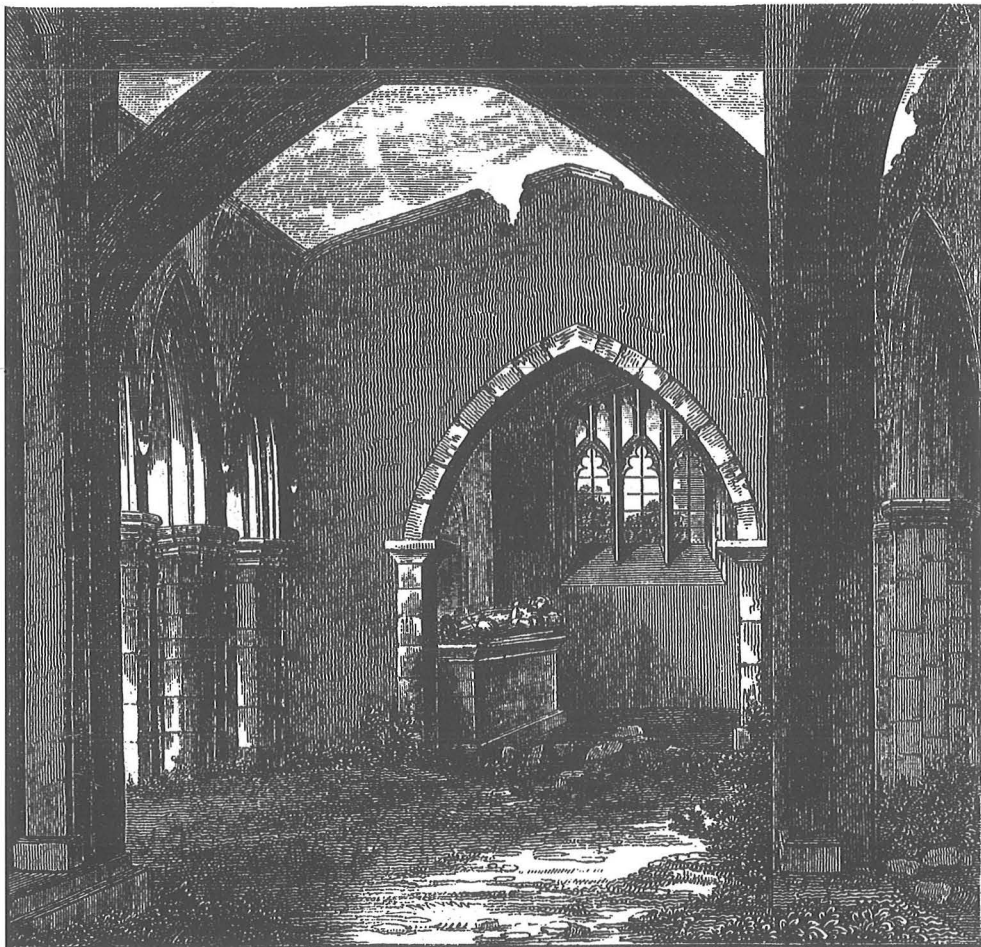
FIGURE 7 Engraved internal view of St Peter's church at Quarrendon in 1828 looking east, reproduced from Anon 1864, Plate 15

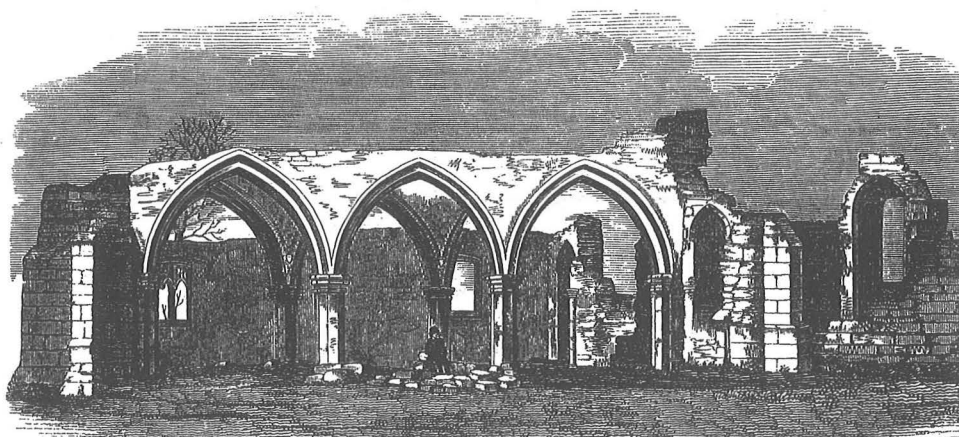
FIGURE 8 Engraved view of St Peter's church at Quarrendon in the 1850s from the south, reproduced from Anon 1864, Plate 16

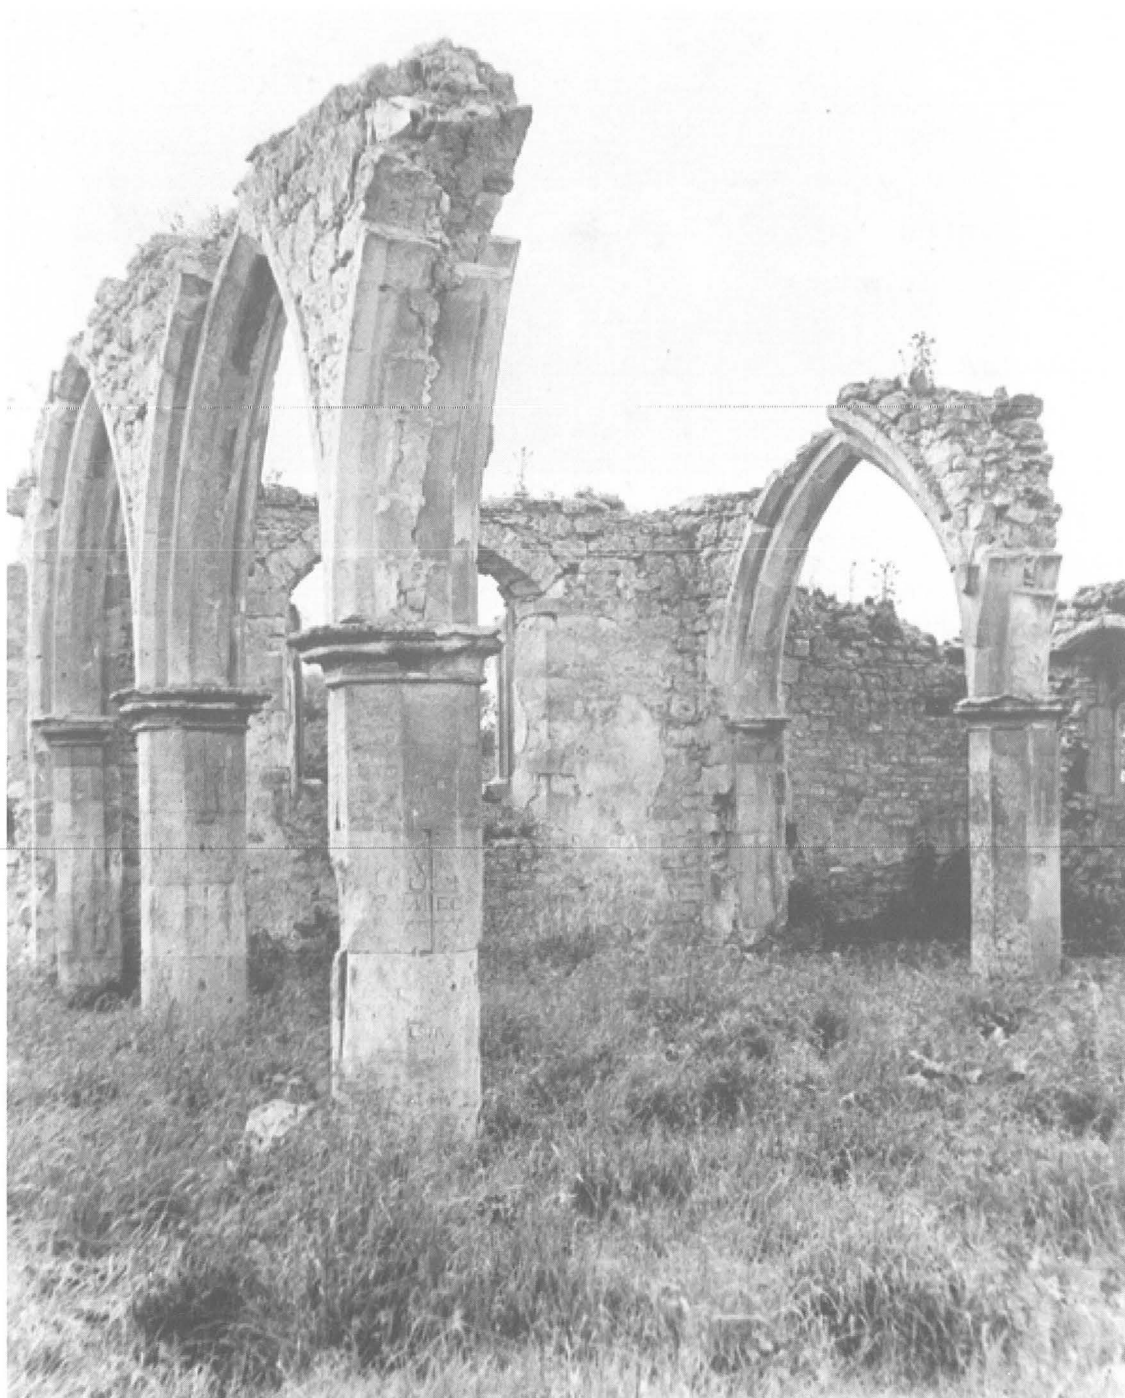
FIGURE 9 View of the nave arcades and inner west end of St Peter's church at Quarrendon looking north-west, ? before 1905 (photo Buckinghamshire County Museum; image reference AYBCM Quarrendon1, reproduced by permission of the Museum)

Museum appear to show the ruin in about 1905 (Figure 9): certainly they complement the investigation by RCHM(E) staff in the period 1909-11, which made a valuable drawn record of the plan and the last vestiges of architectural detailing and mouldings of the chancel east window, of the arcade capitals and labels and of a north aisle window (Figure 10; NMR, Investigators' notes on Quarrendon parish, *Buckinghamshire 1 (south)*).

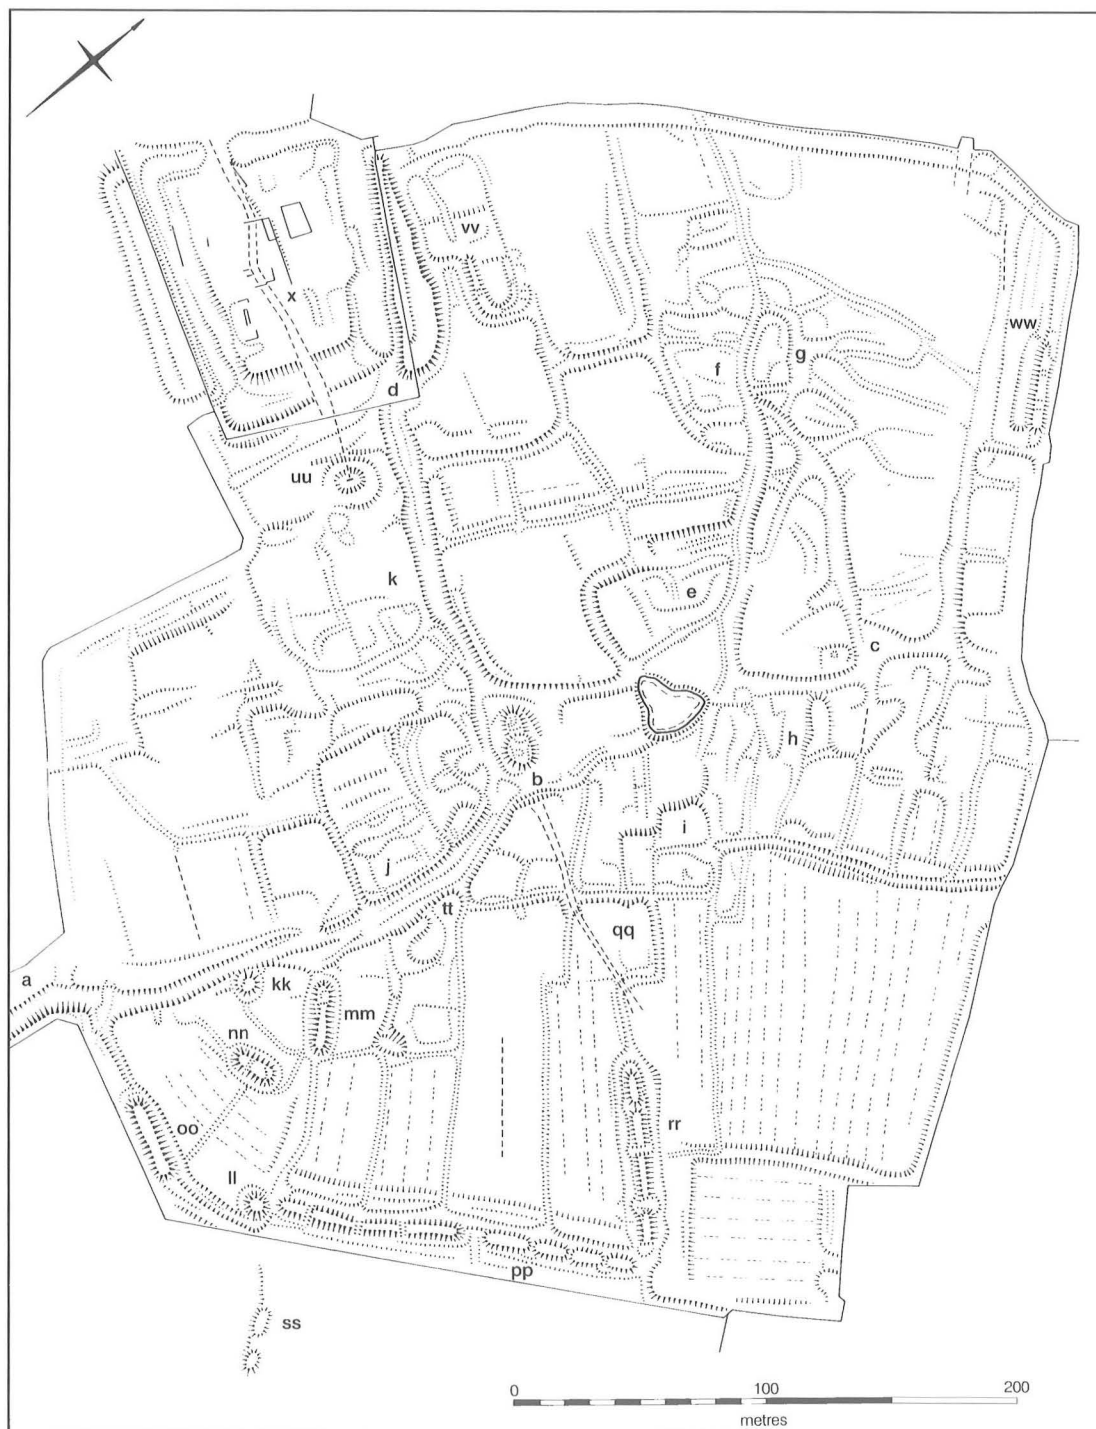
FIGURE 12 RCHME's surveyed plan of the eastern sector of the earthworks, including 'Quarrendon I' settlement remains and the Warren, original at 1:1000

At 'b' on plan (Figure 12), sited within the main junction of hollow-ways of the settlement remains, is a large bi-partite mound measuring 25m by 11m overall. Its east end stands to 1.5m in height and has a flattish top like a building platform, which is quite circular and dished to the centre. Air photographs in optimum conditions suggest a wall foundation around the top. There is no surrounding ditch. This has previously been interpreted as a windmill mound (Ordnance Survey Record Card), though its positioning for that is bizarre and its form unconvincing. Despite a superficial similarity with the nearby warren mounds, it differs from them in most specific details and lies outside the warren and away from a skyline location. Its most plausible interpretation in the context is as a dove-cote, similar perhaps to the surviving 16th-century example within the county at Dinton Hall (English Heritage 1995).

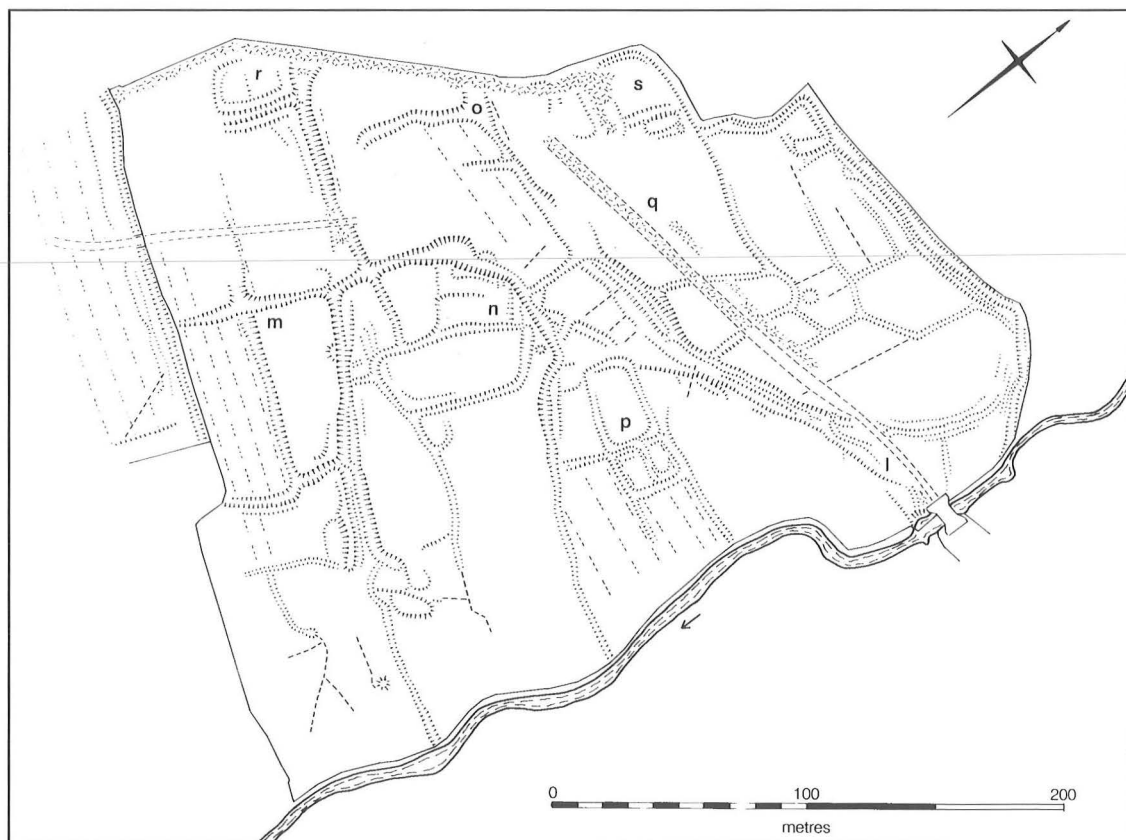
FIGURE 13 RCHME's surveyed plan of the western sector of the earthworks, including 'Quarrendon II' settlement remains, original at 1:1000

The tithe map shows a dwelling on the west side of Quarrendon II, north of 's' on plan (Figure 13), called 'four cottages and gardens', which now lies in arable, and also a 'cottage and garden' with 'yard and buildings' to the south-west of the church at 'v' on plan (Figure 14), which survived as an occupied plot into the later 19th century. Some of the footings of the cottage and the floor of one of the outbuildings are traceable within a plot clearly defined by a curving ditch on the east and scarps to the south and west. It overlies and obscures the west end of an earlier, long building platform, 'u', interpreted here as the site of a row of almshouses situated along the southern boundary of the churchyard.

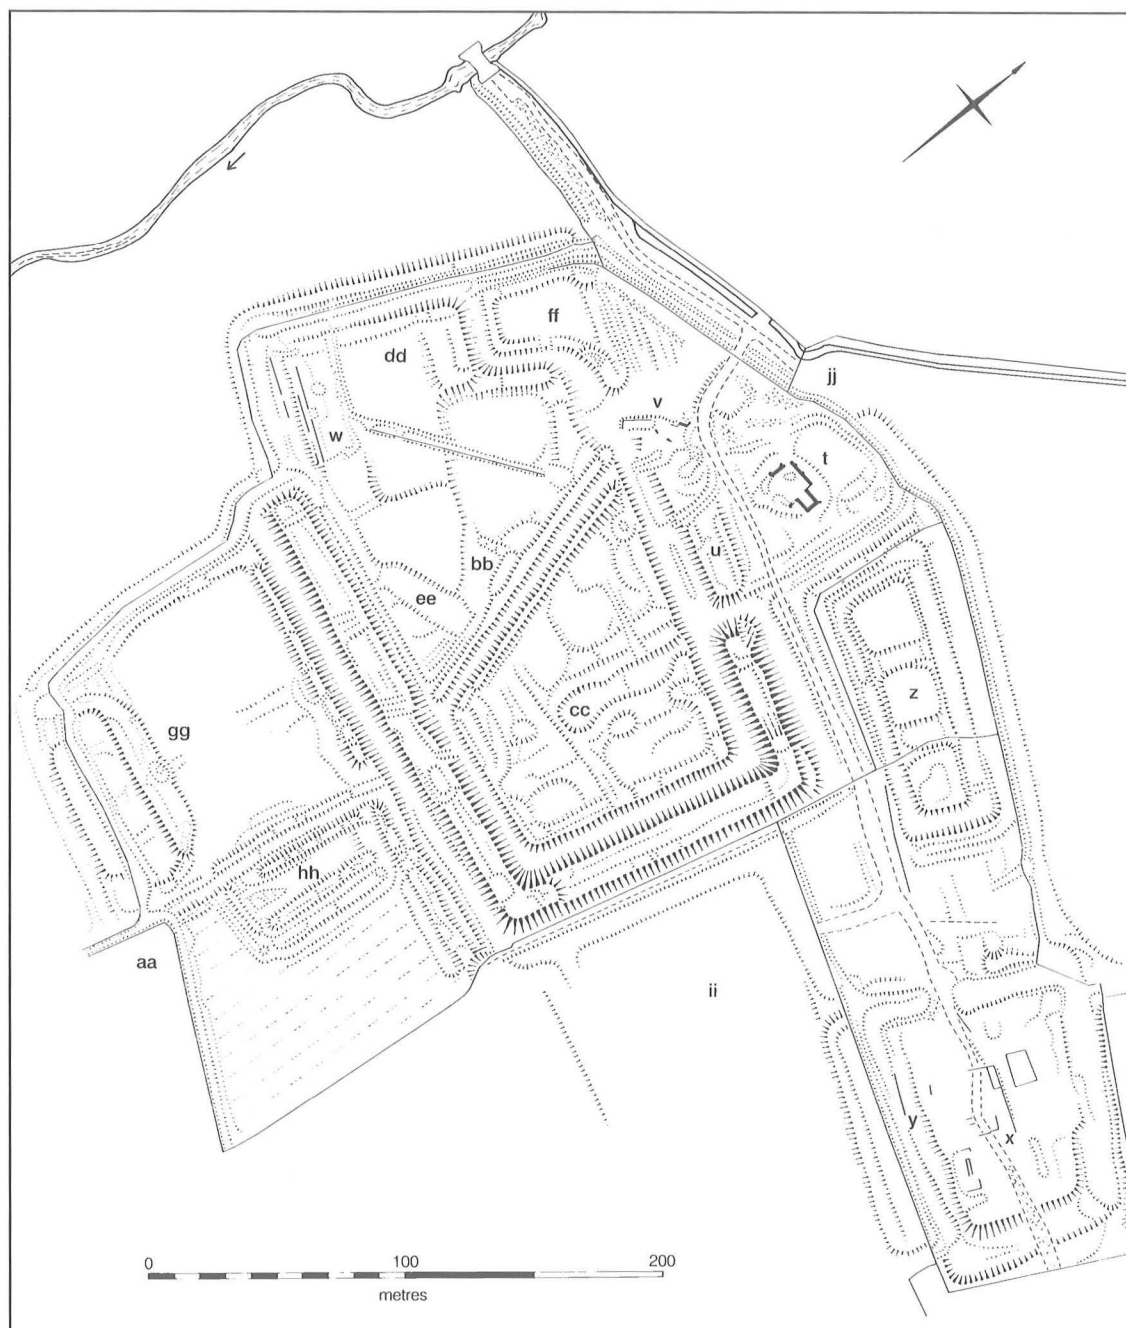
FIGURE 14 RCHME's surveyed plan of the central sector of the earthworks, including the site of St Peter's church, moated enclosure and formal garden earthworks; original at 1:1000

The earthwork remains of a grand country house and its accompanying formal gardens dating from the 16th and 17th centuries (Figures 14 and 19c) occupy the whole central section of the surveyed site. This elaborate complex – an outstanding survival of its date and type in England – occupies an area extending approximately 500m east-west and 380m north-south, that amounts to over 9ha (22.5 acres) in extent. It incorporates and encapsulates the pre-existing site of St Peter's church (described above). The location is relatively flat and low-lying at 73m (240 feet) above OD on the east side of the north-south tributary stream that joins the river

Specifically (Figures 14 and 19c), the approach from the west was over the north-south tributary stream via a predecessor to the present breeze-block and concrete bridge. Leland refers to a stone bridge over this ‘brook’ earlier in the 16th century (Toulmin Smith 1964, vol 2, 110). An impressively wide causeway, some 10m broad between flanking dykes, carries the access route straight east for about 80m. A visual end-point to this alignment is provided by the west end of St Peter’s church, and views are afforded north and south over the improved grazing lands of the tributary valley and south-east over the terraced gardens to Aylesbury. The access way, still broad and dyked on either side, then turns a few degrees north to pass round the north side of the churchyard. An axial view is afforded immediately on the right, through the churchyard between church and (conjectured) almshouses, between the water garden and the north arm of the raised terrace, directly to the great house in the moat. Beyond, the rising ground has the Warren mounds (described below) outlined on the skyline. At the end of the access way, the view opens out to the north-east to the hilly country around Weedon, but the approach continued around the north side of the churchyard, then at right angles south along the churchyard boundary into the garden complex. Here, a change in alignment of the modern field boundary suggests the site of an entrance. From this point, a flat way passes north-south between the churchyard boundary and the west end of the water garden complex. The visitor’s view half right displays the east end of the church and the (conjectured) almshouses, and straight ahead gives a glimpse into the main garden com-

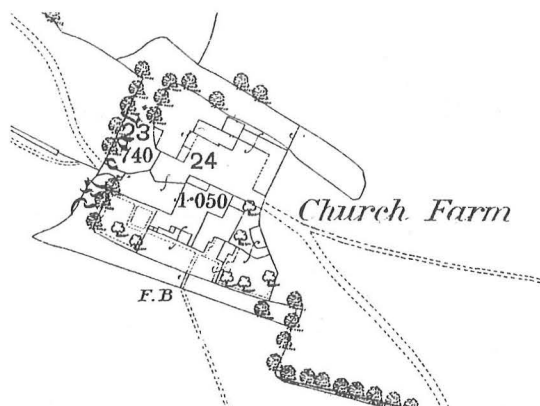
FIGURE 16 Plan of Church Farm farmstead at Quarrendon reproduced from OS 1879

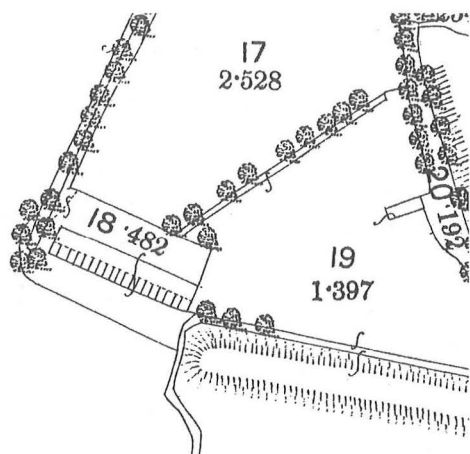
FIGURE 17 Plan of oxpen in the south-west corner of the main formal garden compartment, reproduced from OS 1879

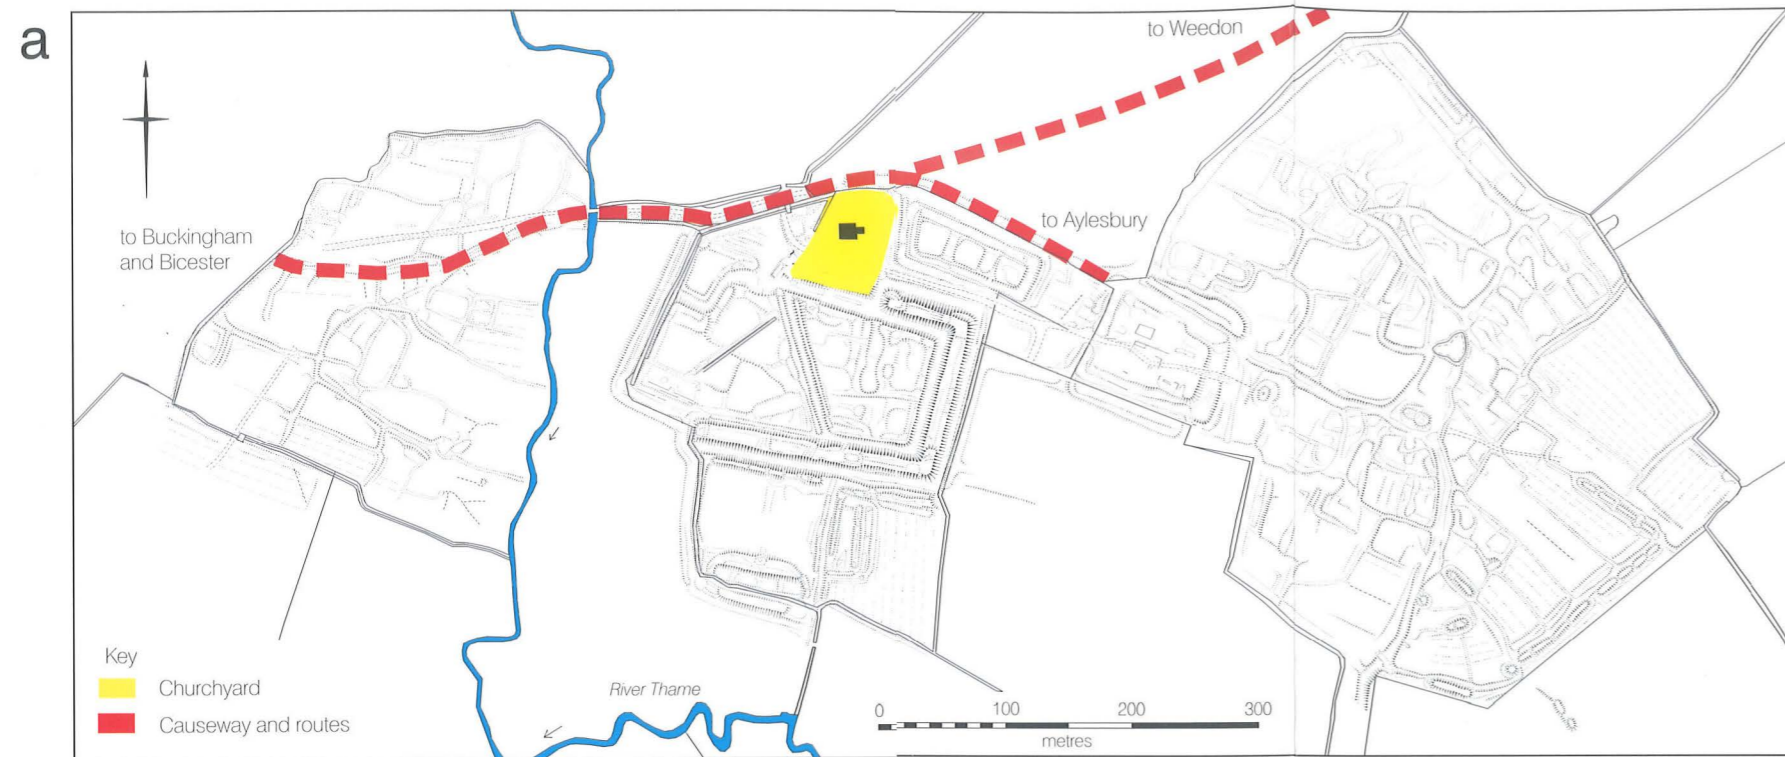
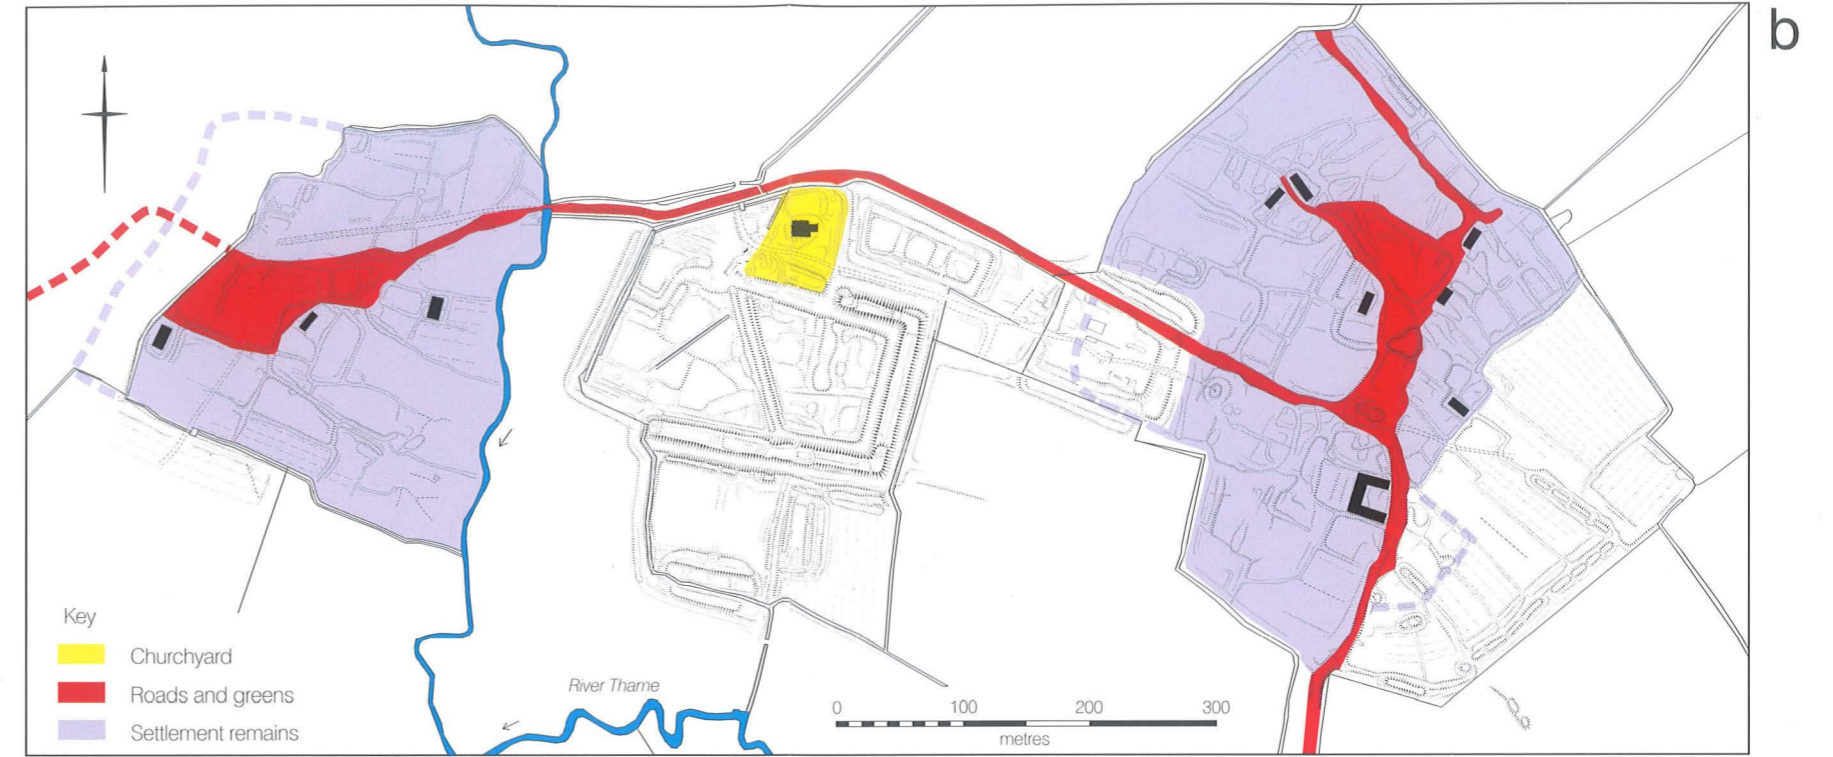
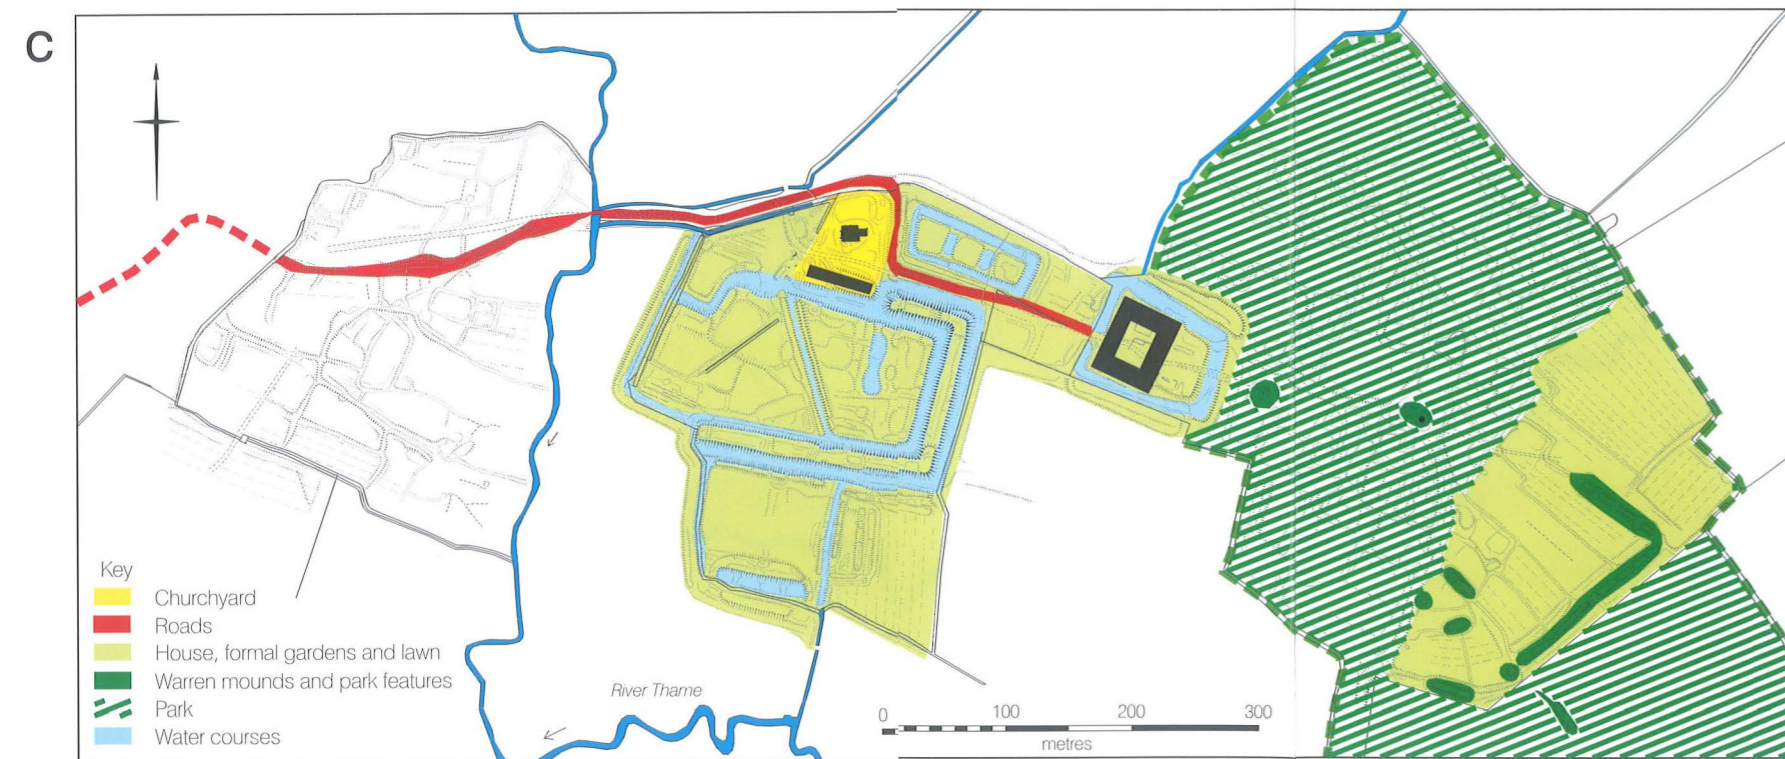
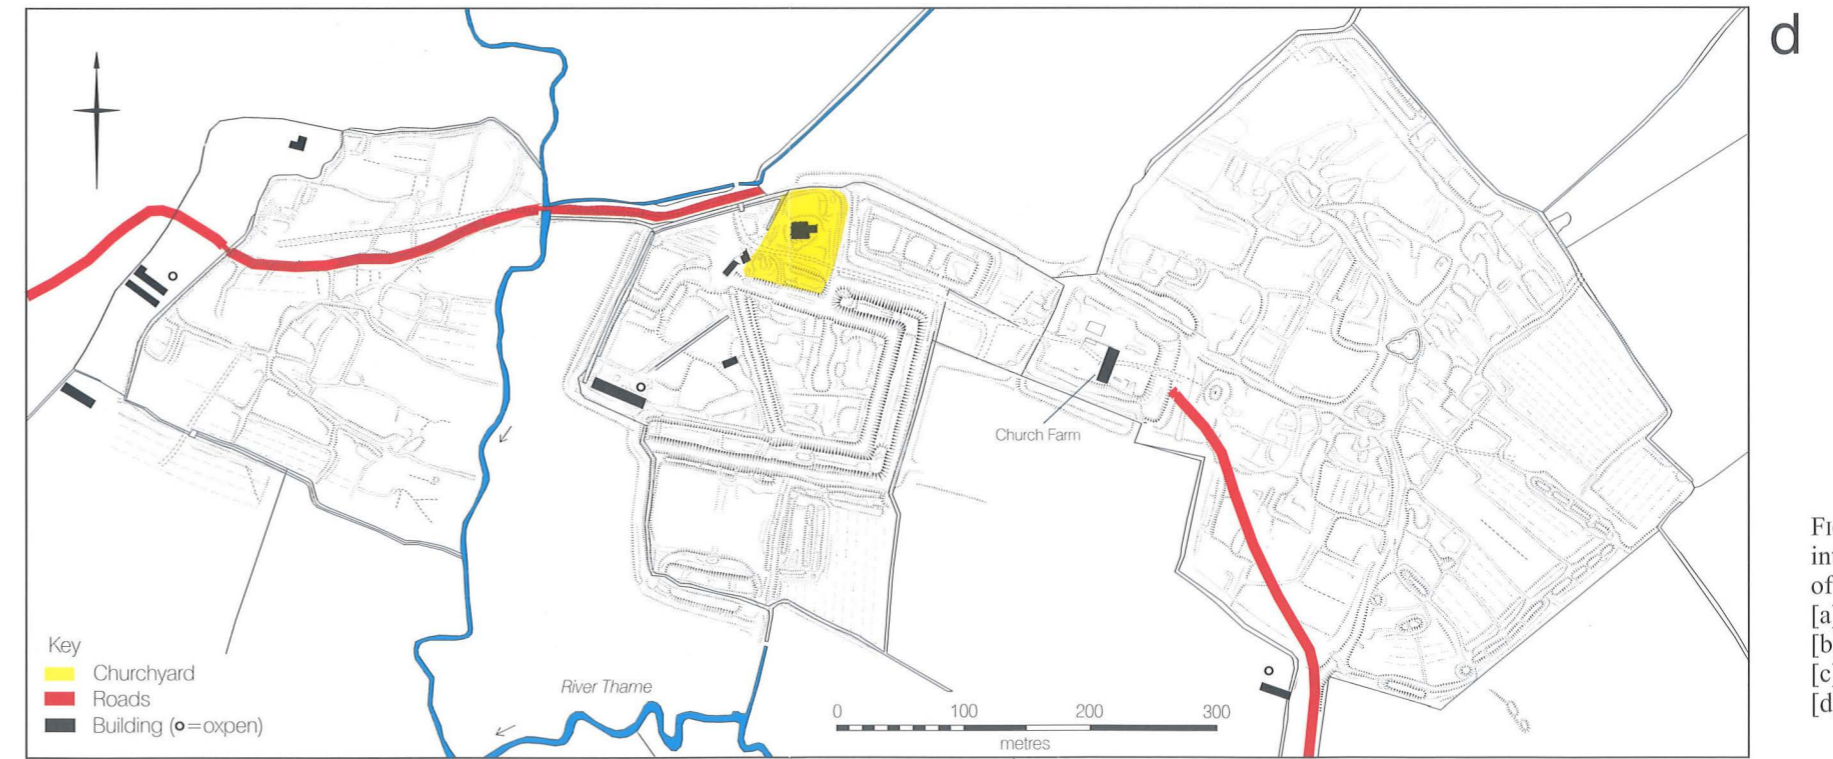
FIGURE 19 Simplified interpretation and phasing of the field remains:
[a] early medieval,
[b] late medieval,
[c] later 16th century,
[d] early modern

The formal garden earthworks were full of water features (Figure 19c), and water control and management systems were a necessary and integral part of the site layout. As elsewhere with formal garden layouts of this date, a secure, controlled water supply was ensured by off-site works (English Heritage 1997, 5, 11). At Quarrendon, as noted in discussing the site location and topography above, this took the form of a header-leat-cum-catchwater-drain of over 1.5km in length that took water off the tributary stream in the valley to the north and augmented it by picking up watercourses from the hills to the east (Figure 18). This arrangement – a considerable archaeological feature in its own right – survives embedded in the modern landscape as functioning drains and dyked hedgelines. It had the additional intended result of converting a large area of former floodplain north of the site, previously liable to winter inundations of the sort that caused (for example) the loss of 3000 head of sheep, cattle and horses in 1570, into rich grazing meadow.

A scatter of early modern features within the surveyed site has generally been noted in the preceding descriptions as they occur within the earthworks (Figure 19d). All are agricultural.
