PEASANTS, PEERS AND GRAZIERS: THE LANDSCAPE OF QUARRENDON, BUCKINGHAMSHIRE, INTERPRETED

PAUL EVERSON

The medieval and later earthworks at Quarrendon, surveyed by staff of the former Royal Commission on the Historical Monuments of England (now English Heritage), are described and interpreted. They reveal a sequence of major land-use phases that can be related coherently to topographical, documentary and architectural evidence. The earliest element may be the site of St Peter's church, located alongside a causeway. The evidence for its architectural development and decline is assembled. The site of a set of almshouses in the churchyard is identified. In the later medieval period, there were two separate foci of settlement, each similarly comprising a loose grouping of farmsteads around a green. It is argued that these form components of a form of dispersed settlement pattern in the parish and wider locality. Following conversion for sheep, depopulation and engrossment by the Lee family, merchant graziers of Warwick, a 16th-century moated country mansion was created, with accompanying formal gardens, warren and park. This was one of a group of residences in Buckinghamshire and north

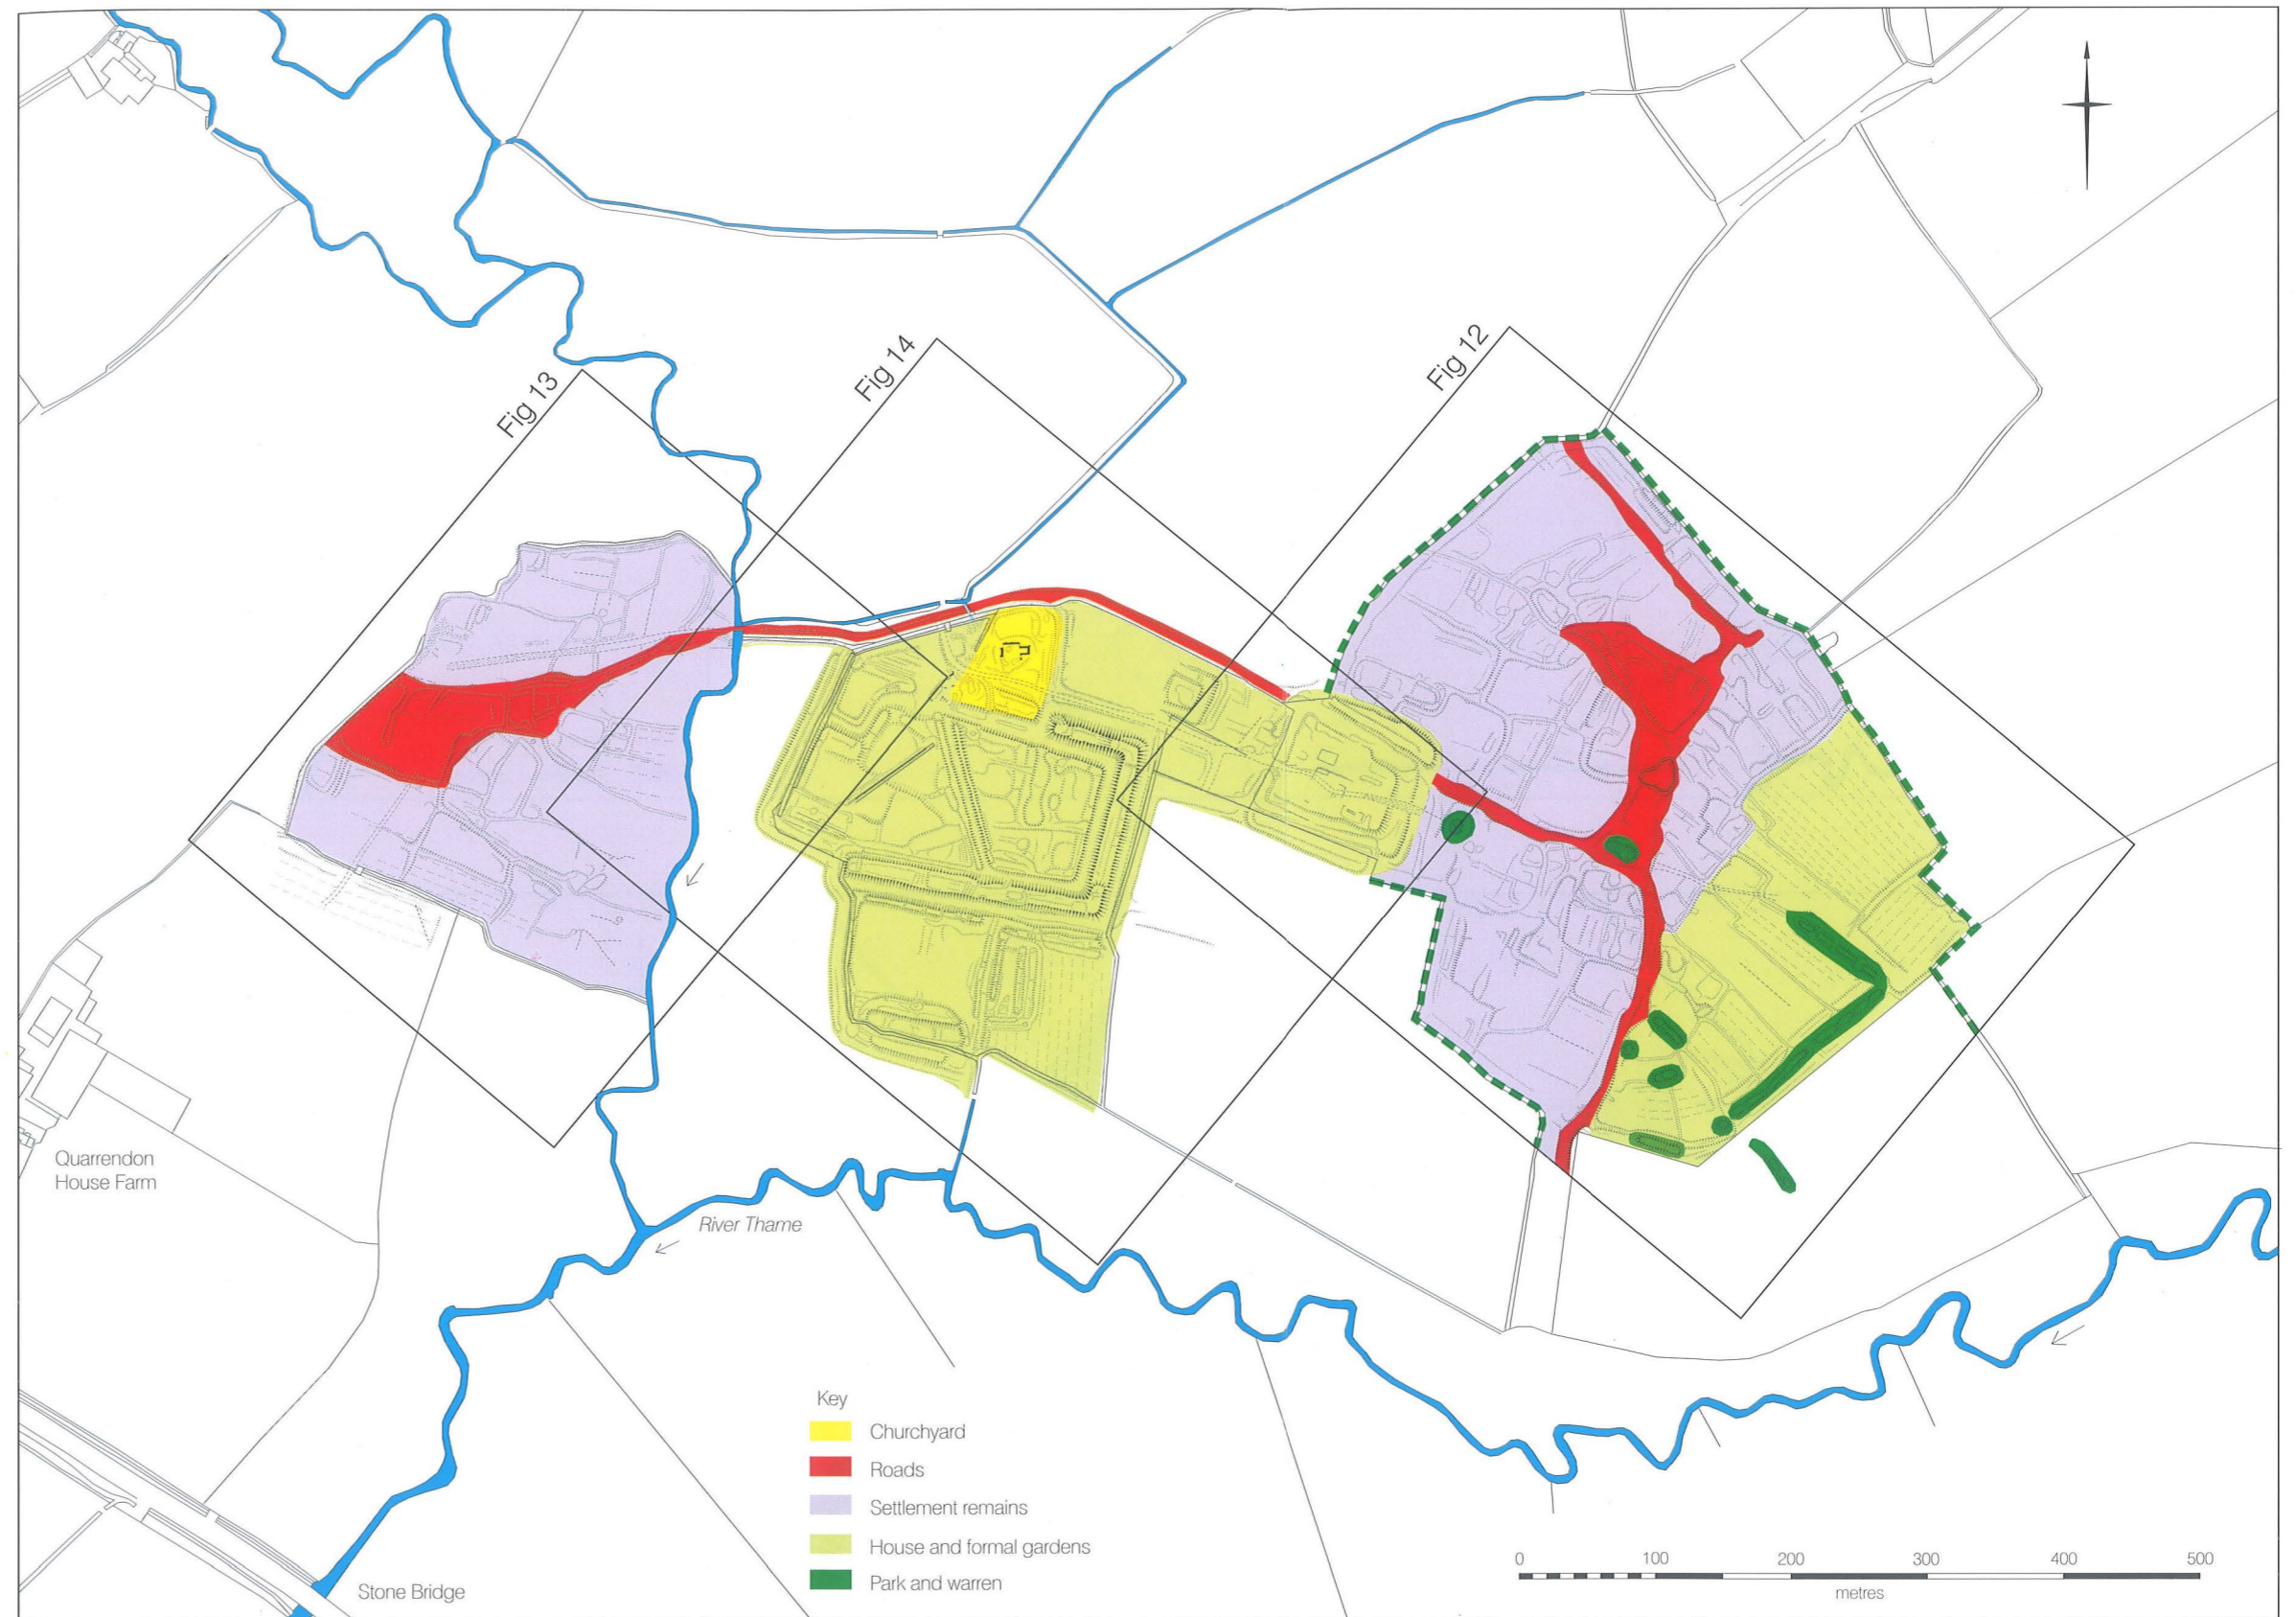
FIGURE 18 Key to FIGURES 12, 13 and 14 and identification of the prial elements of the earthworks

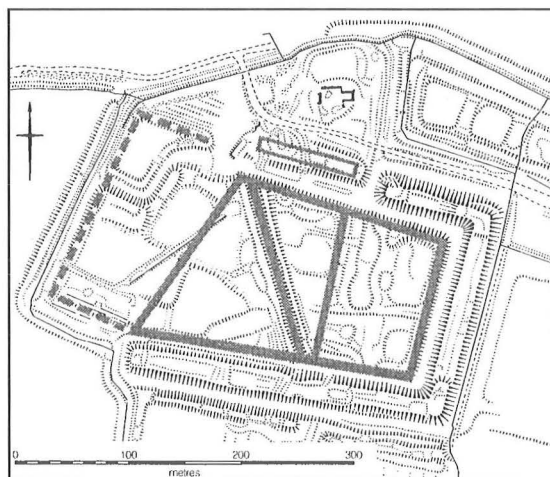
FIGURE 20 Simplified geometry of the main garden compartment

A clue to the reason for the apparent eccentricity of layout may lie in the observation that the lengths of the raised terraces are in a ratio of 1 : 2 : 3. The large building platform along the south side of the churchyard at 'u', proposed as the site of a set of almshouses, seems to have had a length very similar to that of the north raised terrace, at about 60m. If that unit of length is sought within the central area of the garden, a first area with that east-west dimension might be recognised at the east end, containing the north-south pond 'cc'. A second area with the same 60m east-west dimension, whose north end matches the platform for the almshouses, is sliced precisely from corner to corner by the diagonal canal. The eastern centre of the garden might therefore be seen as $1\frac{1}{2}$ units of area, which was further subdivided in geometrical ways reflected by the minor internal earthworks (Figure 20). A constructed alignment from the north end of the diagonal canal south-west to the west end of the southern raised terrace – an alignment only tenuously reflected in the minor earthworks – would turn the space on the south-west side of the diagonal canal into a regular triangle. It quite closely approximates to an isosceles form and may even have been intended for equilateral. That constructed alignment would then become the base for the rectangular layout of the west end of the garden, with its traces of rectangular internal divisions.
