THE SITE OF THE OLD CHURCH AT HARTWELL, BUCKINGHAMSHIRE

MICHAEL FARLEY AND ERIC THROSSELL

The present church at Hartwell, Buckinghamshire, completed in 1755, replaced an earlier parish church. Now in the care of the Churches Conservation Trust the eighteenth-century building was for several decades roofless but has recently been re-roofed. Although the old church was clearly sited near to the present structure, its precise location was not known. This article outlines the information available about the old church and its setting, and describes the results of a geophysical survey which was carried out in an attempt to locate the site more precisely. The survey results, although not entirely conclusive, appear to indicate a structure in the area where the church was expected to be from documentary sources.

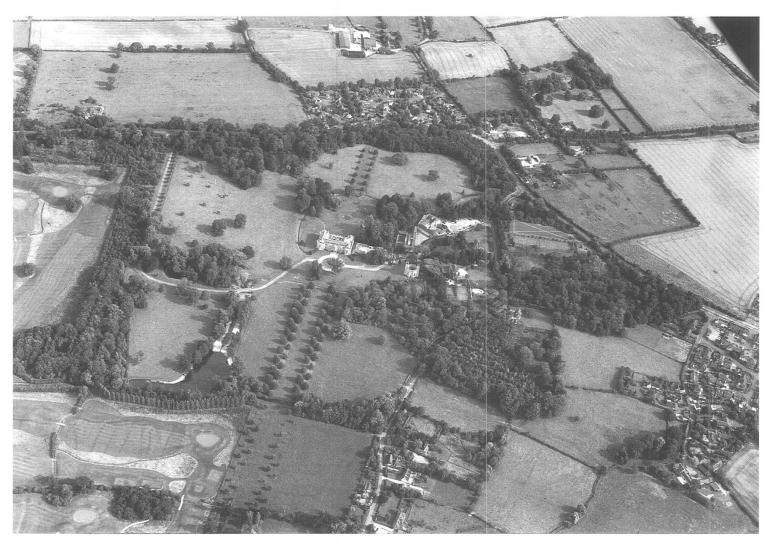
FIGURE 1 Aerial view of Hartwell House, church and grounds (copyright Michael Farley)

The present Hartwell church, dedicated to the Assumption of the Virgin Mary, standing in the grounds of Hartwell House, was designed by Henry Keene for Sir William Lee Bt and built between 1753 and 1755 (Figs.1-3). It is described in some detail by Lipscomb (1847, 319-23) and by Smyth (1851, 11 - including a view - and 1864,19-20 – including a plan). Its condition was allowed to deteriorate seriously before the Second World War, despite the protests of the Society (Anon 1947, 144 and 1952, 320). Eventually the roof collapsed and the building finally passed into the hands of the Redundant Churches Trust, now the Churches Conservation Trust. The church has most recently been described in Pevsner (1994, There is also a useful description in the Victoria County History (VCH 1908, 293-7) but it was not included in the unfortunately Buckinghamshire Royal Commission volume of 1912, since buildings constructed after AD 1700 were not described in their early surveys.

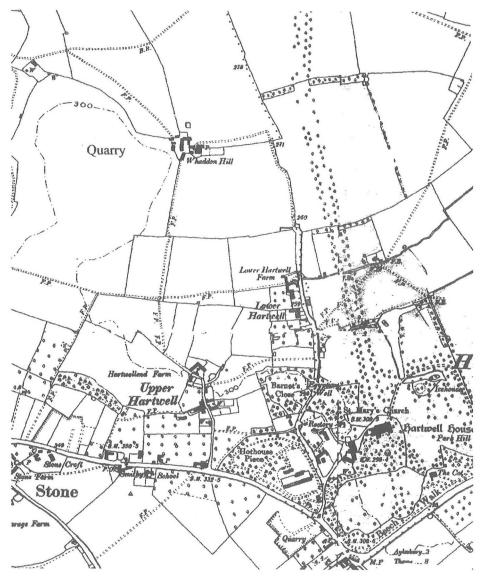
FIGURE 2 Location of Hartwell House, the eighteenth-century church and quarry on Whadden Hill, based on six-inch Ordnance Survey map of 1925

'Wadden Hill' lies less than a mile from the church, today being marked by Whaddon Hill Farm sited on a rise and shown on an estate map of 1777 as 'Whatton Hill' (BRO: D/X 1045/1). Air photographs of the area (Buckinghamshire County Archaeological Service, Run 507, 1985) showed the probable site of the Wadden Hill pits a short distance west of the farm. A field visit confirmed a substantial depression, still circa 3m deep, to be present (Fig. 2). Mr Jack Woodford of Lower Hartwell Farm recalls that a previous occupant of

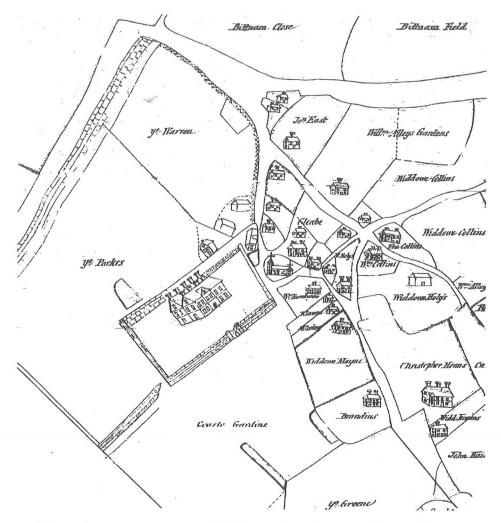
FIGURE 4 Part of a copy of a map of 1661 showing church and house (from a photocopy in Buckinghamshire Record Office, Ref. Ma 260.T)

Fortunately, in the Society's archives is a handdrawn copy in colour of an earlier map of the area (Fig. 4). The Society's copy is by F.G. Gurney. He did it on 7 September 1932, and neatly annotated the fact accordingly (BAS 1997A/23D). Gurney, however, was apparently copying a Victorian version of the map which was in turn headed 'Copied from a Map in the Possession of John Lee Esq LLD Octr 1841, entitled "A Platt of part of the Mannors of Hartwell and Stone in the County of Buckingam Belongeinge to the Right Worshippfull Sr. Thomas Lee Barokt. taken in the monthes of Septembr. & Octobr. in the thirteenth yeare of the Reigne of King Charles the Second by John & Wm Brudenell Surveyors Anno Dom 1661." The whereabouts of the original 1661 map, and of the putative copy map, is at present unknown. One of

The 1661 map includes an image of the church itself, although this is probably schematic (Fig. 4). It shows the church with pitched roof and west tower and spire lying beyond the perimeter wall of the principal house, within a roughly circular enclosure. Helpful also are the oil paintings by Balthasar Nebot in 1738, now in the County Museum, depicting views of the Hartwell Estate. Two of the views clearly looking from the east (Harris 1979, Figs 194 b & f, and Pl. XXb: Strong 2000, Figs 283 & 286) show the church turret, apparently with louvres. A detail from one of these is included here (Fig 5). Both views indicate that the pitched roof of the nave was tiled, and one view shows the end of the chancel with a three-light window, the building itself apparently being of stone. From the oil paintings it is apparent that the old church is very close to the position of the modern one. It is depicted also at a higher level than the house, which matches the situation of the modern church. Other work on the paintings in relation to the modern landscape (by ET) has shown that the accuracy of Nebot's views can be generally relied upon.

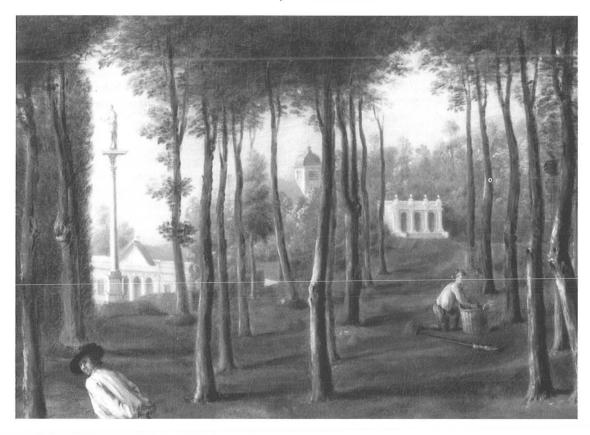
FIGURE 5 Detail from Nebot painting of 1738 showing the old church (reproduced by permission of Buckinghamshire County Museum)

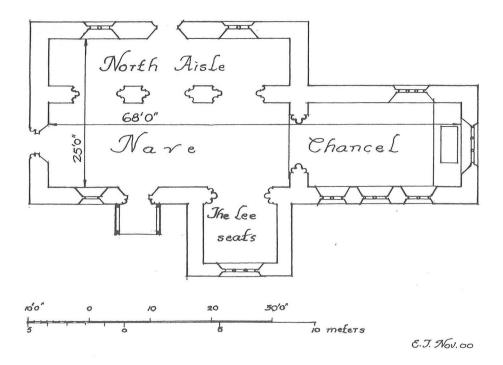
FIGURE 6 Hypothetical plan of the old church, based on Browne Willis's description

The whole suggests, as Willis himself states, a very simple structure of chancel, nave with a

north aisle, and bell turret with a small chapel, probably where the Lee family pews and monuments were, on the south side near the chancel. A tentative reconstruction of the plan is possible (Fig. 6).

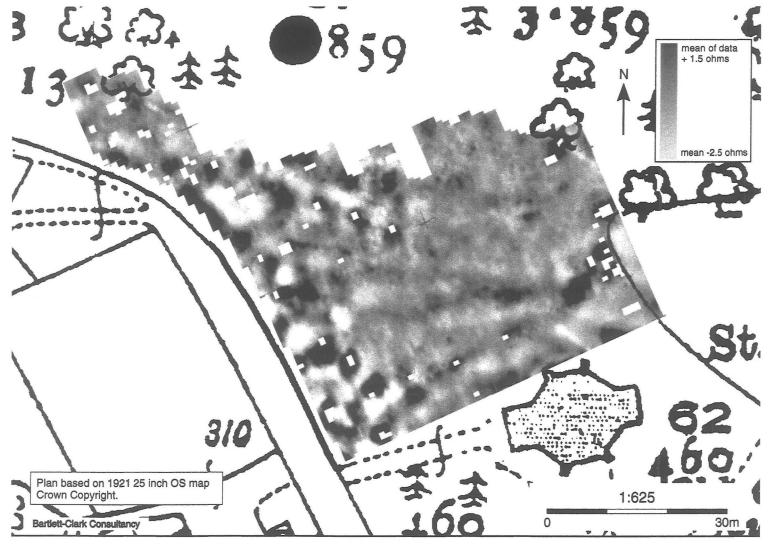
FIGURE 7 Grey-scale plot of resistivity survey 1999, adjacent to St Mary's Church, Hartwell

The factors described above strongly suggested that any surviving remains of the old church should be found within the area investigated, which is indicated by the extent of the survey plots on Figures 7 and 8.

The resistivity plots show considerable variation in the readings, although many of the stronger anomalies are located in the more wooded parts of the site and are probably caused by reductions in soil moisture content in the vicinity of tree roots. (The positions of the larger trees and bushes are indicated by missing readings in the survey plots.) Close examination of the 0.5m grey-scale plot (Fig.7) does, in addition, suggest the presence of some linear features. Figure 7 is a filtered plot in which a mean value calculated from neighbouring readings has been subtracted from each reading in turn. This allows smaller-scale features of potential archaeological interest to be seen against a more uniform background. Figure 8 represents the initial (unfiltered) data, and shows the full range of variations in response. The possible intermittent linear anomalies are difficult to identify against the disturbed background, but the clearest of them, as seen in both plots, are indicated by the outline superimposed on Figure 8.

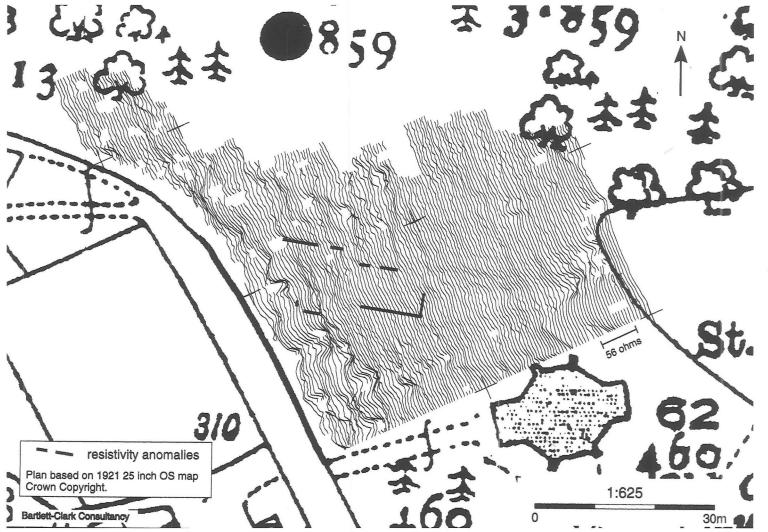
FIGURE 8 Plot of resistivity survey adjacent to St Mary's Church, Hartwell, 1999, with interpretation showing linear resistivity anomalies possibly indicating location of medieval church

The resistivity anomalies as marked on Figure 8 could be seen as representing a structure with a nave, north aisle and chancel, of which the southeast corner of the building, together with the south wall of the chancel and the north wall of the nave or aisle, have been most clearly detected. If so, the dimensions of the structure are possibly 23.5m in length, and 7m wide across the chancel. The length is uncertain, given that the west end is not clearly defined in the plots, but these dimensions (77' x 23') are not greatly different from the size of the old church, which was recorded as 68' x 25'.

The orientation of the detected features also compares well with the NW-SE alignment shown on the 1661 map, and the possible structure is centred at a position some 30 yards from the south-east corner of the new churchyard.
