THE CHURCH OF ST PETER STANTONBURY, MILTON KEYNES

PAUL WOODFIELD

The church of St Peter, Stanton Low, Stantonbury parish, stands close to the River Great Ouse on the northern edge of Milton Keynes. It is now a desolate and atmospheric ruin. This article reviews the architectural evidence provided by historical photographs to which is now added evidence obtained by clearing out accumulated rubble from the interior. Five phases of evolution are now suggested, beginning in the Norman period, and the foundations outside the west end are now interpreted not as a tower, but a mausoleum for the Wittewronge family. A fine fourteenth-century carved stone head was found, and furnishings from the church still extant are noted.

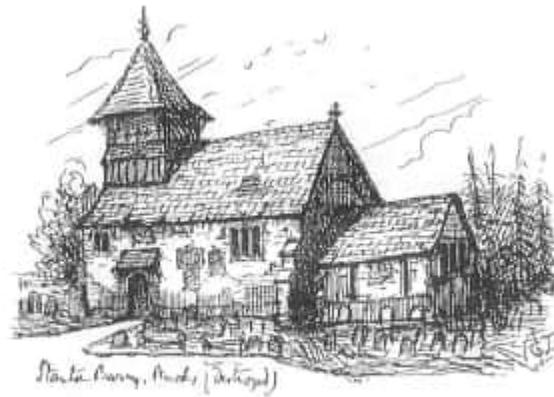
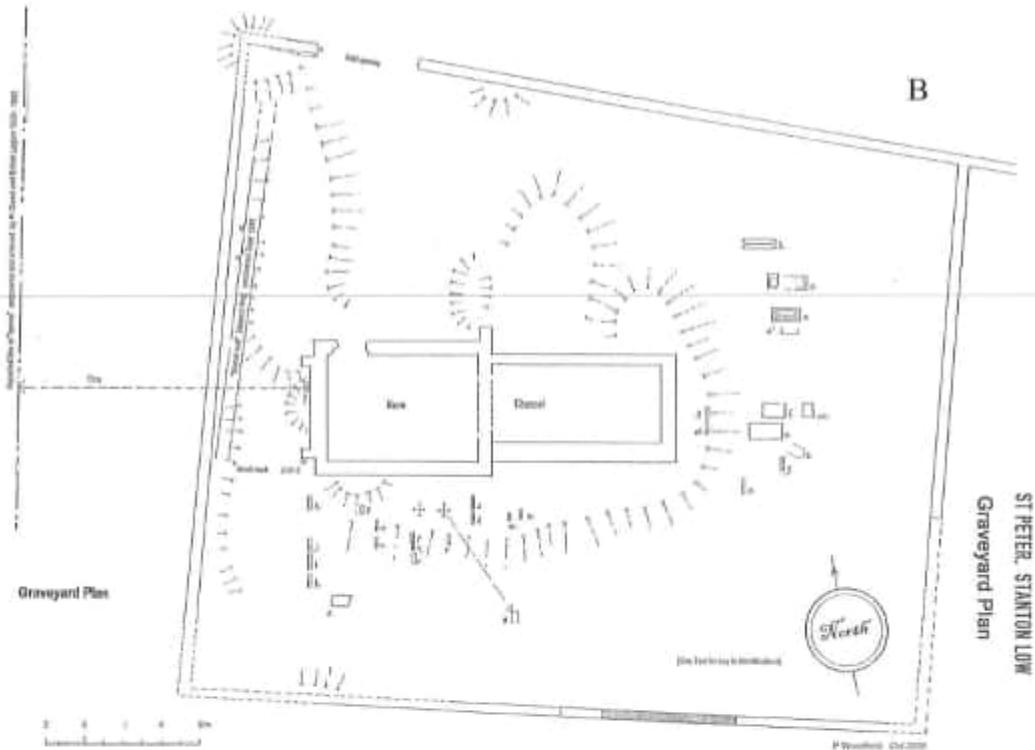
FIGURE 2 The 2001 survey of the church and graveyard, and below, the 1860 sketch of the church. (Reproduced with permission of the Bodleian Library Oxford MS. Top Bucks c.1, fol. 148)

An unpublished pen and ink sketch of the church from the south-east survives in the Bodleian Library¹⁰ (Fig 2A). This is the earliest known illustration of the building and was made about 1860, perhaps in anticipation of its impending redundancy. The drawing is clearly labelled "*Stanton Barry, Bucks (destroyed)*". It shows a low chancel with a 3-light east window, (not like the c.1956 photograph on Fig 3C, probably a draughtsman's error), and two lancets in the chancel south wall. Gravestones obscure the lower part of the walling. The canopied south door of the nave and two high-set windows are clear, but of greater interest is the timber-framed tower over the western end of the nave, and carrying a pyramidal tiled roof. Had not the artist, 'FGD', so clearly named it, the sketch may be taken for elsewhere, for instance, Little Woolstone, 4 miles to the south-east. This church has a similar timber belltower of the fourteenth century, carried on tall timber posts internally. The chancel in the Stanton Barry sketch does not resemble the surviving structure and the depiction of a mysterious relieving arch, large and high on

the eastern nave wall, must raise doubts as to its accuracy, or indeed its identification. There are grave tablets on the sketch fixed to the south nave wall.

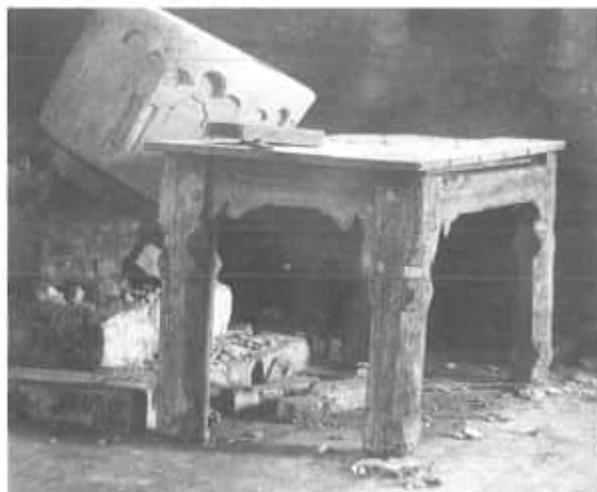
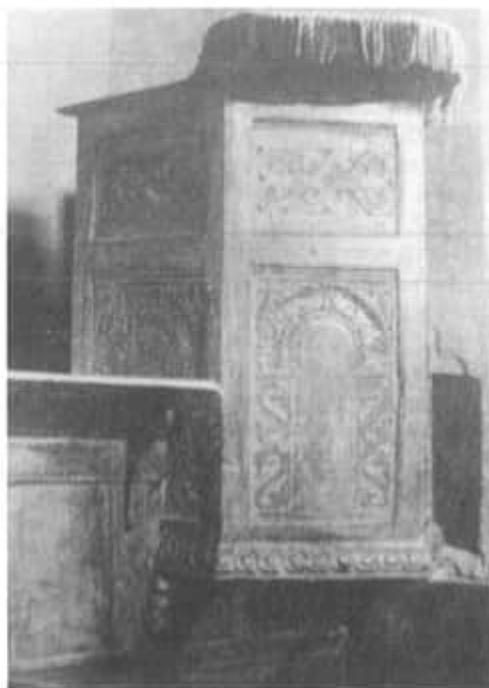
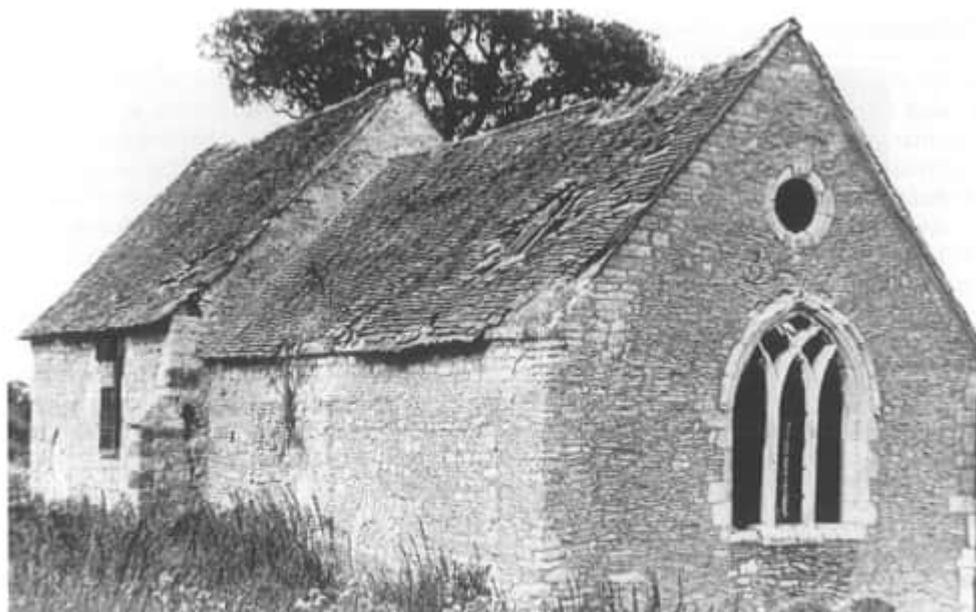
FIGURE 3 (A) the pulpit and reading desk, and (B) a communion table and damaged font, and below, St Peter's church from the north-east, all from photographs taken c. 1956

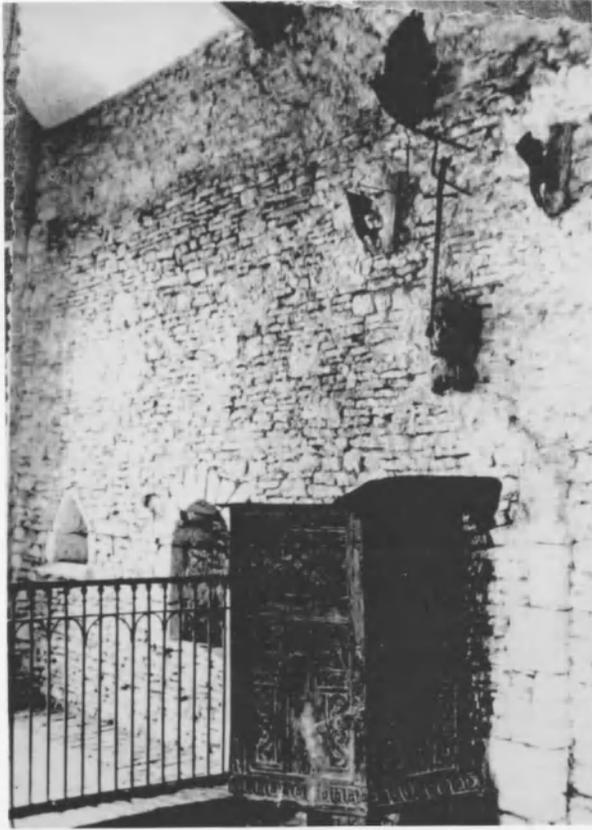
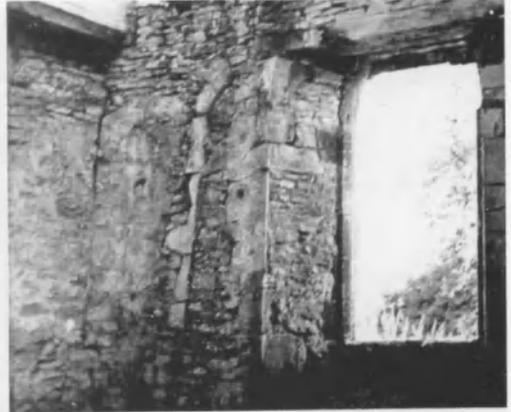
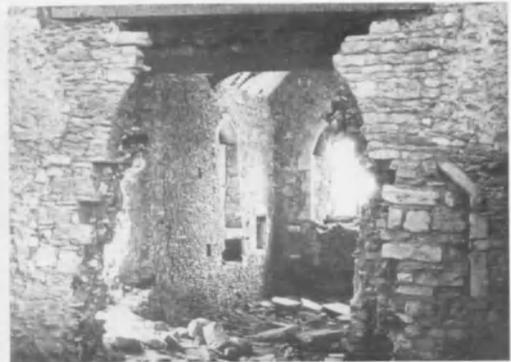
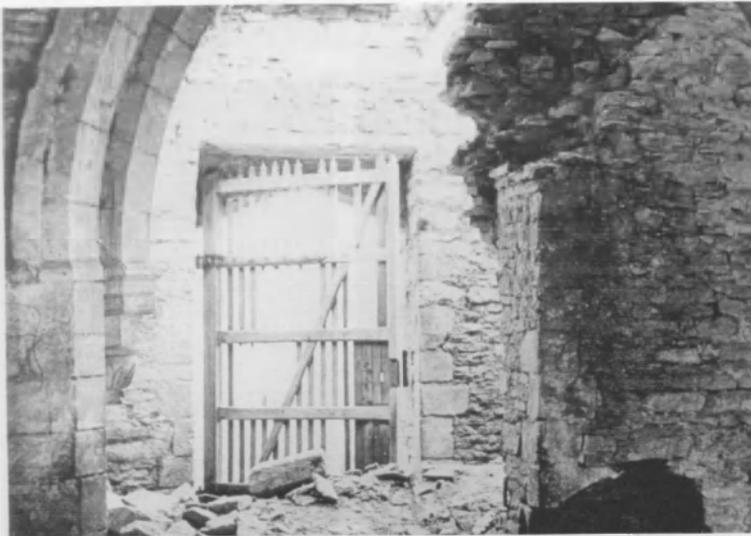
FIGURE 4 The interior as in 1956, showing (a) the south chancel wall with the suspended achievements, (b) the north-west corner of the chancel, (c) the north-east corner of the chancel as seen through the removed chancel arch, and (d) the chancel arch position from the north arcade

Also of the first phase is the south wall of the nave, which had the same thickness (725mm). This is indicated by a photograph (Fig 4B) of the internal corner taken when the church was in ruins, probably in 1956. It shows a small blocked round-headed window cut away by a lancet window, also blocked, and its east jamb cut away by the insertion of a larger square-headed window. The small window may be an opening for a rood stair.

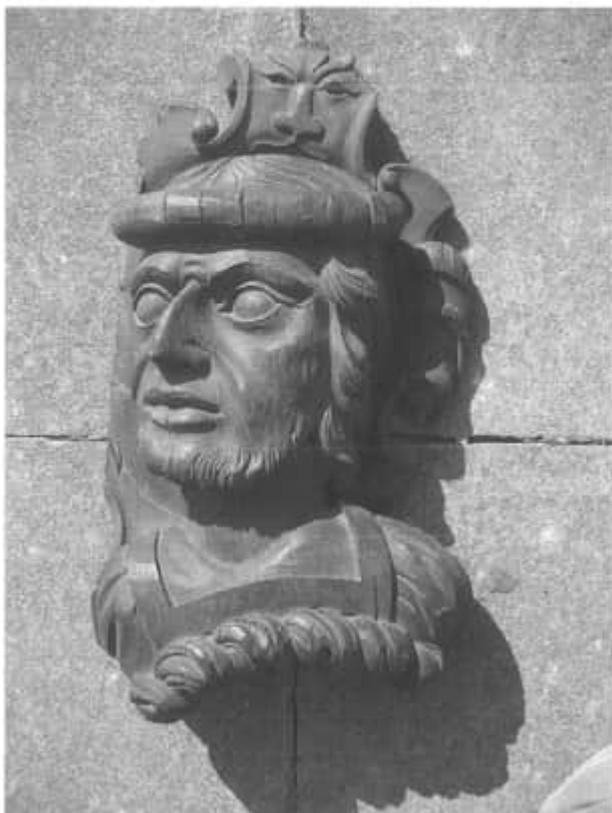
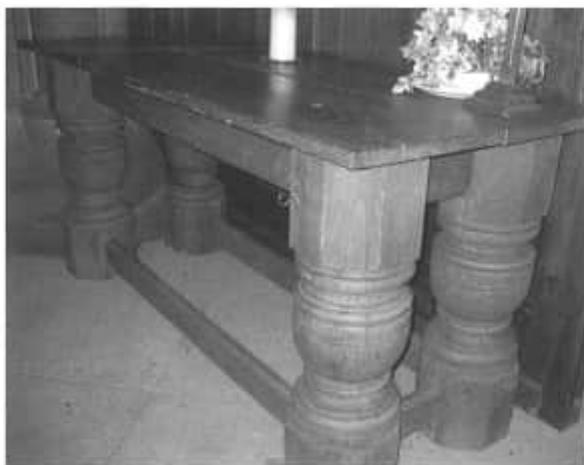
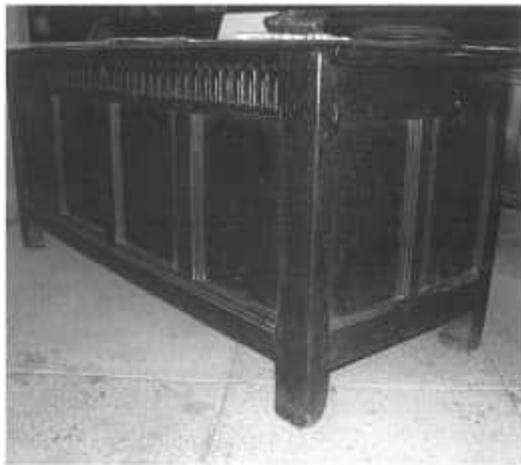
FIGURE 5 (A) The Temple crest (B) the altar table, and (C) the parish chest, all now at St James' church, New Bradwell

seem to have survived; it had a ridged skullpiece, with visor and beaver, nor do the funerary gauntlets or rowel spur. A sword, apparently also part of the achievements, appears in an early (?1957) photograph (Fig 4A). The curiously heavy altar table, dedicated, according to a crudely incised inscription on the top, to the holding of the Mass, by Father A Newman Guest, and the oak crest, probably from above Sir John Temple's helm, together with the fine seventeenth-century parish chest, now reside in St. James's Church, New Bradwell, (Fig 5 a, b and c), but the dossal curtains and altar linen, which also appear in the Church inventory, cannot now be identified. The crest is in the form of a three-quarter Saracen's head set against cushioned strapwork. It is a fine piece of carving, dated by Dr. Eric Gee (RCHM York) to the second quarter of the seventeenth century.¹³ The form suggests that the Temples may have originally claimed ancestors in the crusades, but, by the later medieval period the Saracen's head had become no more than a stock-in-trade item of heralds. Panelling from the broken pulpit finally found reuse as the electricity meter cupboard in a house in Weston Underwood.

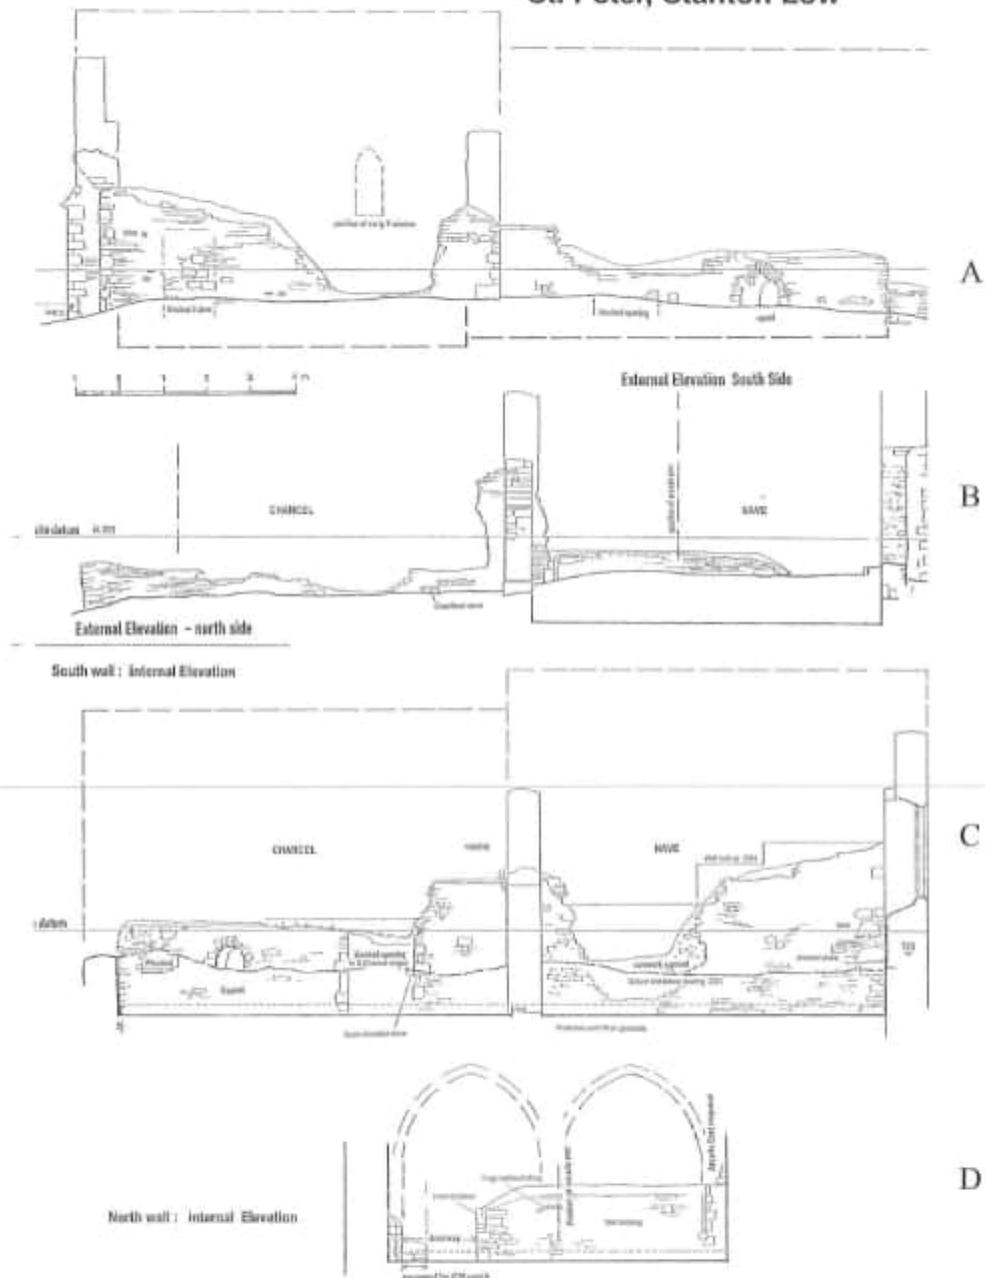
FIGURE 7 The standing walls as drawn at 2001. From the top (A) the exterior south wall, (B) the exterior of the north wall, (C) the interior of the south wall after the interior was cleared, and (D) the interior of the north nave wall, with the arcade outlined

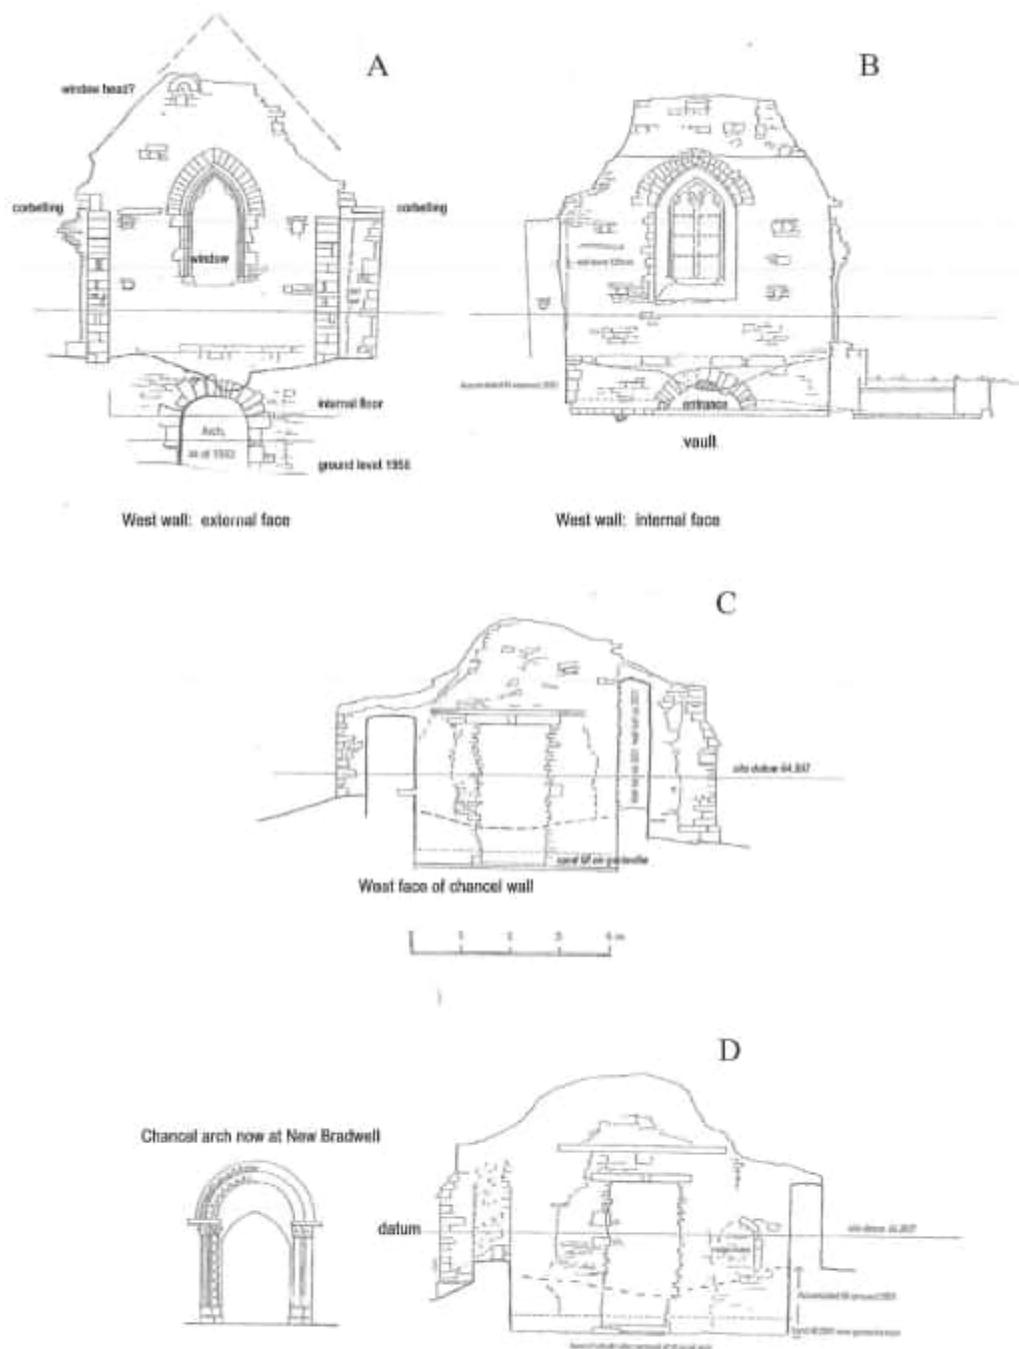
FIGURE 8 The cross walls, as drawn in 2001, (A) Exterior of the west wall; (B) the internal face of the west wall; (C) the west face of the chancel wall; and (D) the east face of the chancel wall, with the chancel arch at St James' to the same scale

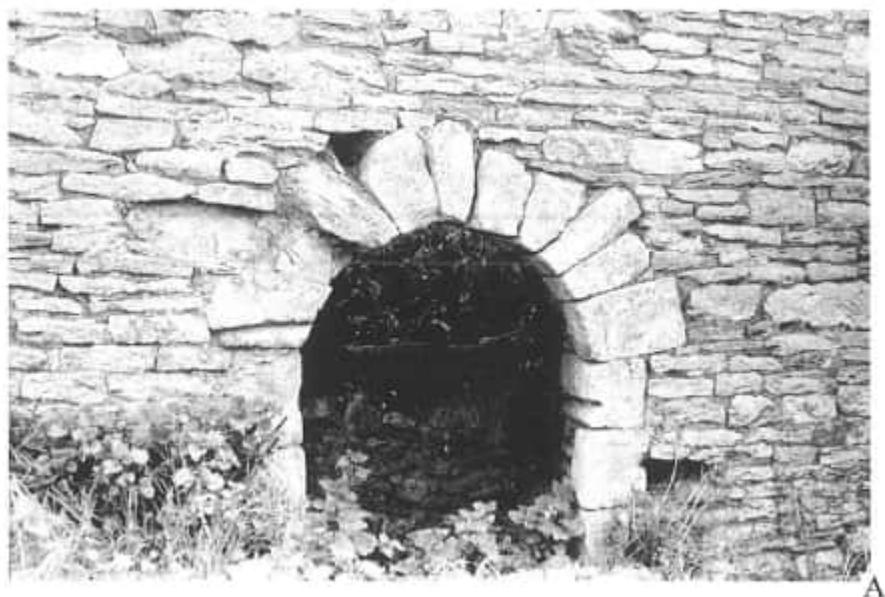
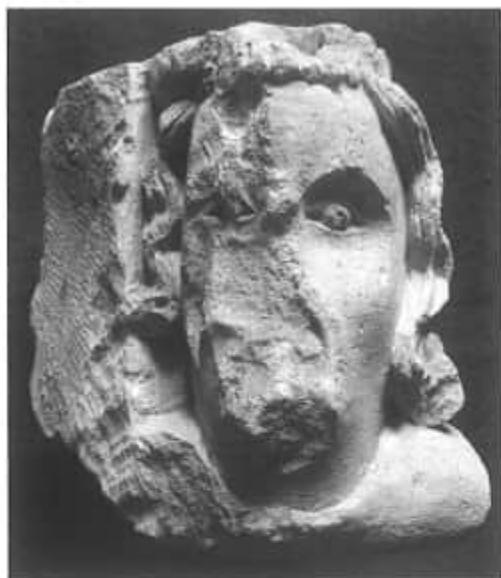
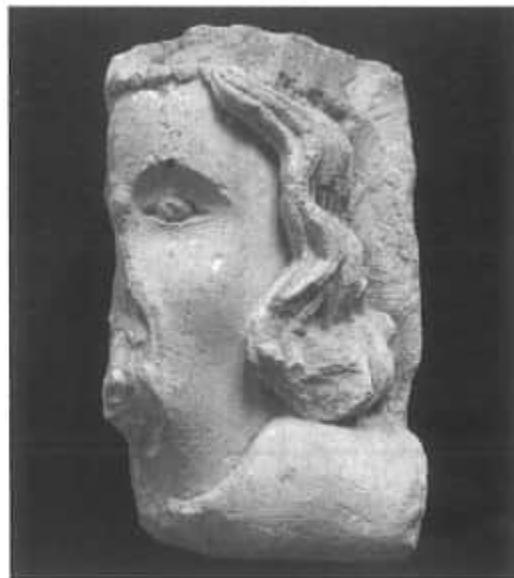
FIGURE 9 (A) The 'tunnel' as seen from the exterior in c.1956. (B) and (C) the carved head, found in 2001 built in to the north wall doorway, front and side view

One handsome piece of sculpture, a carved head was recovered, built in loosely to the east internal angle of the porch door, within the church, (Fig 9B and C). It was found built into the inner, east corner of the doorway from the nave to the north porch. This position cannot be its original location. The form is an elongated oval, with wavy hair falling to either side down to the shoulders. The neck is short, and the shoulders simply indicated, without any detail. It has been seriously defaced, but one eye survives sufficiently to judge that it is a very competent piece of sculpture, the eye set in a sharply defined socket, and the eyeball is drilled, with the eyelid draped over. Only the deep cutting for the second eye remains. The cheekbones are gently pronounced, and the chin is prominent, though badly damaged.

This realistic treatment of the eyes appears in the fourteenth century, a useful parallel being the figure seated on the south side of the Percy Tomb at Beverley, dated to c.1340.²³ Similarities can be found in the elongated face, and the wavy treatment

of the long hair, which at Beverley is restrained from falling forward over the face by a plaited head band. Damage on our piece has obliterated the treatment of the hair. There is no beard, without which it cannot have represented a prophet or elder of the church. Altogether it is a youthful face, but one without any obvious religious connotation.

Commoners, merchants and the like, usually wear appropriate headdresses; twisted head bands are sometimes worn by angels or even Christ himself, *viz* in the Angel Choir of Lincoln Cathedral (1256–80).²⁴ Bare shoulders occur frequently, at Coventry Whitefriars Lincoln Angel Choir, and especially often on misericords. The sculpture from Stanton Low has a hole drilled down from the top, not precisely vertical. This is unexplained and is probably later in date. It is concluded that the Stanton Low piece is of the fourteenth century, and probably from early in that century.

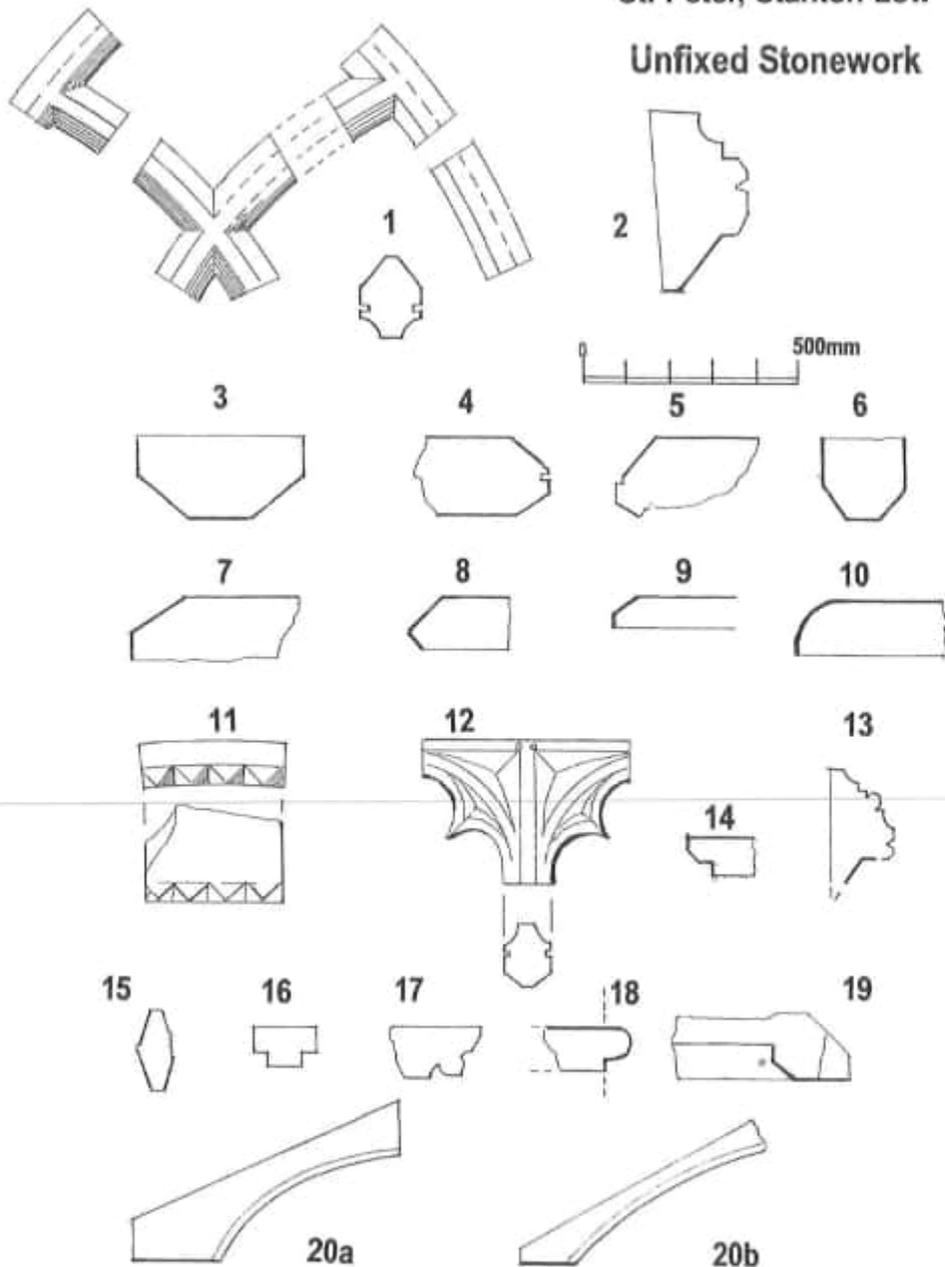
St. Peter, Stanton Low
Unfixed Stonework

FIGURE 10 Drawings of the more significant pieces of stonework found in 2001. (1) east window tracery with section of mullion; (2) a door jamb, (3) chamfered voussoir, probably the arcade arch, (4–10) other moulded stones, (11) section of nailhead string; (12) head of a pair of late medieval windows; (13) Window jamb; (15–19) various other moulded stones of uncertain original location; (20a and b) rebated door heads

1. Four sections of intersecting window tracery, from the CHANCEL east window. The section is plain chamfered externally and hollow chamfered internally – overall depth 85mm, width 60mm. (Fig 10, No 1) Lead runnels are visible on the joining faces, Fig 11D.

2. Jamb moulding of window. Chamfered either side of glazing groove, with check and internal hollow chamfer. Probably the E window. 315mm run. (Fig 10, No 2)

3. Two light window mullion developing trilobed cusping. Depth 145mm. (Fig 10, No 12 and Fig 11B).
4. Window jamb, cut to a radius, 180mm deep, flat 80mm with glazing groove, chamfer each side 110 and 80. Chancel: Window head arch. Seven sections totalling 1m 659mm run.

5. Door jamb, 190mm overall, with two hollow chamfers. Probably the north door. (Fig 10 No 13). 4 lengths, 175,170,145, and 205mm run.
6. Intrados of arch, the intrados face itself 150mm, with plain chamfers, 150mm. 11 lengths, totalling 2m 835mm. Probably the north nave arcade. (Fig 10, No 3)

7. Intrados voussoirs. 250 and 205mm 2 stones, 310 and 260mm run.
8. Hood moulding with nailheads 85mm wide, 215mm to 205mm deep, each 11 lengths, totalling 3m 795mm. (Fig 10 and Fig. 11A). These are parts of the north aisle arcade hood mouldings.

9. Flat of 155mm, with equal 155mm chamfers each side. 6 sections totalling 893mm run. Chancel area. (Fig 10, No 3).
10. Flat 145, with unequal chamfer each side 90 and 70+. 1 section, 350mm run.
11. Single chamfer of 210mm, on a stone 180mm thick: 8 lengths, totalling 1,375mm.
12. Small chamfer, of 75mm, whitewashed. 2 lengths totalling 440mm run
13. Chamfered stone, 135 chamfer, 230mm horizontally. With vertical drilling at top of chamfer.
14. Small chamfered stone, 72 thick, 600mm chamfer. 1 section 295mm run.
15. Undersquinted chamfered stone, 129mm deep, chamfer 115, undersquint 50mm One section 210mm run.
16. Flat bull nose mounded stone, 120mm deep, 2 sections totalling 470mm run. (Fig 10 No 18).
17. Small piece 145 wide, with 2 square rebates. 1 section 145mm run. (Fig 10 No 16)
18. Indeterminate piece, 170mm deep, roughly chamfered, with V-cut.

19. Window mullion, 185mm deep, 85mm wide, plain chamfers each side. Glazing groove. 1 section 300mm run. (Fig 10 No 4)
20. Window jamb, section as last. One section of 255mm run.
21. Window jamb, section as last, with additional external hollow chamfer, and start of internal splayed reveal. (Fig 10 No 2). 1 section of 250mm
22. Flat of 155mm flanked by equal chamfers each of 155mm 16 sections, totalling 2m 668mm.
23. Unilateral chamfer of 150mm top up to 360mm. 19 sections, totalling 3,626mm run. Average run of one piece is 190mm.
24. Unequal chamfered section, with small rebate. 1 section, 200mm run. (Fig 10 No 5)
25. Intrados 150mm, with chamfer 150, and part chamfer of 80+. 11 sections, totalling 2m.835mm.
26. Rebated door head, with small chamfer. 1 section. (Fig 10 No 20a)
27. Plain rebated section. 260mm run.

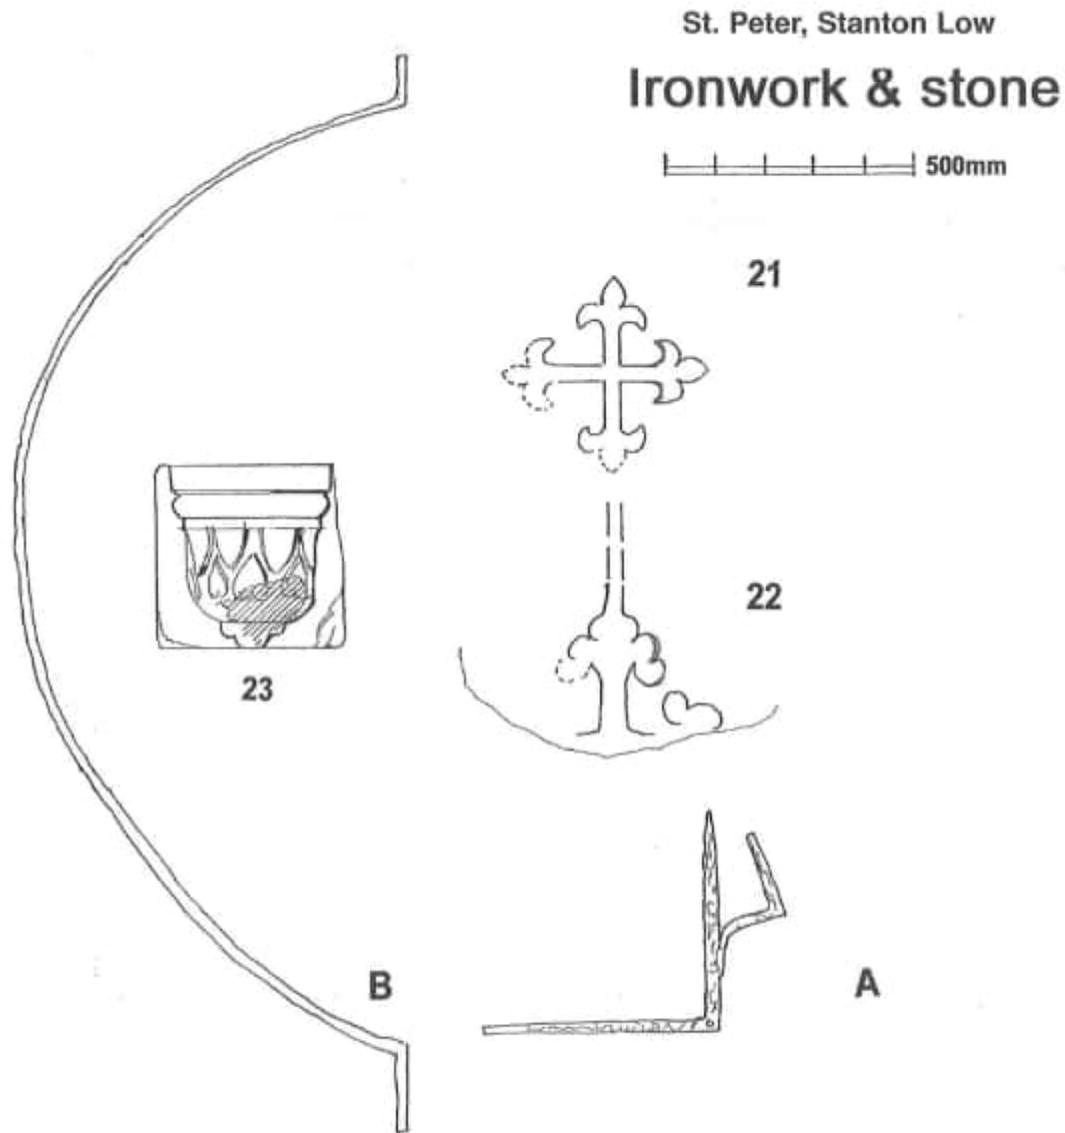
FIGURE 12 Finds of iron: (A) wall hook for the Temple achievements; (B) iron binding probably for the helm; and stone items (23) the respond corbel found in 1956 (drawn from a photograph), and (21-22) inscribed crosses on the two graveslabs re-used as side benches in the porch
