# ARCHAEOLOGICAL INVESTIGATIONS AT MISSENDEN ABBEY, 1983–88

YVONNE EDWARDS, JILL HENDER AND MARION WELLS

*Missenden Abbey was founded in 1133 by William de Missenden and was a house of Arrouaisian canons until its dissolution in 1538. At this time, many of the buildings, including the conventual church, were destroyed. The remaining buildings have experienced a great deal of change and redevelopment. Today, the main building is associated with a management college, which stands on the site of the cloister. In 1983, plans for the development of new buildings enabled excavations to be carried out by Buckinghamshire County Museum (BCM). The intention was to establish the position, dimensions and structure of the conventual church and associated buildings. Further development occurred during 1983–6 and in 1988 an exploration was undertaken during the relaying of the drive. Subsequently some specialist reports were prepared, but the lack of funds inhibited further study. In 2012, CVAHS set out to review all the data and materials in the archive held by BCM in order to complete and publish the results of the excavations and the finds reports. This has allowed insights into the layout o

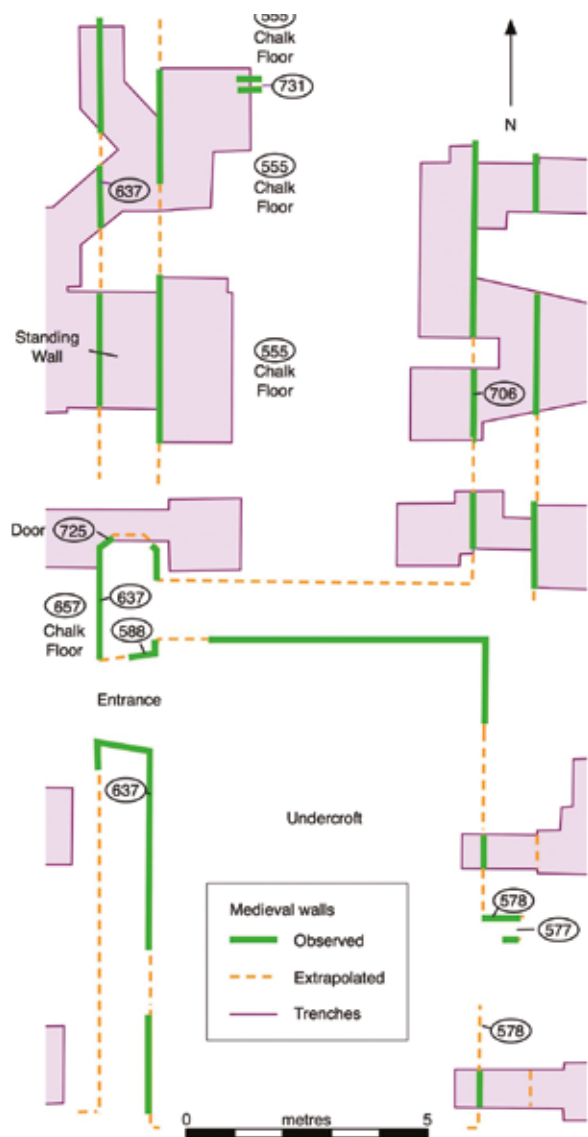
FIGURE 28 Area 28, layout of wall footings and chalk floor, including medieval wall (637)

roof tiles. To the north in Area 28, a medieval chalk floor surface about 1.20m wide was found butting against a narrow medieval wall [637], built of flints and large chalk blocks with a white-plastered clunch facing surviving on its west side (Figs 3 & 28).

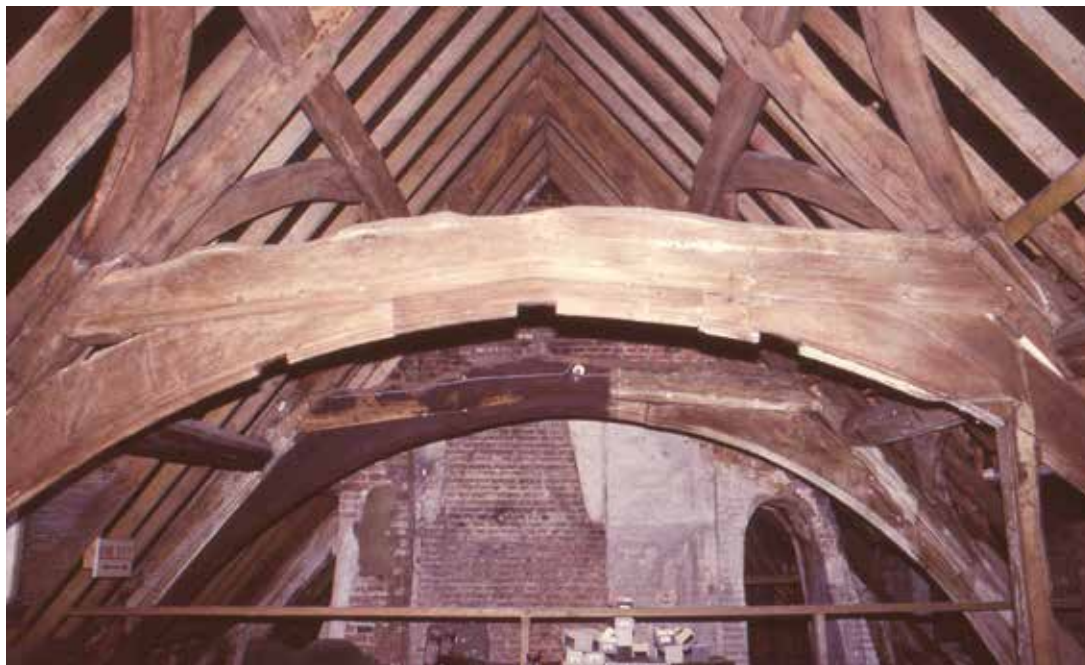
FIGURE 31 View along one of the East Range roofs prior to the 1985 fire

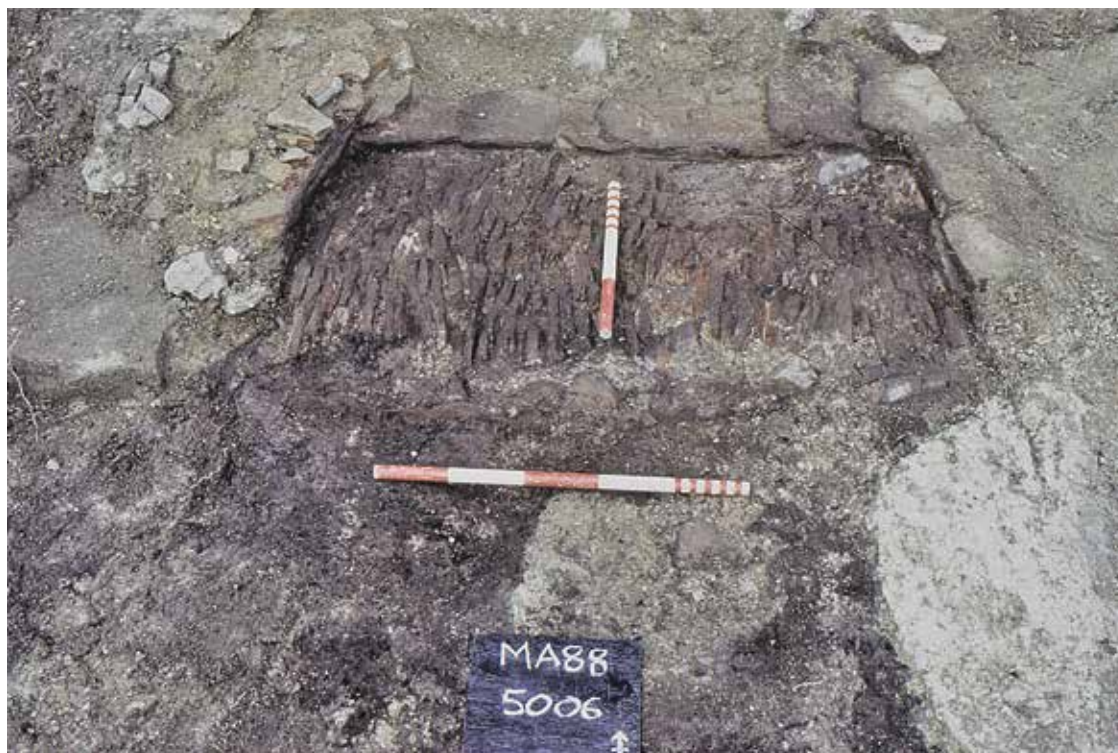
FIGURE 35 Pitched tile hearth added to the west range towards the end of the abbey's life
