THE SOUTH TERRACE, CLIVEDEN: ARCHAEOLOGICAL INVESTIGATIONS, 2013–2017

JONATHAN GILL

Cliveden House near Maidenhead is a Grade I listed mansion which has been home to members of the royal family, the aristocracy and some of the wealthiest families in the world, as well as having been associated with notorious scandals and prominent national events. The 130m long South Terrace is among the most significant surviving elements of the site, as it is the only structure which is believed to substantially survive from the great mansion that the Duke of Buckingham began to build in the 1670s, reputedly for his lover the Countess of Shrewsbury. The house has twice been destroyed by fire and then rebuilt but the magnificent terrace, which provides distant views towards the south, has remained a key element of each complex. Between 2013 and 2017 the National Trust undertook a major programme of conservation, repair and remedial works on the terrace, as well as in areas immediately surrounding it, and Oxford Archaeology undertook various archaeological investigations during these works.

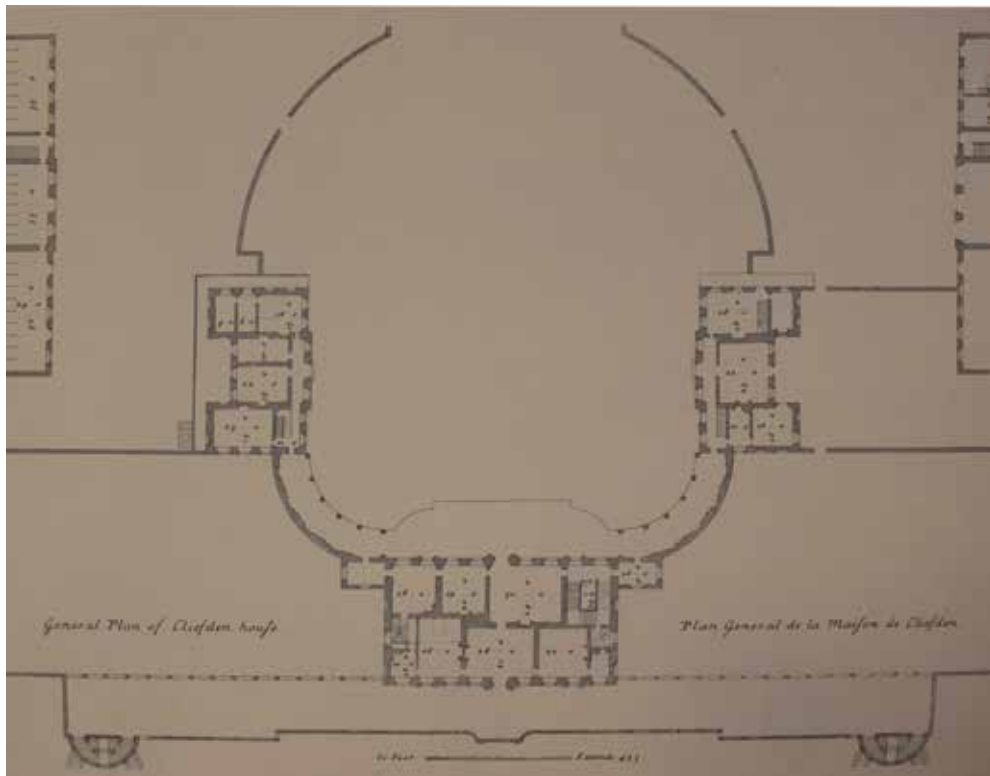
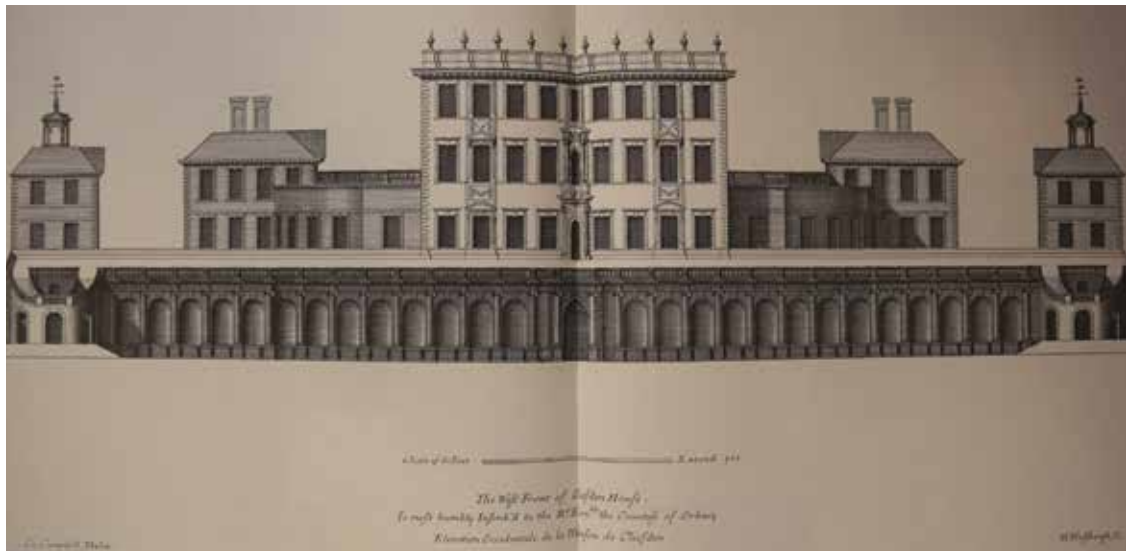
FIGURES 1 and 2 Plan and elevation of Cliveden from *Vitruvius Britannicus* by Colen Campbell (published 1717)

drawing is the fact that the terrace is shown with a series of 26 apparently semi-circular niches to its main elevation, flanking a central entrance. The niches shown on the elevation are so different to the existing blind arches that it would be easy to dismiss it as an entirely unexecuted proposal. However, in 2012 two trial entry holes were opened in the face of the blind arches, revealing curved niches behind the current secondary brick face. This suggests that Campbell's drawings are probably more accurate as a record of the original terrace than might initially be imagined, although there may well be elements which were unexecuted proposals.

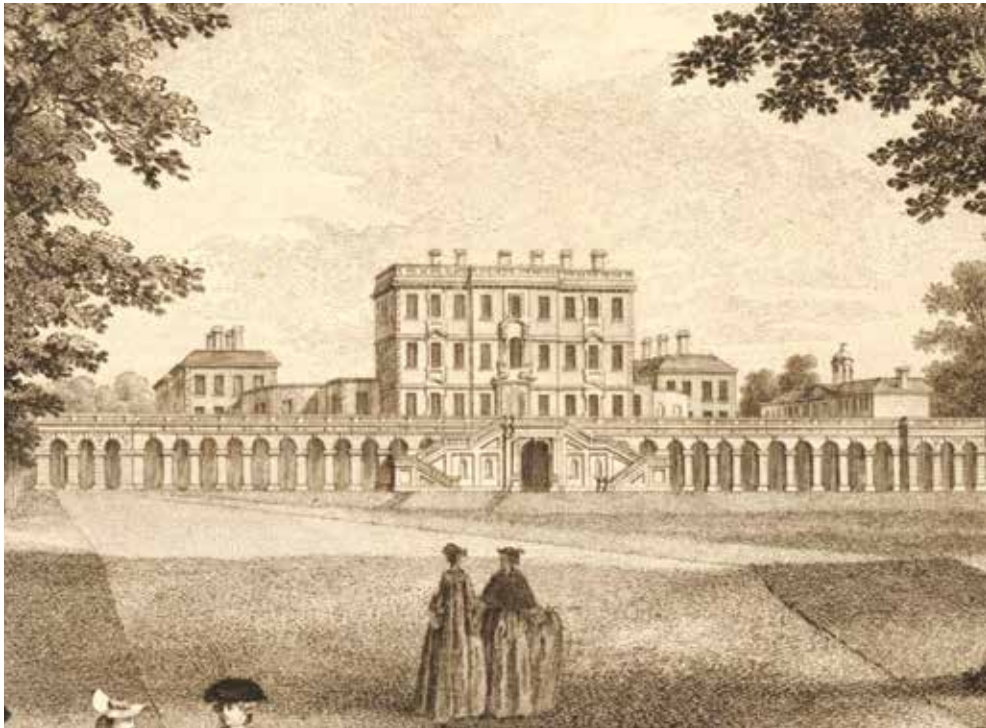
FIGURE 3 A View of Cliveden in Buckinghamshire by Luke Sullivan, 1759. ©British Museum

Although the second half of the 18th century was a period of neglect for Cliveden, its previous royal occupants had given it a certain status and several valuable views were produced in this period showing the house and terrace from the south. A view by Luke Sullivan dating from 1759 is of particular interest because the arcading at the front

of the terrace appears to pre-date the blind arcade that survives today (Fig 3). This is suggested by the fact that the south face of the eastern fernery is set slightly in front of the adjacent arcade, whereas today the blind arcade is slightly in front of the fernery face. It is also noticeable in close-up that coursing is shown to the arcade piers similar to that on the fernery piers, whereas later views all show them as plain, as if they were rendered, distinct from the fernery elevations. There are two later views, probably from the 1770s, one included in *The Modern Universal British Traveller* from 1779 and a similar undated engraving by John Donowell, which show a number of interesting differences from the 1759 view (Fig 4). These two views appear to show the arcade as rendered and being aligned with the end chambers, rather than being recessed behind it as in the 1750s, suggesting that an entirely new blind-arcade front was constructed between 1759 and 1779. The two 1770s views also show the staircase with slightly different detailing to its face to that shown on the 1750s views.

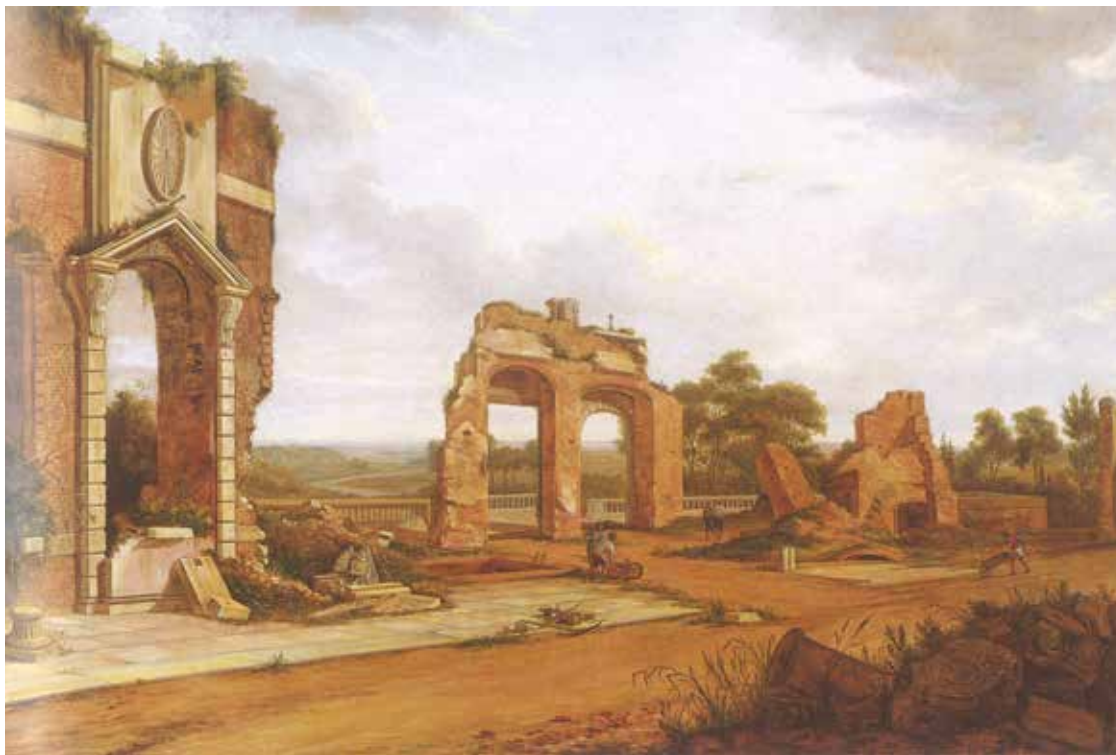
FIGURE 5 The ruins of Cliveden after the 1795 Fire by Hendrik de Cort (Collection Lord Astor)

A useful view of the ruins was produced by Hendrik de Cort, looking south-westwards and showing the balustrading of the terrace behind the remains of the house (Fig 5). In relation to the terrace, the most useful aspect of this view is that it shows that at the western end of the terrace there was a brick northern retaining wall and that the ground immediately north was considerably lower than the level of the terrace itself.

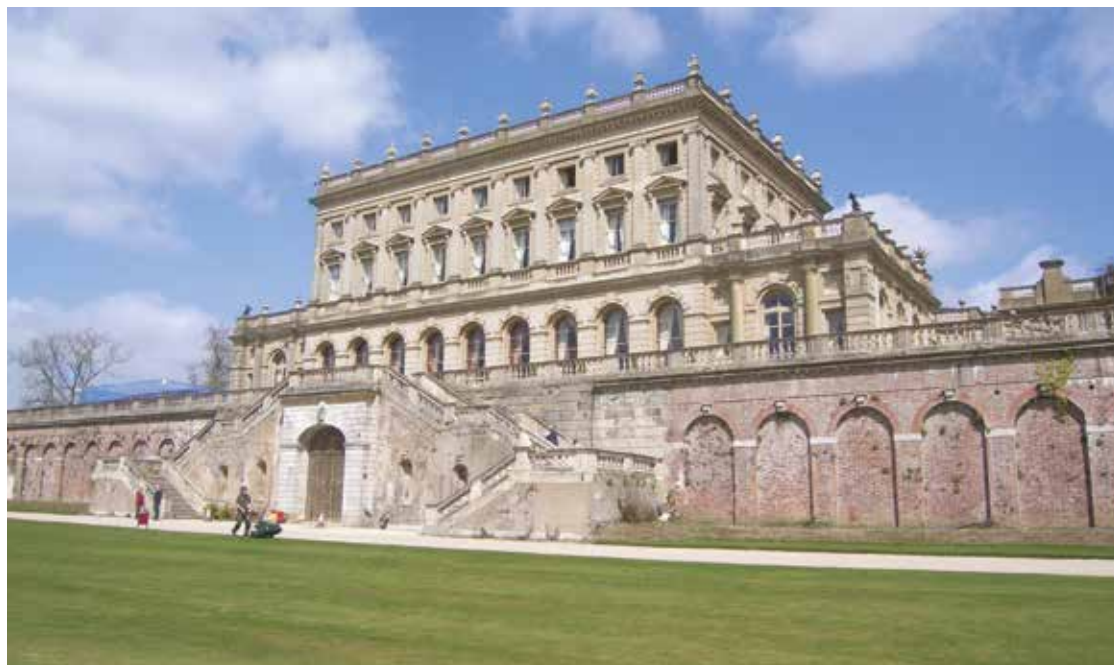
FIGURE 6 The South Terrace and mansion at Cliveden

The southern face of the terrace, facing the parterre, is formed by a blind arcade with nine arches to either side of the central staircase as well as a further two partially visible arches to each side, abutted by the staircase. Beyond each end of the blind arcade are a further three open arches which form the front of two chambers known as the east and west ferneries. Adjacent to the two ferneries (*i.e.* behind the outermost parts of the blind arcade) there are further vaulted spaces known as the east and west barrel-vaulted chambers. At the centre of the terrace there is an archway which leads into a pair of rooms, one beneath the terrace and one beneath the house, known as the sounding chambers.

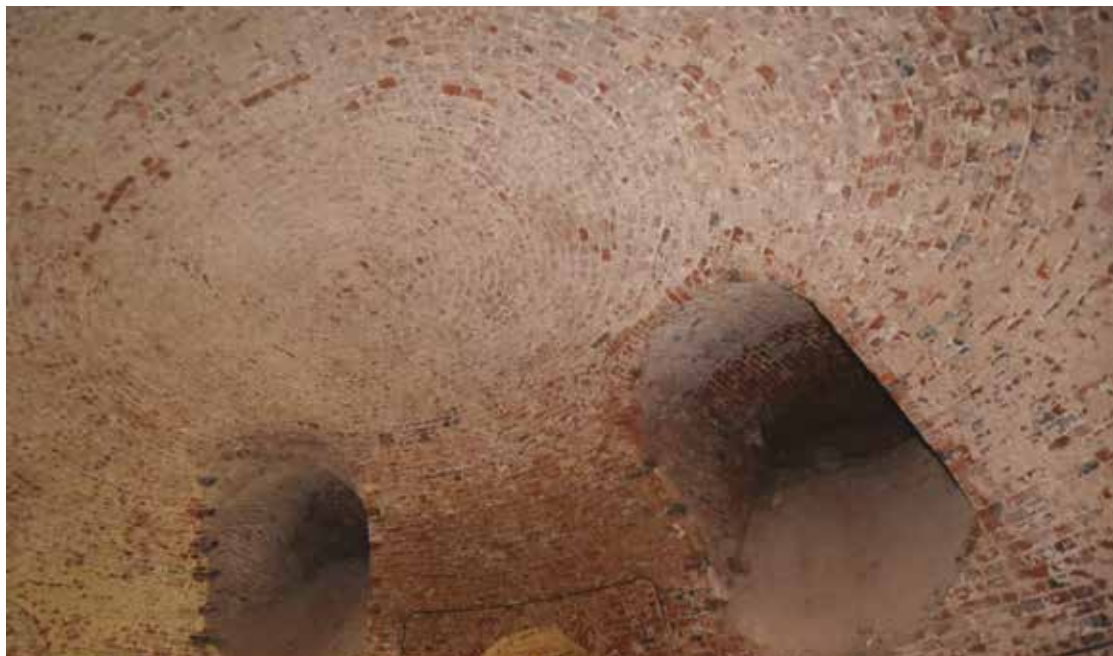
FIGURE 7 Light wells or funnels exposed within Sounding Chamber beneath mansion

The other intriguing features revealed by plaster removal in the inner chamber were a pair of large broadly oval-shaped openings in the southern side of the elliptical dome and two brick-lined, funnel-shaped ducts extending up to the terrace (Fig 7). These features appear to be part of the primary structure and although it is believed that they were principally light wells to illuminate the innermost sounding chamber, they would presumably also have allowed music to travel up to the terrace. Unfortunately, the upper parts of the funnels have been substantially altered, probably in the 19th century, so the historic form of these parts of the structure is not fully known, but it is believed that the funnels would have reached the terrace at a point immediately in front of the front wall of the mansion. It may be that there was an east to west sunken passage in the terrace, immediately in front of the mansion, to which the upper

ends of the funnels connected. There is a feature shown in the floor on Hendrik de Cort's c.1798 view which could be interpreted as such.

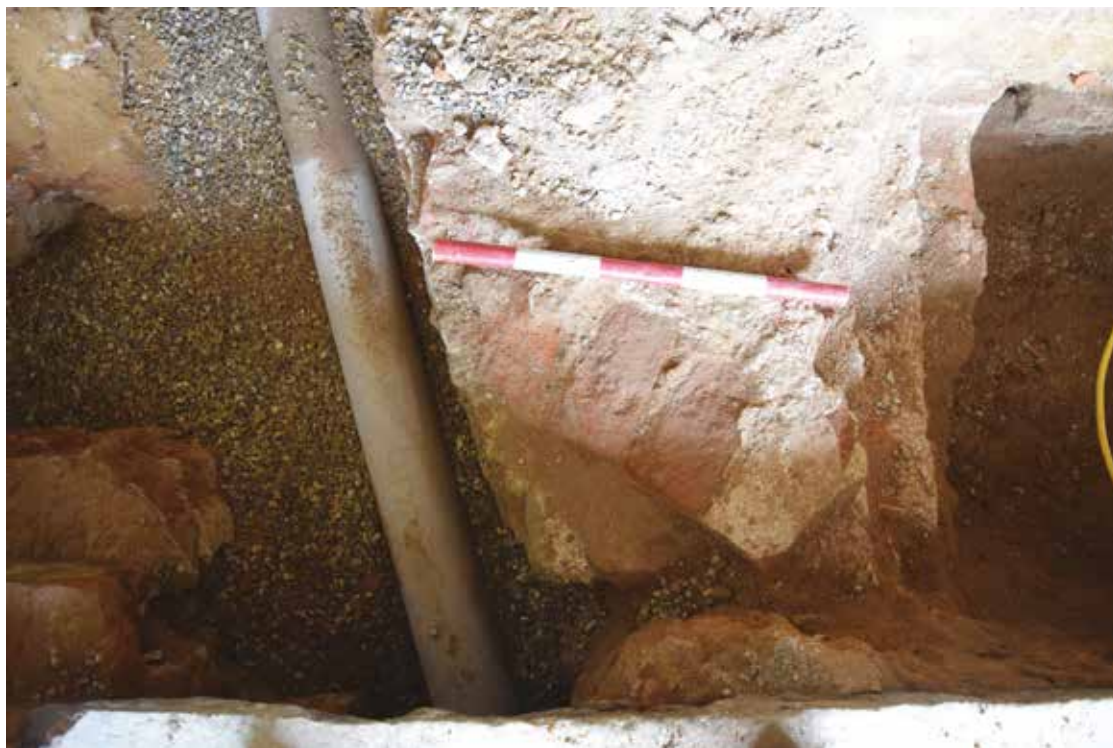
FIGURE 8 Trace of former curved niche found beneath front wall of eastern fernery

Perhaps the most intriguing features revealed in the current phase of work have been in trenches dug in the floor of each fernery. These include the base of a very wide brick wall which extends east to west beneath the front of the terrace and which must have been constructed in the 1670s to form a solid foundation for the front of the new structure. The section of this wall exposed in the eastern fernery has been of particular interest because it showed traces of semi-circular features in the upper surface which, it is assumed, formed niches

or similar structures (Fig 8). Whatever form these 'niches' in the area of the ferneries took they were clearly replaced by the current fernery structures, although it is uncertain exactly when that occurred. It may have been in the first quarter of the 18th century, when the central staircase replaced what are believed to have been end staircases, but there is also a possibility that the structure was replaced during the initial construction phase in the 1670s. As referred to above, there is a reference from 1677 to the duke threatening to pull down a part of his new construction due to 'a little mistake in my builders' (Hitchmough 1997). It is also relevant to note here the drawings in *Vitruvius Britannicus* (1717) which show either end of the terrace comprising semi-circular stair projections, quite different to the ferneries that survive today. It is uncertain whether these were ever constructed, or how this curved niche could have related to it, but they provide interesting evidence for early alterations and changes of design in this area.

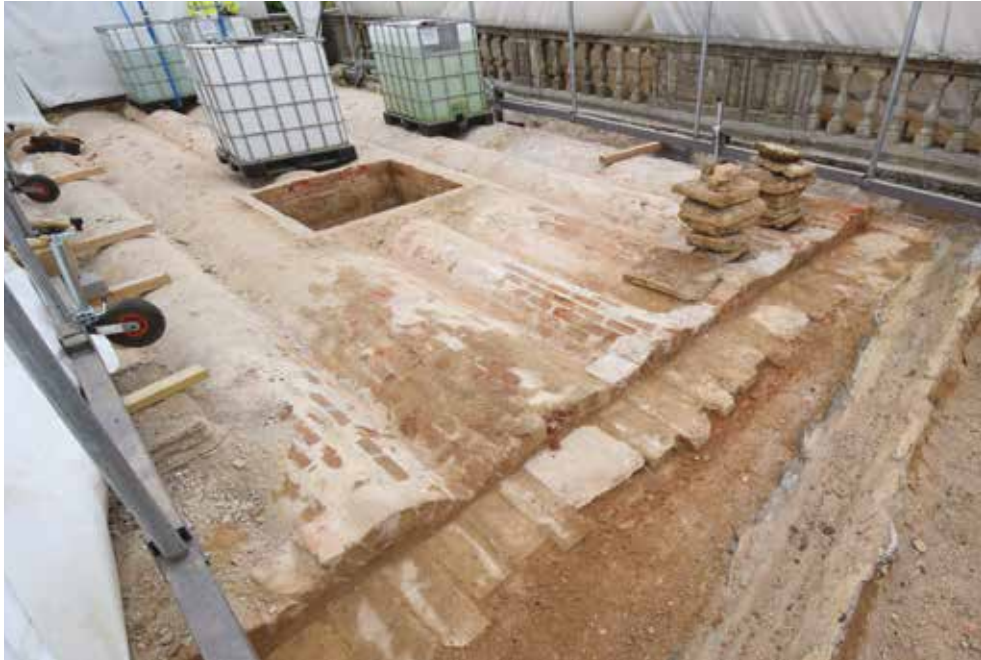
FIGURE 9 Brick vaulting and square base of former skylight exposed over eastern fernery

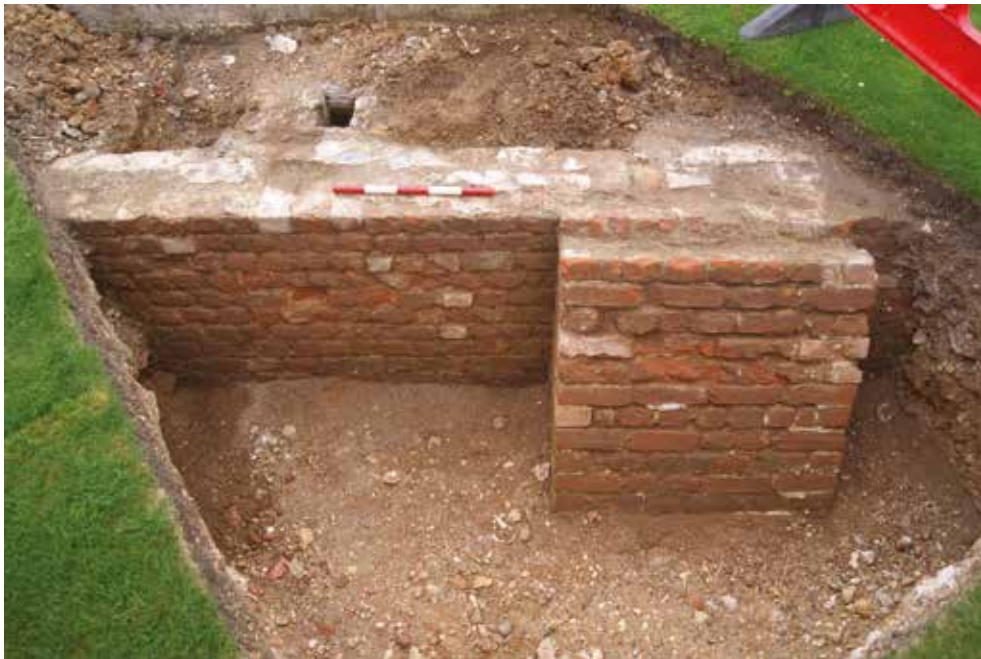
FIGURE 10 Section of former north wall of western third of terrace exposed by excavations by West Lawn

documentary sources that either side of the house the ground level immediately to the north of the terrace was significantly lower than that of the terrace. Parts of the former northern retaining wall of the terrace were exposed in several trenches dug in the current project. In some areas this wall had been cut back or truncated, but it was well preserved towards the west end, adjacent to the brick-vaulted substructure. Here it was exposed to a maximum of c.1m below the terrace surface (Fig 10). Various features of interest were noted in the exposed northern face of this wall, including three simple sloped brick buttresses, a pair of semi-circular structures which relate to the fernery windows in this wall, and a conventional rainwater downpipe hopper fixed to the wall 0.85m below the terrace surface. Clearly this hopper must pre-date the raising of the ground level in this area.

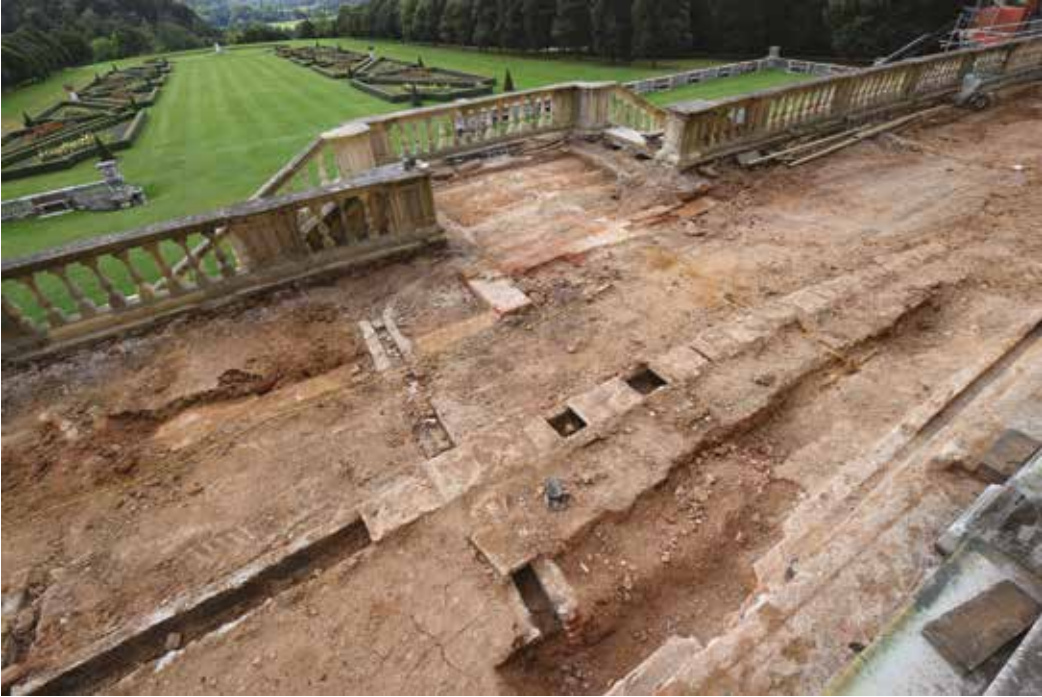
FIGURE 11 East-west wall and tops of vaults exposed by southern balustrade of terrace

Among the most interesting and consistent features revealed by the excavations on the terrace was the top of an east-west sleeper-type wall (0.35m wide and c.0.5m below surface) c.1.7m to the north of the balustrade along the terrace front (Fig 11). This wall is believed to continue along almost the full length of the terrace (although it was not fully exposed), and was associated with a set of contemporary brick vaults immediately to the south, extending towards the main balustrade of the terrace. The tops of the vaults were close to the limit of the excavation so many of these were only slightly exposed and in some areas not at all, but it is reasonable to assume that they continue across the full width of the terrace, other than above the ferneries. The character of the bricks in the sleeper wall and vaults would be consistent with a later 17th century date, so it seems most likely that these features are part of the duke's original construction, possibly protecting a set of niches below as shown on the drawings in *Vitruvius Britannicus*. However, it is also possible that they belonged to a phase of remedial works in the 18th century, such as when the blind arcade front was constructed in the c.1760s or 1770s. The sleeper wall and vaults were covered by a distinct, east-west band of

puddling clay, presumably intended to carry water northwards away from the front of the terrace. Towards the centre of the terrace, over the vaults of the sounding chambers, the layer of clay continued across the full width of the terrace.

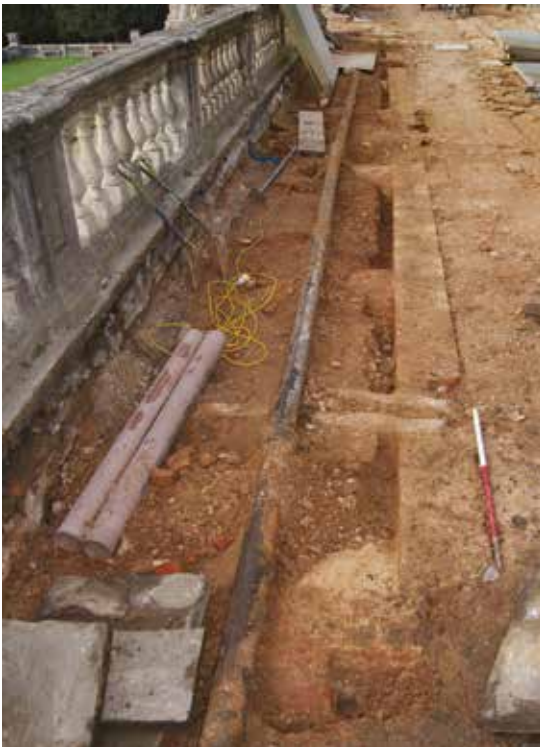
FIGURE 12 Drains and other features exposed towards centre of terrace

The brick-vaulting at either end of the terrace was set at a shallow depth beneath the paving slabs. In the rest of the terrace substructure there was a greater depth of loose fill: within this, numerous small drainage channels were uncovered in the excavations, mainly brick lined and many with stones laid over the top. The character of the bricks and the use of a hard render lining suggest that these are likely to be secondary insertions from the 18th or 19th century.

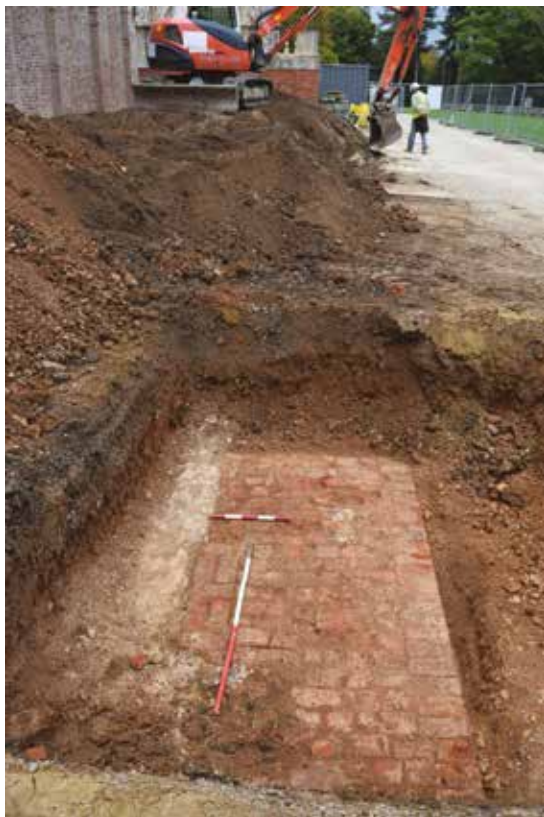
FIGURE 14 East-west plinth type wall exposed in front of western half of terrace

The most significant archaeological features revealed in the current works in this area were a number of sections of very large brick plinths or wall bases which are believed to date from the Duke of Buckingham's 17th-century phase of construction. An east-west wall (c.1.45m wide) was found

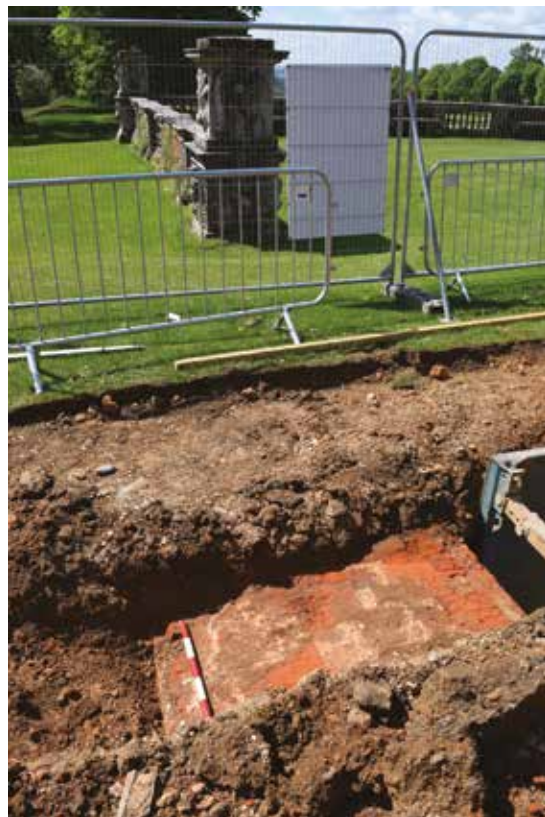
FIGURE 15 North-south wall exposed in front of eastern fernery

The landscaping (shallow ground reduction) works in front of the eastern fernery revealed a large, distinct spread of what appeared to be demolition rubble (a thick layer of loose white mortar with brick fragments mixed in) immediately north of the large east-west plinth-type wall and continuing up towards the fernery. This was c.3.8m wide (although the central part had been truncated) and it was broadly centred on the fernery. This suggests that there was a substantial above-ground structure that was taken down in this location, possibly similar to the stair projection shown on the *Vitruvius Britannicus* drawings, or maybe due to a change of design before it was fully completed.
