TRACES OF A LATE SAXON CHURCH AT ST. MARYS, AYLESBURY

BRIAN DURHAM

Restricted salvage observations suggest that the existing thirteenth century nave of St. Mary's church, Aylesbury developed from a shorter nave employing stone-saving footings, with a western tower added and then removed. The earliest footings are probably late Saxon, perhaps set into a plough headland. There is slender evidence for a cloister and a water distribution system in the twelfth century, which would agree with the assumption that this was once a 'minister' church.

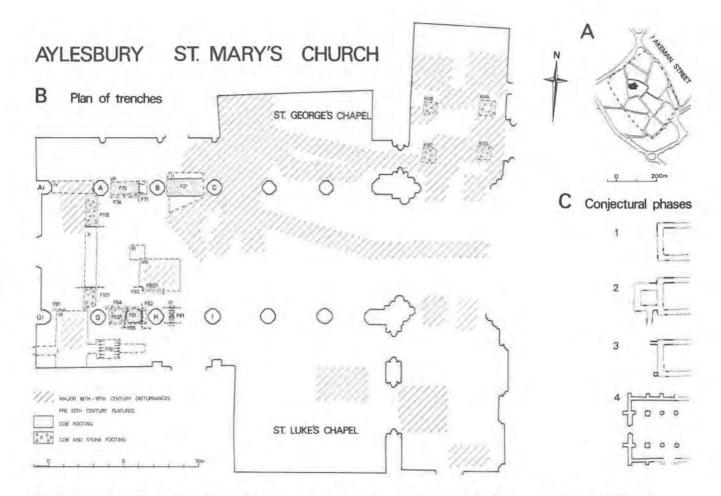
- Fig. 1. A. Aylesbury showing the possible line of a late Saxon Burghal defence (after Farley, op. cit. note 2, Fig. 1);
 - B. Principal features of all periods;
 - C. Conjectural phasing, footing-faces shown with a hard line, irrespective of construction type.

The Excavation (Fig. 1.B)

Figure 1.B shows the extent of modern disturbances exposed by the present works. The stated intentions of the restoration of 1850 suggest that huge concrete shoring bases and underpins may exist in the region of the crossing,¹⁴ and since the heating system and internal burials have disturbed large areas of the nave, it is likely that the 1978 builders' trenches could not have been better placed to gain a first insight into the development of the church.
