HOUSES IN HIGH STREET, CHALFONT ST. PETER

C. F. STELL, F.S.A.

NOS. 43-47 HIGH STREET

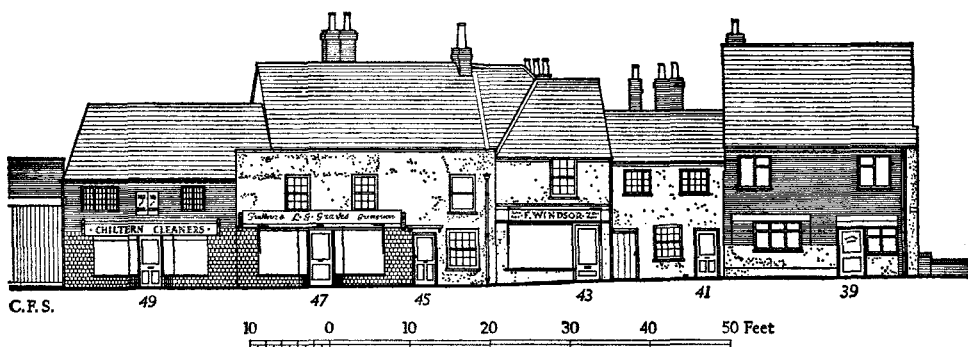
Fig. 1. Nos. 39-49 High Street, Chalfont St. Peter.

The principal range consisted of Nos. 39-49 High Street (Plate I and Fig. 1), besides a few further buildings to the north, some of which although much altered and encased in brickwork retained considerable portions of timber-framed buildings concealed in their structure; these dated from the beginning

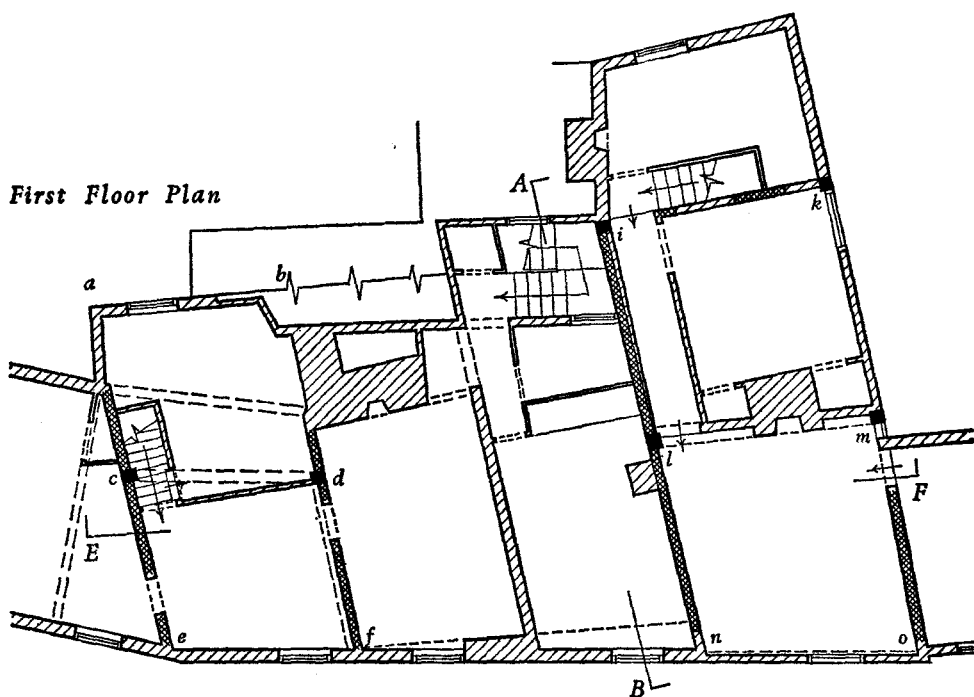
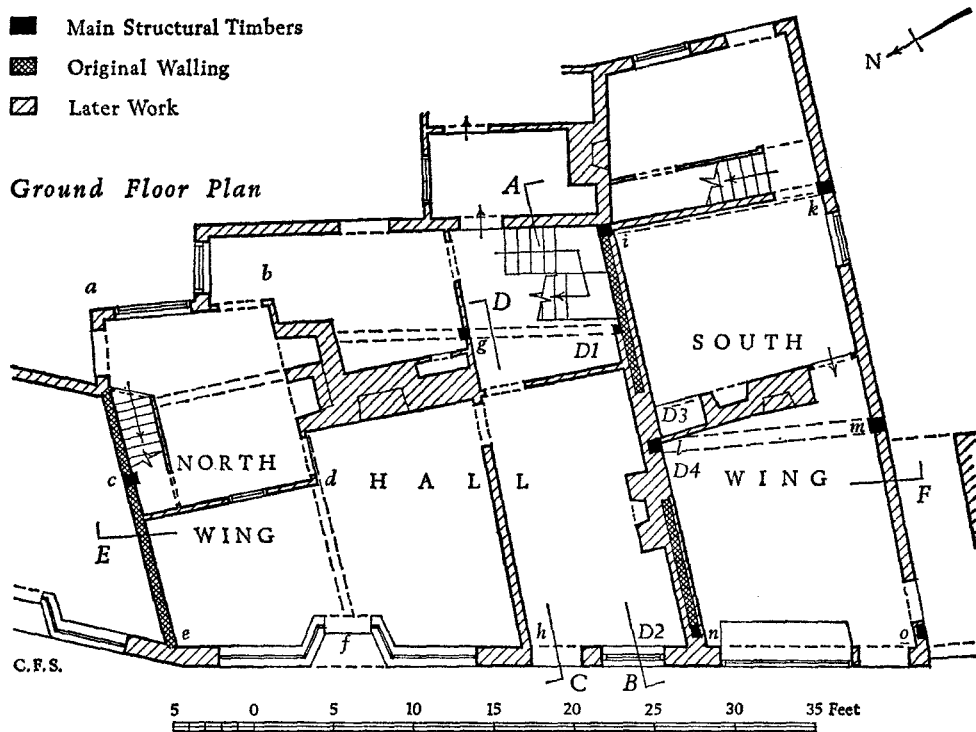
Fig. 2. Plans of Nos. 43-47 High Street.

The layout of the original building which embraced Nos. 43–47 became clear as demolition proceeded; it was that of a hall house with north and south wings, planned with some irregularity presumably from initial limitations in the boundary of the site which stretched from the road to the river. The hall was a parallelogram with 20 ft. sides with a screens passage at the south end having a doorway *D2* from the street and another *D1* in the back wall; two further doors *D3* and *D4* led into the south wing. The hall and wings all had crown-post roofs, but the roof of the hall had been very much altered in the 18th century when it was raised some six feet to give a full upper storey; the original tie-beam and crown post were, however, re-used and the post formerly supporting them at the east end survived as evidence of their former location. Most of the original common rafters were also reset at the upper level. The line of the former hall roof was visible in the south wall (Plate II *b*) and the seating for a brace at the north end of the collar purlin remained in the north wall. One half of the arched head of the doorway at the east end of the screens passage also remained. The *south wing* was higher than that to the north and was clearly of greater importance. The roof structure survived almost complete with a crown post with moulded capital and curved braces. The *north wing* was in a more fragmentary state but the crown post of the roof remained (Plate III *a*) with braces to the collar purlin of a quality much inferior to that in the opposite wing.

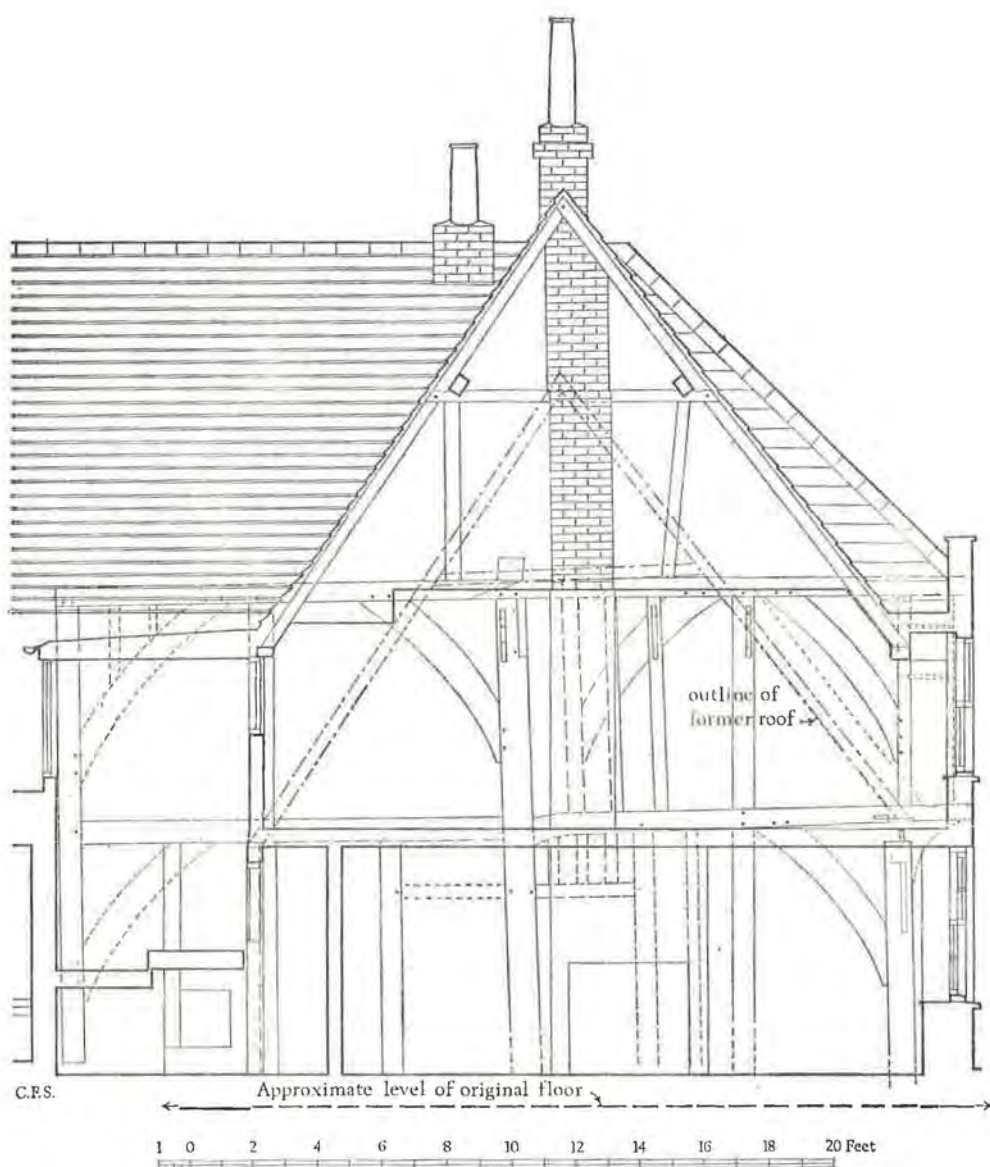
Fig. 3. Section A-B, No. 45 High Street

South wall. This was the best preserved of the original walls in the building (Fig. 3), although the lower part had been encased on both sides in later brickwork and was only seen with difficulty during demolition. It was structurally the north wall of the south wing, the most prominent feature being the post 1 supporting the roof truss of the wing; this had a curved brace to the wall-plate on its east side. A cutting on the west side near the top of the post appeared to be an original patching or replacement of defective timber. At the top of the north

Front (West) wall. No original timbering of the wall survived in the ground floors of Nos. 45 and 47. A wall-plate supporting the roof in its raised position was visible in the first floor (Fig. 3) but the possibility that this might have been the former wall-plate re-used could not be determined. Evidence for the existence of the outer doorway to the screens passage remained in the east face of post *n* where the mortice for the door-head was visible and similar to that surviving in door *D1*, together with the seating for the wall-plate above it.

face of this post and of two exposed posts to the west (Plate II and Fig. 3) were mortices for brackets, of which the broken-off tenons remained. The purpose of these was not apparent though they may have been intended to give support to some form of louvre in the roof. The plastering of this wall was heavily smoke blackened, much more so than the opposite wall of the hall, indicating that the fire and possibly the smoke exit was at this end. An intriguing stepped outline free from smoke blackening also appeared on the back of post *l* (Plate II *a*) but the possibility of its being the outline of a smoke hood is negated by the presence of the screens passage and the uniformity of the smoke blackening

window formerly existed east of post *n* in the first-floor room (see Fig. 3).
