Great Horwood Village Survey : October 2011

Section 6: **NASH ROAD**

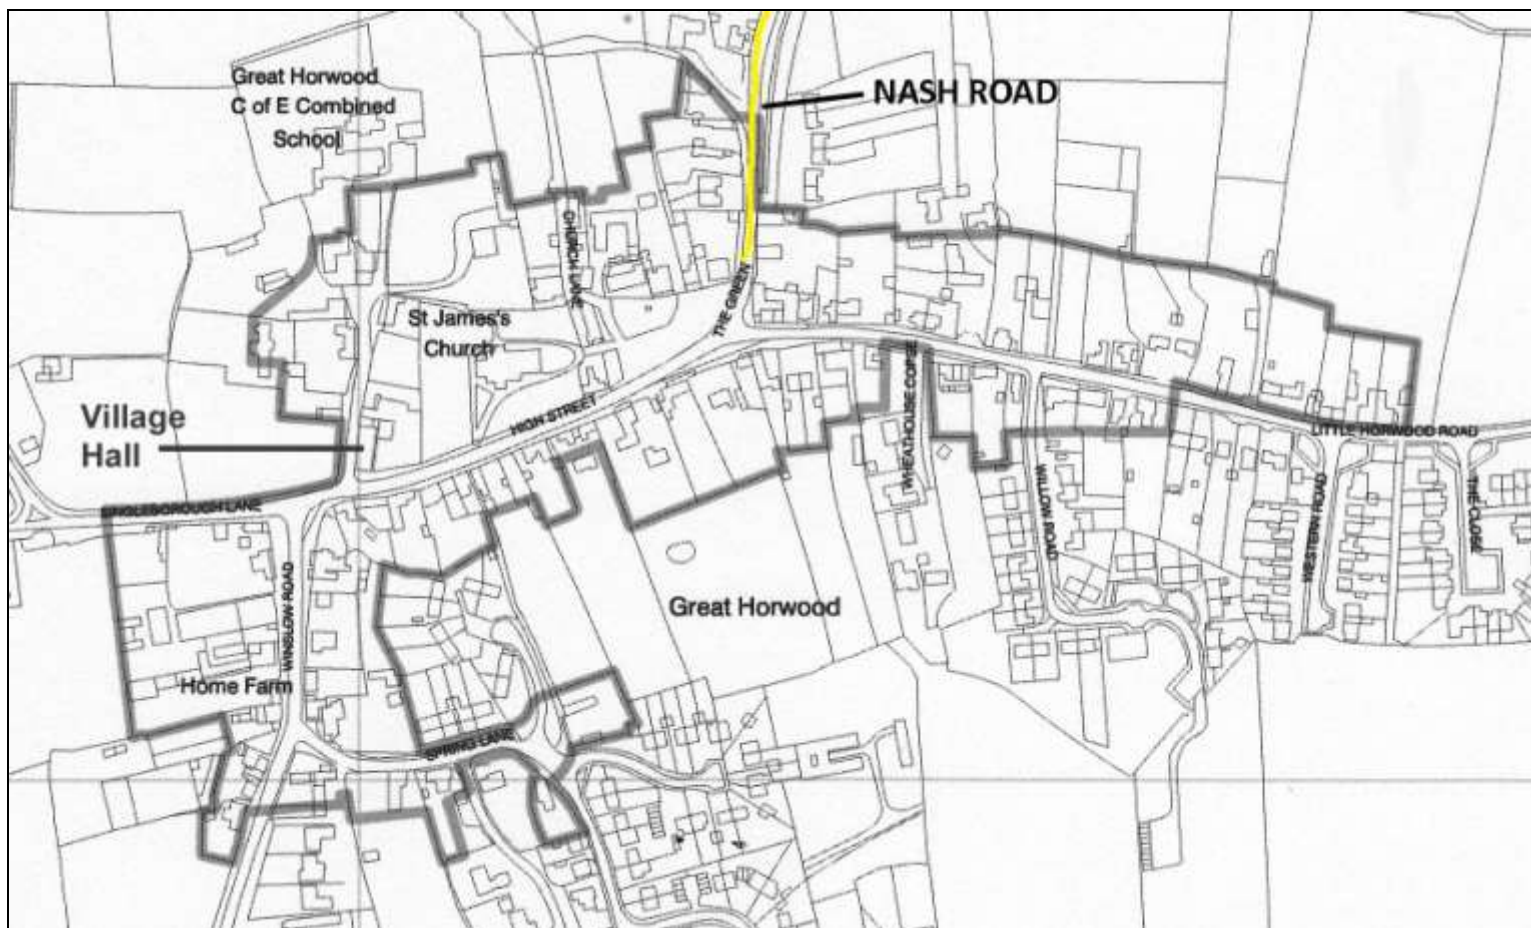
1 and 3 Nash Road

HOUSE NO/NAME:	1 and 3
STREET:	Nash Road
BUILDING USE:	Residential
CONVERTED FROM EARLIER USE?	Built on the site of some former shops
PERIOD:	Post-1960
PLANFORM:	Semi-detached pair of houses, with integral garages
STYLE:	Modern
BUILDING/CLADDING MATERIALS:	Multi-coloured brick, metal garage doors
ROOFING MATERIALS:	Concrete tiles
ROOF FORM:	Gable-ended with shared central chimney stack
OTHER FEATURES/INFORMATION:	Modern 'picture windows'
CONDITION:	Good
NOTES:

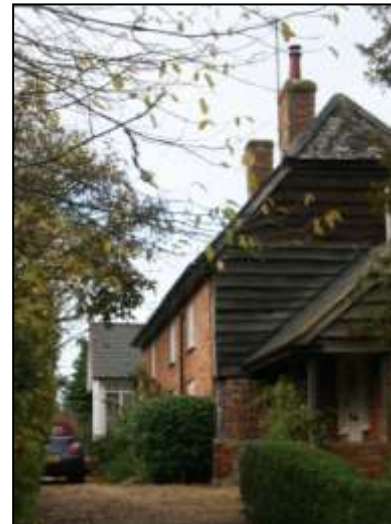
5 Nash Road

HOUSE NO/NAME:	5
STREET:	Nash Road
BUILDING USE:	Residential
CONVERTED FROM EARLIER USE?	?? Originally two cottages, numbered 5 and 7.
PERIOD:	C17, altered C20
PLANFORM:	Single E-W 2-storey range, with modern porch to east and modern extension to west.
STYLE:	Vernacular
BUILDING/CLADDING MATERIALS:	Brick, cladding timber frame (exposed in east gable and to rear), set on rubblestone plinth. Weatherboarding to east gable and porch.
ROOFING MATERIALS:	Slate
ROOF FORM:	Half-hipped. Two intermediate chimney stacks.
OTHER FEATURES/INFORMATION:	Modern casement windows
CONDITION:	Good
NOTES:	Listed Grade 2 (number 1213554). List description adds 'Front rebuilt in brick late C19. Queen strut roof.'

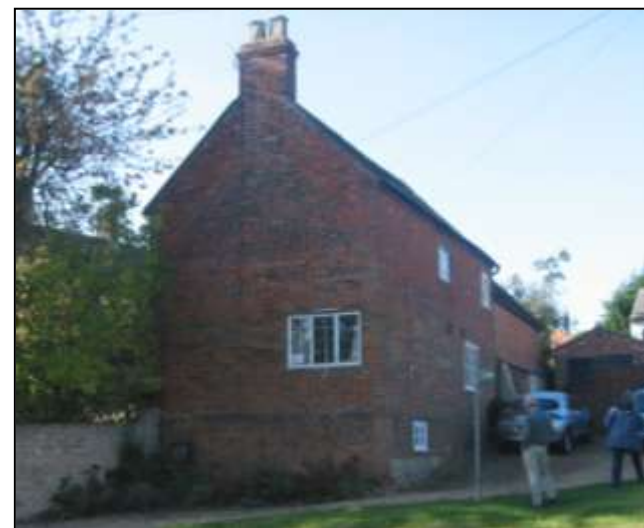
9 Nash Road

HOUSE NO/NAME:	9
STREET:	Nash Road
BUILDING USE:	Residential
CONVERTED FROM EARLIER USE?	May be conversion from agricultural store or workshop.
PERIOD:	C19, altered.
PLANFORM:	Two storeys on cellar, with lower-level outbuilding to west and single internal chimney stack to east gable..
STYLE:	Vernacular
BUILDING/CLADDING MATERIALS:	Red and blue brick, rubblestone plinth. Outbuilding part tile-hung.
ROOFING MATERIALS:	Plain old clay tiles.
ROOF FORM:	Gable-ended
OTHER FEATURES/INFORMATION:	Windows are small and asymmetrically placed, indicating insertion at various times. Brickwork on the east gable and north front indicates that the upper storey is a later addition.
CONDITION:	Good
NOTES:

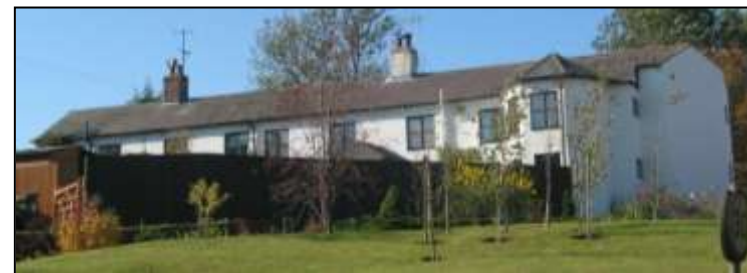
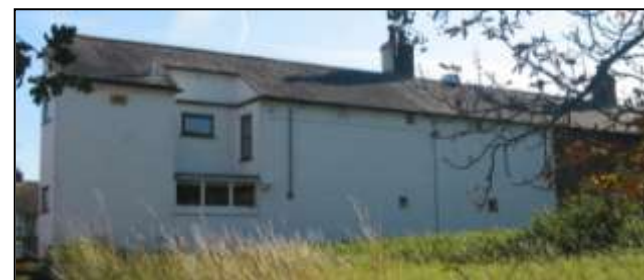
11 and 13 Nash Road

HOUSE NO/NAME:	11 and 13
STREET:	Nash Road
BUILDING USE:	Residential
CONVERTED FROM EARLIER USE?	Most likely originally a terrace of 4 workers' cottages.
PERIOD:	C19, altered and extended
PLANFORM:	Two storeys. Number 11 two bays; number 13 2 bays plus C20 1.5-bay extension including octagonal 2-storey extension on east.
STYLE:	Victorian
BUILDING/CLADDING MATERIALS:	Painted brick
ROOFING MATERIALS:	Natural slate, with two intermediate chimney stacks.
ROOF FORM:	Gable-ended, with north gable is at a 45-degree angle and pitched octagonal slate roof on extension.
OTHER FEATURES/INFORMATION:	Windows are symmetrically placed casements, probably modern replacements. The rear of the terrace, facing west, is without windows (except on the inset extension) – reason unknown.
CONDITION:	Good
NOTES:

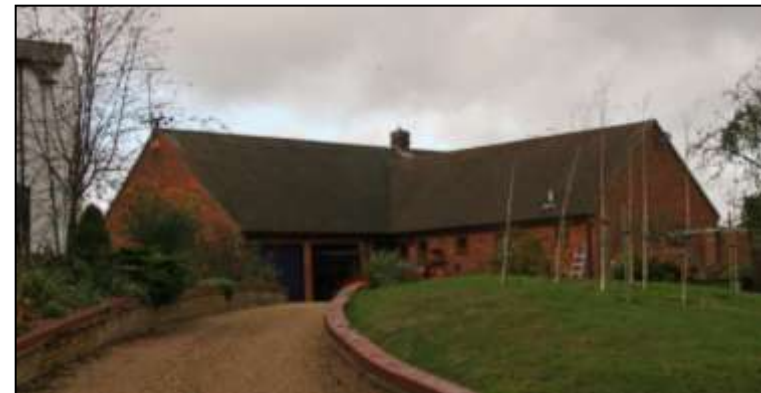
Russets, 13a Nash Road

HOUSE NO/NAME:	Russets, 13a
STREET:	Nash Road
BUILDING USE:	Residential
CONVERTED FROM EARLIER USE?	No
PERIOD:	Post-1960
PLANFORM:	L-shaped single-storey bungalow with integral double garage
STYLE:	Modern
BUILDING/CLADDING MATERIALS:	Red brick
ROOFING MATERIALS:	Concrete tiles
ROOF FORM:	Gable-ended, with single small chimney
OTHER FEATURES/INFORMATION:	
CONDITION:	Good
NOTES:

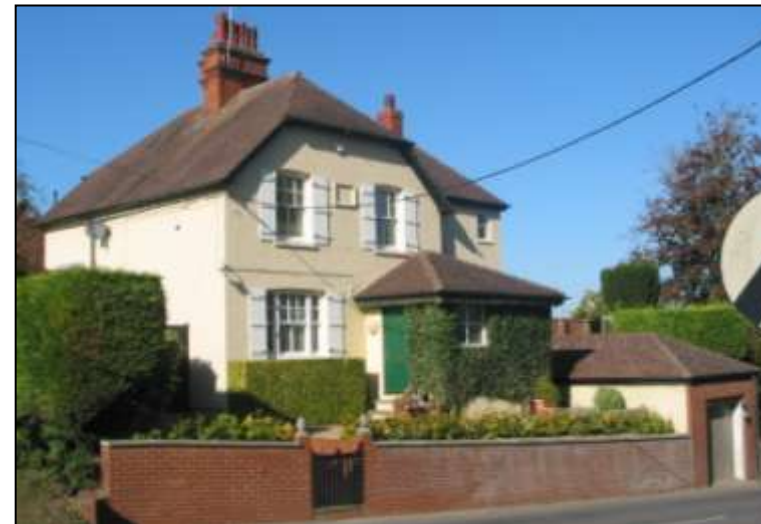
Hillside Cottage, 15 Nash Road

HOUSE NO/NAME:	Hillside Cottage, 15
STREET:	Nash Road
BUILDING USE:	Residential
CONVERTED FROM EARLIER USE?	No
PERIOD:	1900-1910
PLANFORM:	Two storey, L-shaped (original building plus C20 extension to north) with C20 porch and single garage at road level
STYLE:	'Edwardian'
BUILDING/CLADDING MATERIALS:	Painted brick
ROOFING MATERIALS:	Machine-made tiles
ROOF FORM:	Half-hipped main building with fully hipped extension, porch and garage.
OTHER FEATURES/INFORMATION:	Sash windows and shutters on main building
CONDITION:	Good
NOTES:

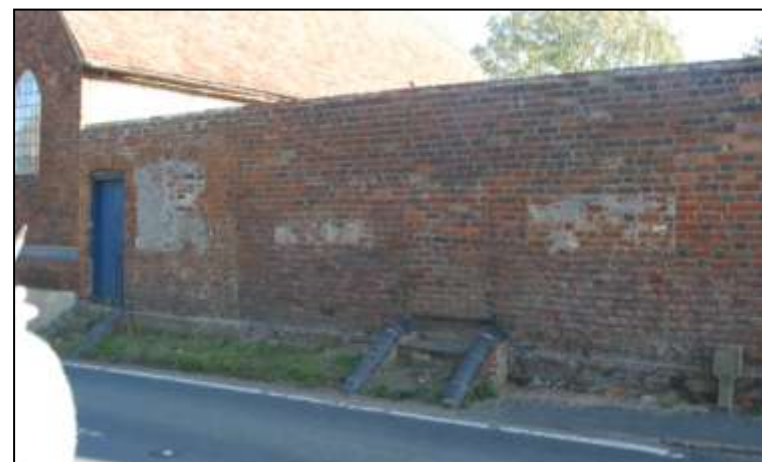
Blocked house fronts, east side of Nash Road

HOUSE NO/NAME:	No
STREET:	Nash Road
BUILDING USE:	Now a garden wall
CONVERTED FROM EARLIER USE?	Two former cottages
PERIOD:	C19 or earlier?
PLANFORM:	
STYLE:	'Edwardian'
BUILDING/CLADDING MATERIALS:	Red and blue brick wall with one open and one blocked doorway, both with steps to roadway, and two blocked window openings.
ROOFING MATERIALS:	None
ROOF FORM:	None
OTHER FEATURES/INFORMATION:	
CONDITION:	Poor
NOTES:	The blocked openings indicate the position of two earlier cottages.

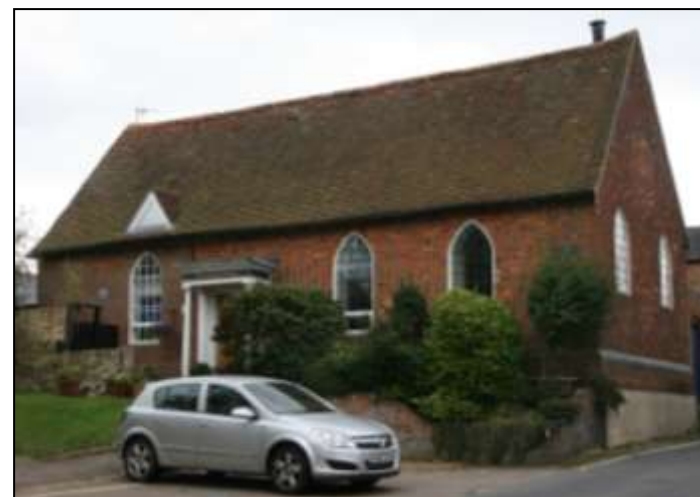
The Chapel House, Nash Road

HOUSE NO/NAME:	The Chapel House
STREET:	Nash Road
BUILDING USE:	Residential
CONVERTED FROM EARLIER USE?	Originally a barn, converted to a Congregational chapel, now a dwelling
PERIOD:	C18 barn, converted 1821 and late C20.
PLANFORM:	Inserted upper floor
STYLE:	Vernacular
BUILDING/CLADDING MATERIALS:	Mixed red and blue brick
ROOFING MATERIALS:	Old plain clay tiles
ROOF FORM:	Gable-ended with stove pipe near western end
OTHER FEATURES/INFORMATION:	
CONDITION:	Good
NOTES:	Listed Grade 2 (number 1289031). List description adds: 'North front has 3 barred wooden windows with pointed arched heads, and blocked ventilation slits. Double panelled doors between left-hand windows have fine wooden porch with entablature hood on slender Doric columns and pilasters. West end has 2 similar pointed windows and blocked rectangular window above. Altered East end has wide double doors with barred rectangular fanlight and wooden lintel, 3-light casement above with leaded outer panes. Royal Exchange fire insurance plaque above upper window. Interior has some original fittings, including gallery on slender wooden Doric columns at east end.'

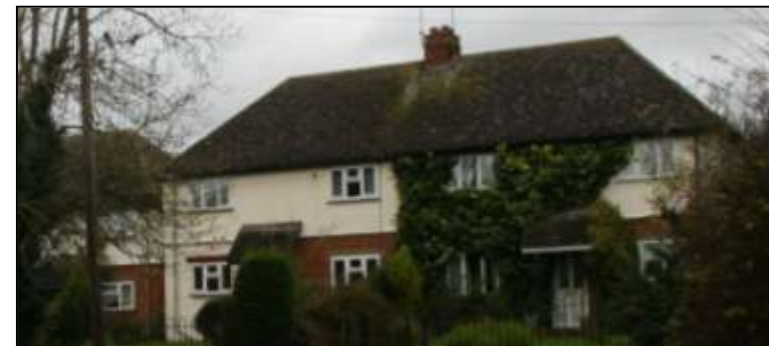
2-12 Nash Road

HOUSE NO/NAME:	2-12
STREET:	Nash Road
BUILDING USE:	Residential
CONVERTED FROM EARLIER USE?	NO
PERIOD:	1950s
PLANFORM:	Three pairs semi-detached houses
STYLE:	Modern
BUILDING/CLADDING MATERIALS:	Part-rendered red brick
ROOFING MATERIALS:	Concrete tiles
ROOF FORM:	Hipped, with shared central chimney stack
OTHER FEATURES/INFORMATION:	
CONDITION:	Good
NOTES:
