Great Horwood Village Survey : October 2011

Section 3: **WINSLOW ROAD**

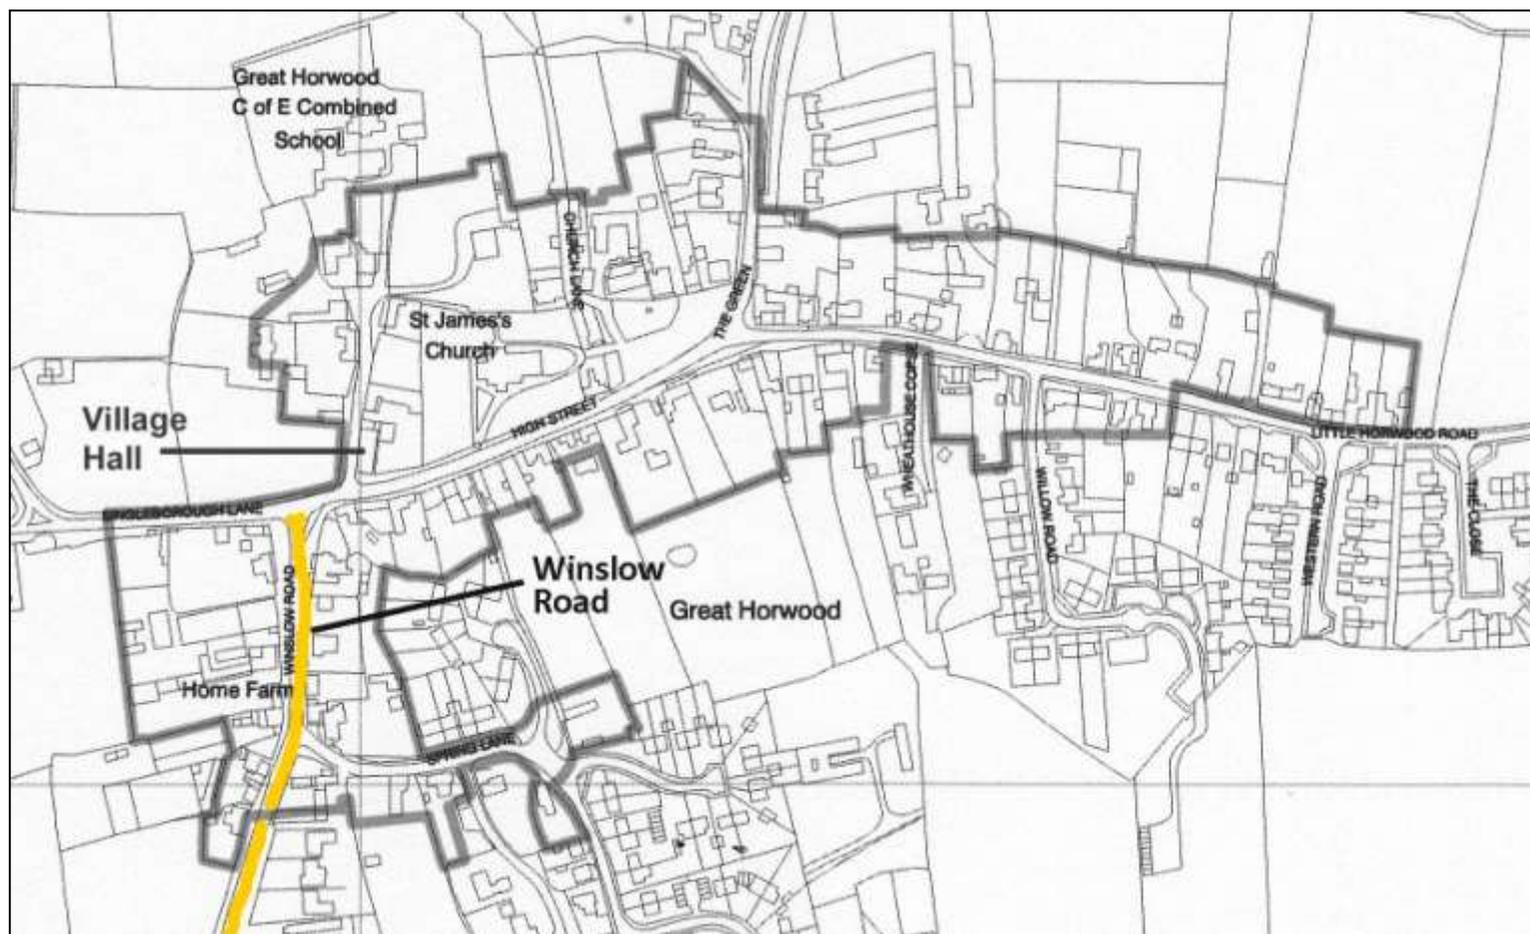
HOUSE NO/NAME:	The Swan
STREET:	1 Winslow Road
BUILDING USE:	Public House
CONVERTED FROM EARLIER USE?	No
PERIOD:	C18
PLANFORM:	Gable and chimney, single-storey gabled extension to left, two-storey extension to rear. Two storeys plus attic.
STYLE:	Vernacular with classical door frame
BUILDING/CLADDING MATERIALS:	Rendered with brick plinth
ROOFING MATERIALS:	Natural slate
ROOF FORM:	Gable-ended, with chimney stacks to right and at rear.
OTHER FEATURES/INFORMATION:	Central doorway with classical door frame and hood. Two-storey canted bay windows to each side.
CONDITION:	Good
NOTES:	Listed Grade 2 (number 1213759)

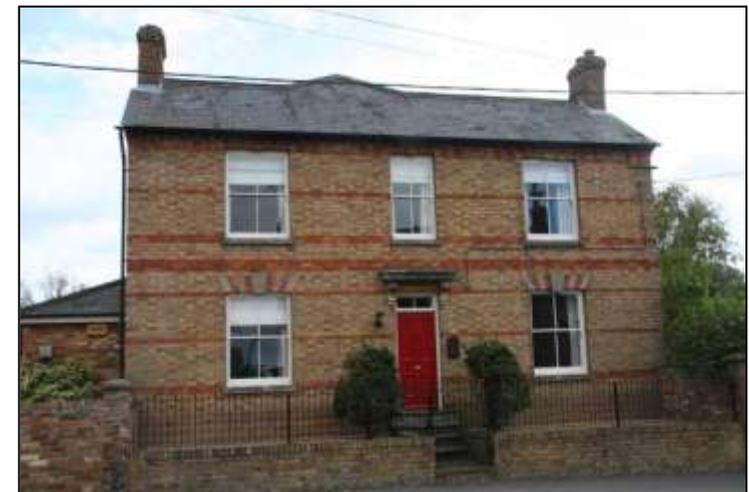
Old Swan House, 3 Winslow Road

HOUSE NO/NAME:	Old Swan House
STREET:	3 Winslow Road
BUILDING USE:	Residential
CONVERTED FROM EARLIER USE?	No
PERIOD:	1850-1900
PLANFORM:	Gabled with end chimneys and rear wing. Two storeys.
STYLE:	'Victorian villa'
BUILDING/CLADDING MATERIALS:	Yellow brick with red-brick decorative band, segmented lintels and on gable-end walls.
ROOFING MATERIALS:	Natural slate
ROOF FORM:	Gable ended, low-pitched
OTHER FEATURES/INFORMATION:	Rear wing and later single-storey extension to left.
CONDITION:	Good
NOTES:

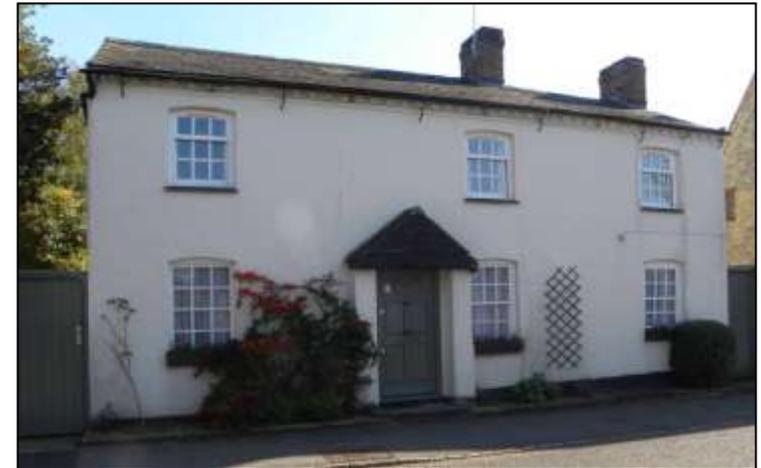
5 Winslow Road

HOUSE NO/NAME:	5
STREET:	Winslow Road
BUILDING USE:	Residential
CONVERTED FROM EARLIER USE?	Originally three cottages
PERIOD:	1800-1850
PLANFORM:	Originally terraced
STYLE:	'C19 workers' cottages'
BUILDING/CLADDING MATERIALS:	Rendered brick
ROOFING MATERIALS:	Natural slate
ROOF FORM:	Gable ended, low-pitched
OTHER FEATURES/INFORMATION:	Two chimneys, modern replacement sash windows. Modern porch.
CONDITION:	Good
NOTES:

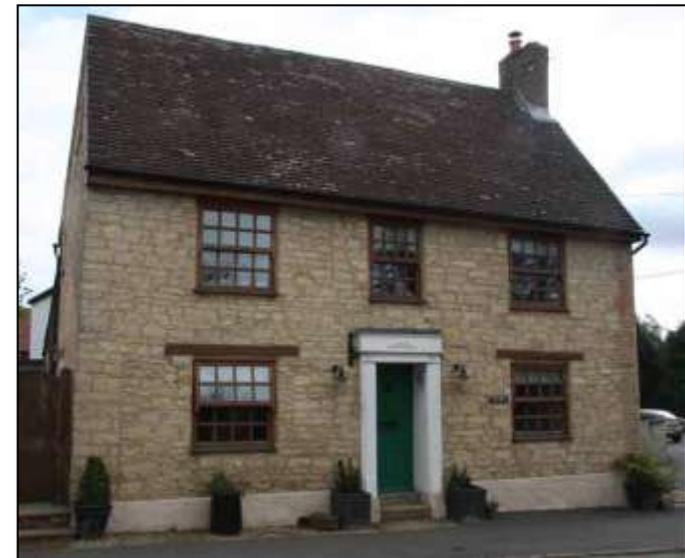
Wheelwright Cottage, 9 Winslow Road

HOUSE NO/NAME:	Wheelwright Cottage
STREET:	9 Winslow Road
BUILDING USE:	Residential
CONVERTED FROM EARLIER USE?	No
PERIOD:	C19? Difficult to date due to over-modernisation
PLANFORM:	Gabled with chimney
STYLE:	Vernacular
BUILDING/CLADDING MATERIALS:	Local stone, with stucco on right-hand gable to resemble stone
ROOFING MATERIALS:	Plain clay tiles. Recently re-roofed. Steeply pitched.
ROOF FORM:	Gable ended with single chimney to left
OTHER FEATURES/INFORMATION:	Brickwork visible at left corner. No original features except perhaps doorframe.
CONDITION:	Good.
NOTES:

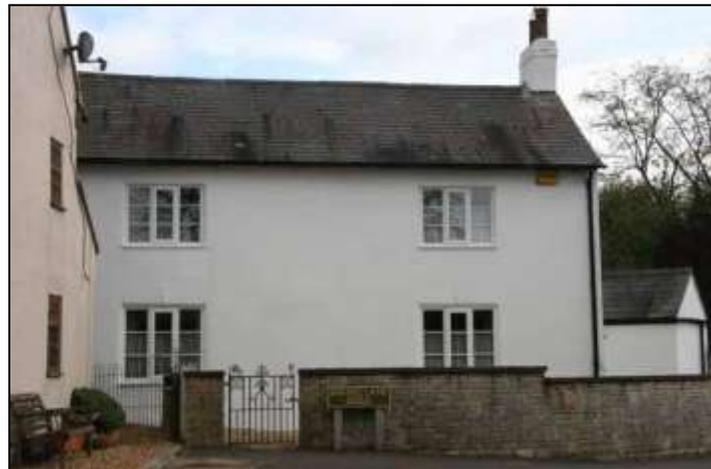
Stonecroft, 11 Winslow Road

HOUSE NO/NAME:	Stonecroft
STREET:	11 Winslow Road
BUILDING USE:	Residential
CONVERTED FROM EARLIER USE?	Possible an earlier farmhouse
PERIOD:	C18? Difficult to date due to over-restoration
PLANFORM:	Gable and chimneys, with C19 extension at rear
STYLE:	Vernacular
BUILDING/CLADDING MATERIALS:	Rendered
ROOFING MATERIALS:	Natural slate, low-pitched
ROOF FORM:	Gable ended
OTHER FEATURES/INFORMATION:	Set at a slight angle to no.9, which stands to its left and closer to the road – indicating that no.11 is earlier? Vestiges of yard at rear.
CONDITION:	Good
NOTES:

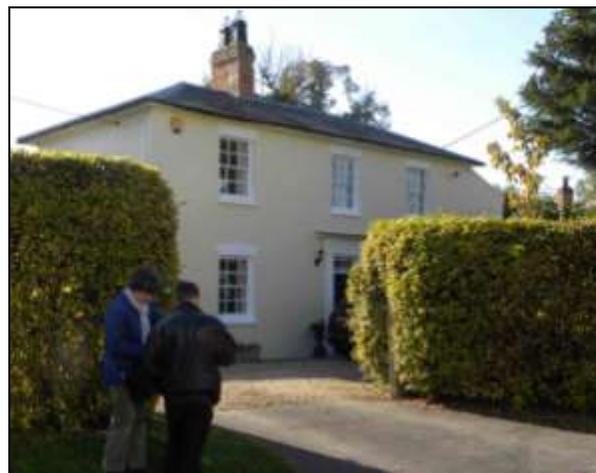
The Firs, 13 Winslow Road

HOUSE NO/NAME:	The Firs
STREET:	13 Winslow Road
BUILDING USE:	Residential
CONVERTED FROM EARLIER USE?	No
PERIOD:	1800-1850
PLANFORM:	Three bays with central door, plus two later extensions
STYLE:	Classical
BUILDING/CLADDING MATERIALS:	Painted brick, possibly Flemish Bond, but extensions in stretcher bond.
ROOFING MATERIALS:	Natural slate, low-pitched
ROOF FORM:	Hipped, with off-centre chimney stack
OTHER FEATURES/INFORMATION:	Right-hand extension has former arched doorway, now blocked
CONDITION:	Good
NOTES:

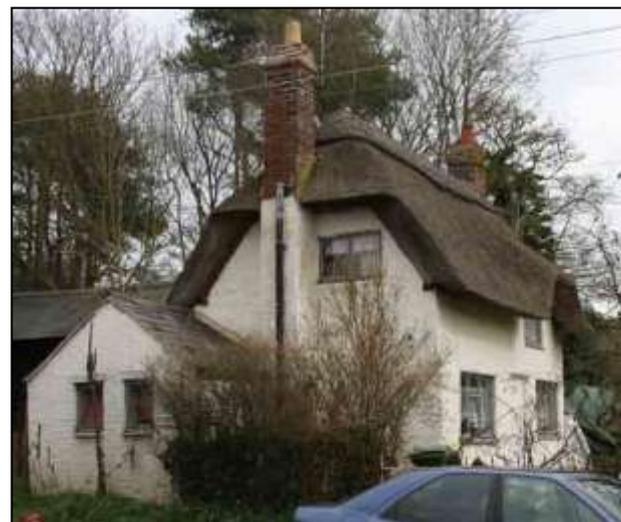
17 Winslow Road

HOUSE NO/NAME:	17
STREET:	Winslow Road
BUILDING USE:	Residential
CONVERTED FROM EARLIER USE?	No
PERIOD:	C18?
PLANFORM:	Two-storey detached, two bays with central front door
STYLE:	Vernacular
BUILDING/CLADDING MATERIALS:	Rendered and painted
ROOFING MATERIALS:	Thatch
ROOF FORM:	Half-hipped with external end chimneys
OTHER FEATURES/INFORMATION:	Small brick extension offset at rear of left-hand gable, of single-storey with slate roof (lean-to, then pitched beyond gable). Boarded detached building at rear with brick plinth and pitched slate roof.
CONDITION:	Good
NOTES: Gable end to road. Property boundaries indicate an 'intake' from the highway (also nos.19 and 21). Formerly an alehouse named The Ewe and Lamb (Terrier attached to New College Estate map 1855, in Oxford University Archives).

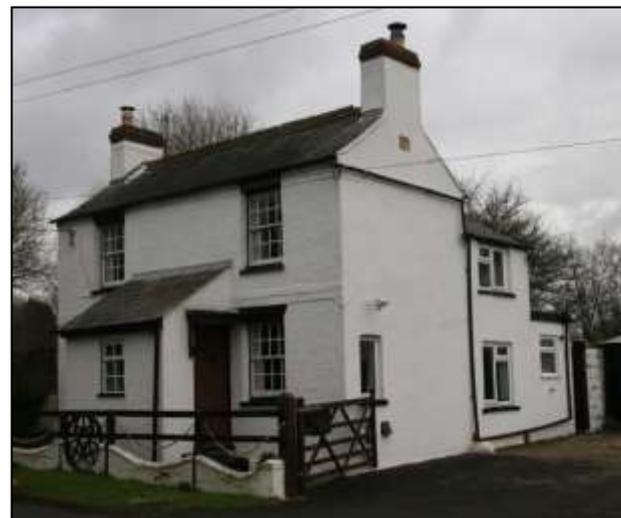
19 Winslow Road

HOUSE NO/NAME:	19
STREET:	Winslow Road
BUILDING USE:	Residential
CONVERTED FROM EARLIER USE?	No
PERIOD:	1850-1900. Plaque on right-hand gable says '1872'
PLANFORM:	Two-storey detached, two bays with central doorway. Rear extension under pitched roof to side side, with lower storey heights.
STYLE:	Vernacular
BUILDING/CLADDING MATERIALS:	White-painted brick with 3-brick upper-floor string course and denticulated brick course to eaves.
ROOFING MATERIALS:	Natural slate
ROOF FORM:	Gable-ended with two internal chimneys. Low-pitched.
OTHER FEATURES/INFORMATION:	Original sash windows. Modern lean-to porch.
CONDITION:	Good
NOTES: Faces on to road; property boundaries indicate an 'intake' from the highway (along with nos.17 and 21).

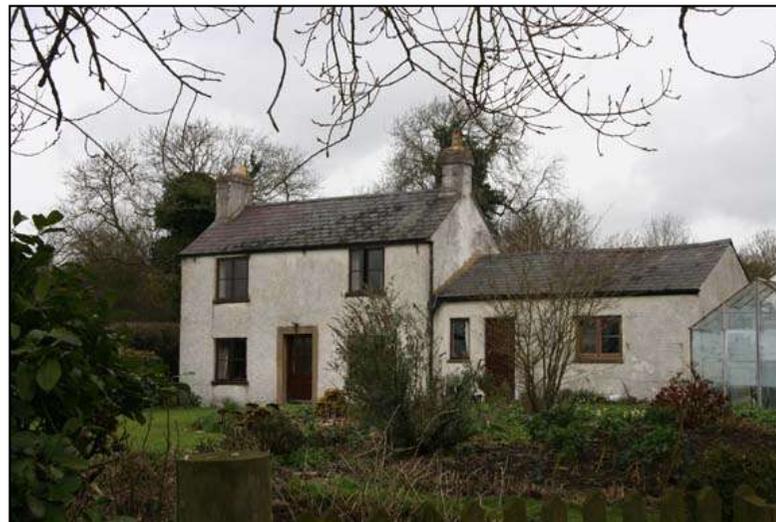
21 Winslow Road

HOUSE NO/NAME:	21
STREET:	Winslow Road
BUILDING USE:	Residential
CONVERTED FROM EARLIER USE?	No
PERIOD:	1800-1850
PLANFORM:	Two-storey detached of two bays with central doorway. In-line single-storey former agricultural building of lower build quality, now integrated. Rear two-storey lean-to extension with low storey heights
STYLE:	Vernacular
BUILDING/CLADDING MATERIALS:	Rendered and painted brick, with exposed render around doorway.
ROOFING MATERIALS:	Natural slate
ROOF FORM:	Gable-ended with internal end chimneys.
OTHER FEATURES/INFORMATION:	
CONDITION:	Good
NOTES:	Gable end to road. Property boundaries indicate an 'intake' from the highway (also nos.17 and 19).

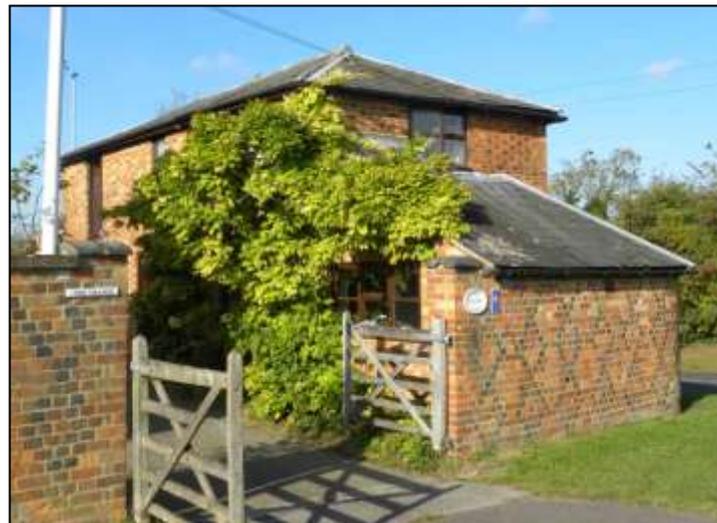
HOUSE NO/NAME:	The Grange Stables
STREET:	Winslow Road
BUILDING USE:	Residential with Bed and Breakfast
CONVERTED FROM EARLIER USE?	Formerly stables and other outbuildings to The Grange, no.2
PERIOD:	1800-1850
PLANFORM:	Converted two-storey detached outbuilding. Originally three loose boxes with stairs to hay loft. Lean-to single-storey at right in two sections with differing pitches. Further lean-to at left
STYLE:	Vernacular
BUILDING/CLADDING MATERIALS:	Red brick stretchers and vitrified headers, Flemish bond. Lean-to at right has diamond-pattern.
ROOFING MATERIALS:	Natural slate
ROOF FORM:	Hipped, no chimneys
OTHER FEATURES/INFORMATION:	
CONDITION:	Good
NOTES:	Owner informed surveyors that the building is contemporary with the extension of The Grange in 1836.

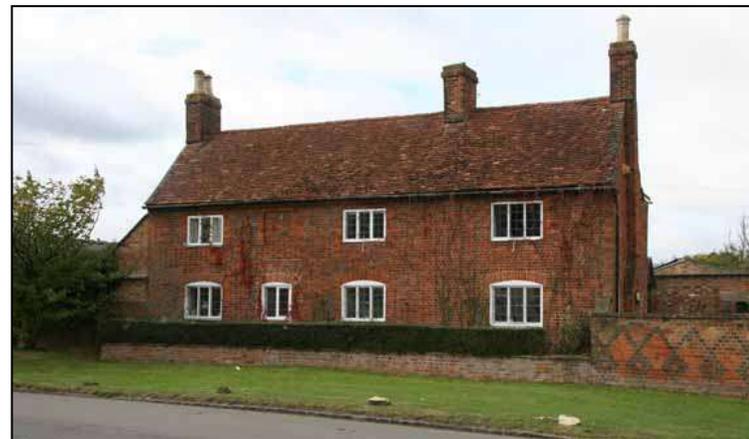
The Grange, 2 Winslow Road

HOUSE NO/NAME:	The Grange
STREET:	2 Winslow Road
BUILDING USE:	Residential
CONVERTED FROM EARLIER USE?	Former farmhouse
PERIOD:	C18
PLANFORM:	Four-bay detached; originally three bays with central doorway (now blocked) and blank window above; right-hand bay added in 1836. Lean-to at left. Two-storey flat-roofed modern extension at rear.
STYLE:	Vernacular
BUILDING/CLADDING MATERIALS:	Red brick stretchers and vitrified headers, Flemish bond.
ROOFING MATERIALS:	Old red clay tiles.
ROOF FORM:	Original 3-bay gable-ended with end chimneys; 1836 extension gable-ended with external end chimney.
OTHER FEATURES/INFORMATION:	Walls to former farmyard on right have diamond-pattern brickwork.
CONDITION:	Good
NOTES:	Some bricks on frontage marked with initials MT, AV, MB, JK. Left gable wall has '1836' in vitrified headers. Listed Grade 2 (number 1213688)

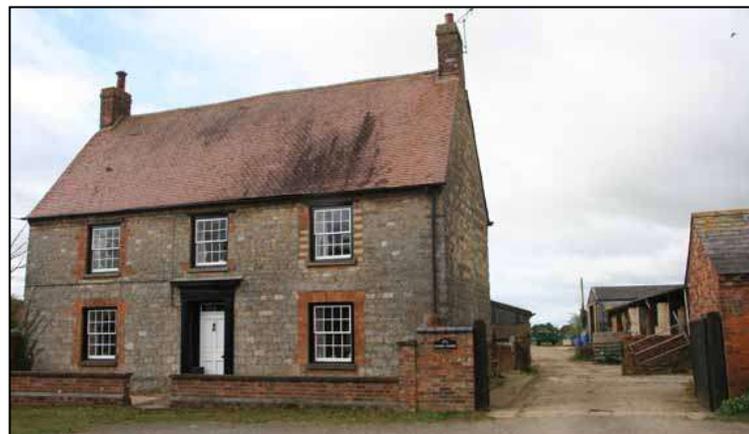
Home Farm, 4 Winslow Road

HOUSE NO/NAME:	Home Farm
STREET:	4 Winslow Road
BUILDING USE:	Farmhouse
CONVERTED FROM EARLIER USE?	No
PERIOD:	C18
PLANFORM:	Two-storey detached of three bays with central doorway. Possibly older rear cross-wing visible at left, with timber sills and lintels.
STYLE:	Vernacular with classical doorframe.
BUILDING/CLADDING MATERIALS:	Squared, coursed stone to rear wing and left gable; rubblestone to front with red-brick window surrounds.
ROOFING MATERIALS:	Plain clay tiles; maybe newly re-roofed. Steeply pitched.
ROOF FORM:	Gable-ended with internal end chimneys. Irregular roofline indicating old roof frame. Farmyard to rear, access gates to left.
OTHER FEATURES/INFORMATION:	Farmyard to rear, accessed through gates to left.
NOTES:	Listed Grade 2 (number 1288934).

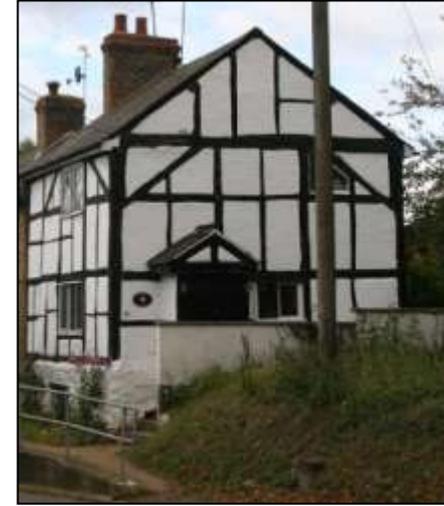
Tudor Cottage, 6 Winslow Road

HOUSE NO/NAME:	Tudor Cottage
STREET:	6 Winslow Road
BUILDING USE:	Residential
CONVERTED FROM EARLIER USE?	No
PERIOD:	C17
PLANFORM:	Box frame, end terrace. Two storeys with undercroft.
STYLE:	Vernacular
BUILDING/CLADDING MATERIALS:	Timber frame with irregular large rectangular panels and painted brick infill on rubblestone plinth. Straight braces to front and side. Some replacement timbers. Windows not in original positions.
ROOFING MATERIALS:	Natural slate
ROOF FORM:	Gable-ended with shared chimney stack on party wall with no.8.
OTHER FEATURES/INFORMATION:	Undercroft with original window: four lights with oak mullion. Modern porch on gable end.
CONDITION:	Good
NOTES:	Listed Grade 2 (Number: 1213690)

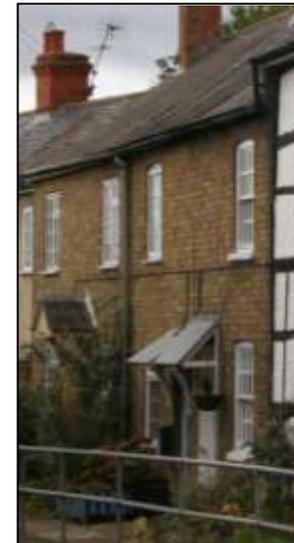
8, 10 and 14 Winslow Road

HOUSE NO/NAME:	8, 10 and 14
STREET:	Winslow Road
BUILDING USE:	Residential
CONVERTED FROM EARLIER USE?	No
PERIOD:	1850-1900
PLANFORM:	Terraced cottages
STYLE:	C19 workers' cottages
BUILDING/CLADDING MATERIALS:	Yellow brick
ROOFING MATERIALS:	Natural slate.
ROOF FORM:	Gable-ended with chimneys in party walls.
OTHER FEATURES/INFORMATION:	No.14 originally two cottages – blocked doorway evident.
CONDITION:	Good
NOTES:

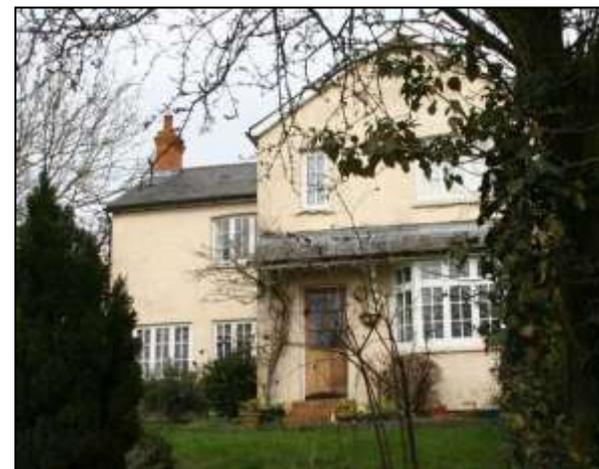
Hardingham House, 16 Winslow Road

HOUSE NO/NAME:	Hardingham House
STREET:	16 Winslow Road
BUILDING USE:	Residential
CONVERTED FROM EARLIER USE?	No
PERIOD:	1900-1920 (built 1913, with extension 1983)
PLANFORM:	Two-storey detached. Two-storey extension at rear.
STYLE:	Edwardian villa
BUILDING/CLADDING MATERIALS:	Painted brick, with denticulated course at eaves.
ROOFING MATERIALS:	Natural slate
ROOF FORM:	Gable-ended with central chimney.
OTHER FEATURES/INFORMATION:	Front door and canted bay window in gable end below slate pentice roof.
CONDITION:	Good
NOTES: Built to order for Fred Carey, entertainer and impresario. [Thanks to householder John Whitehead for providing extra information.]
