## BUCKS CHURCHES.

## SS. Peter and Paul, Ellesborough.

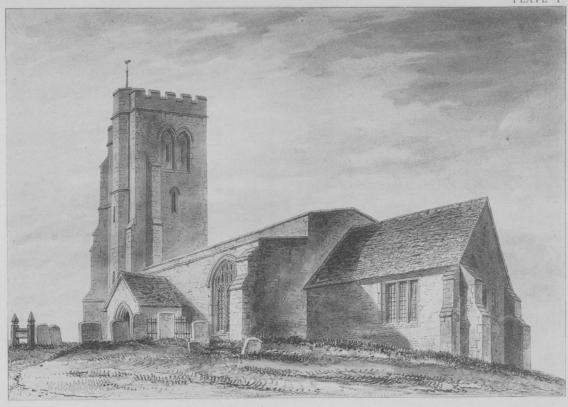
Ellesborough Church Before the Modern Alterations

Familiar to us all from its prominent site and its nearness to the Great Western Railway, Ellesborough Church was very much restored in 1854 and 1871,\* when this process was commonly more drastic than now; "The walls were almost entirely re-faced outside, the chancel, tower, and south aisle were partly re-built, vestry and organ chamber added, and the building generally restored. The chancel is modern except the chancel arch. . . . . "† Happening to have a drawing of this church by J. Buckler, dated 1837, a wash drawing in Indian ink, carefully executed by this well-known artist, I have thought it might be interesting to compare this with the building as we see it now and as shown in a recent photograph.

The R. Com. Report, in its description of the church, states that "the tower is almost entirely modern," but a comparison of the two views raises some doubt as to the truth of this, the similarity,

even to the weatherings of the buttresses (where the modern architect often fails) being so great. chancel, as shown in the old drawing, was probably, from its small size, of earlier date than the 15th cent. chancel arch, which might, likely enough, have taken the place of a smaller opening of the 12th The flat-headed windows shown in the century. drawing may have been 17th century renewals. Of alterations and destruction here before 1854 Lipscomb # tells us that a north porch was taken down in 1828 and the doorway closed. . . . . "One of the windows on the south side has been closed for the erection of a monument" (to Lady Bridget Croke, 1638). . . . . "Between the nave and chancel are remains of an old carved and gilt oak screen, with four cinque-foil headed and crocketed arches, under a pediment; and in the spandrils of the central arch, on each side, a swan. . . . . The north side of the nave was formerly fitted up with pews, but the opposite side retained the old open seats of the time of King James, with folding or moveable stools fastened to the ends of the seats, capable of being drawn out for the accommodation of persons in the middle of the nave. These have been lately removed and another range of pews substituted. . . . . In the chancel are three very ancient chests.".... Possibly some view may exist of the fine screen described above and thus barbarously removed.

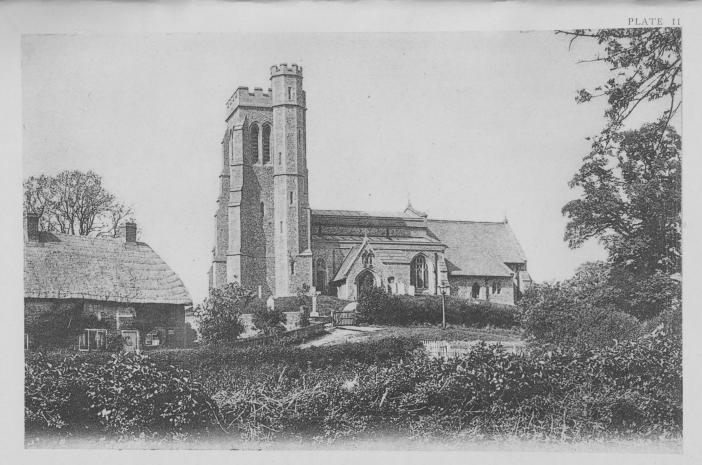
Ellesborough Church As Now
