HITCHAM CHURCH.

CHURCH OF ST. MARY, HITCHAM,
PLAN.

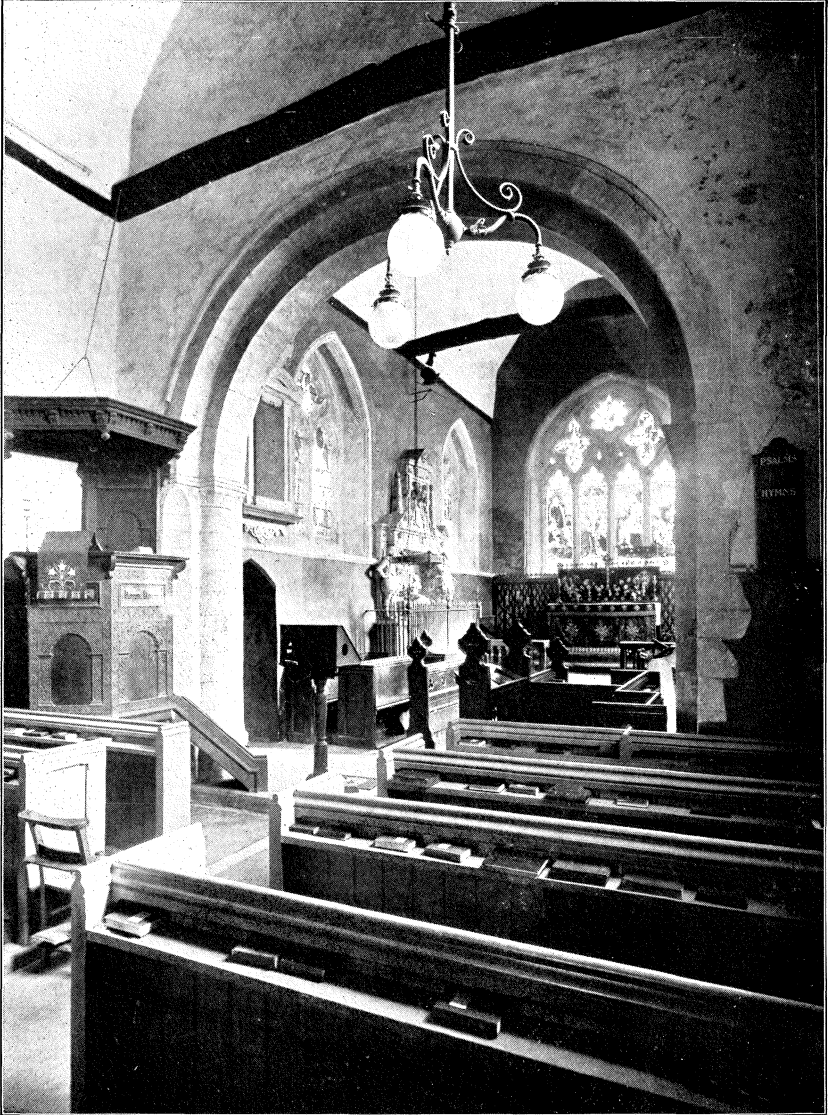
CHURCH OF ST. MARY, HITCHAM.

There are instances here both of the low and the high side windows—as will be seen in the photo plate of the exterior—the former much restored. Controversy has raged about the use of “low side windows,” chiefly in chancels, and not far from an altar, ever since Mr. J. H. Parker started the subject in 1844. They are found in nearly all parts of England, and also in Denmark,§ but, it is said, not in other parts of the continent. They have been called lepers’ windows, but lepers were not admitted even to the church-yards. They have been said to have been used for confessions. The priest of Husaby, Verster-götland, said that such an opening in his church was for persons who, on account of grave offences, could not enter the church, to make their confession outside this window, and through it afterwards receive the sacrament—apparently shutting his eyes to the objection that anyone who could be admitted to the sacrament could not be excluded from the church. They were said by others to have been for depositing gifts from those cured at an adjacent holy well. But they are found where there was no holy well. They were look-out holes, to observe from the chancel what was taking place outside—such as the approach of a funeral procession. They were holes for archers, churches serving as places of refuge in troublous times. They have also been said to have been intended to look through, from without, upon a painting of St. Christopher, which would preserve the beholder from death for at least that day. They were for the purpose of throwing a light towards the church-yard to drive away the devil. Another theory, and better than some

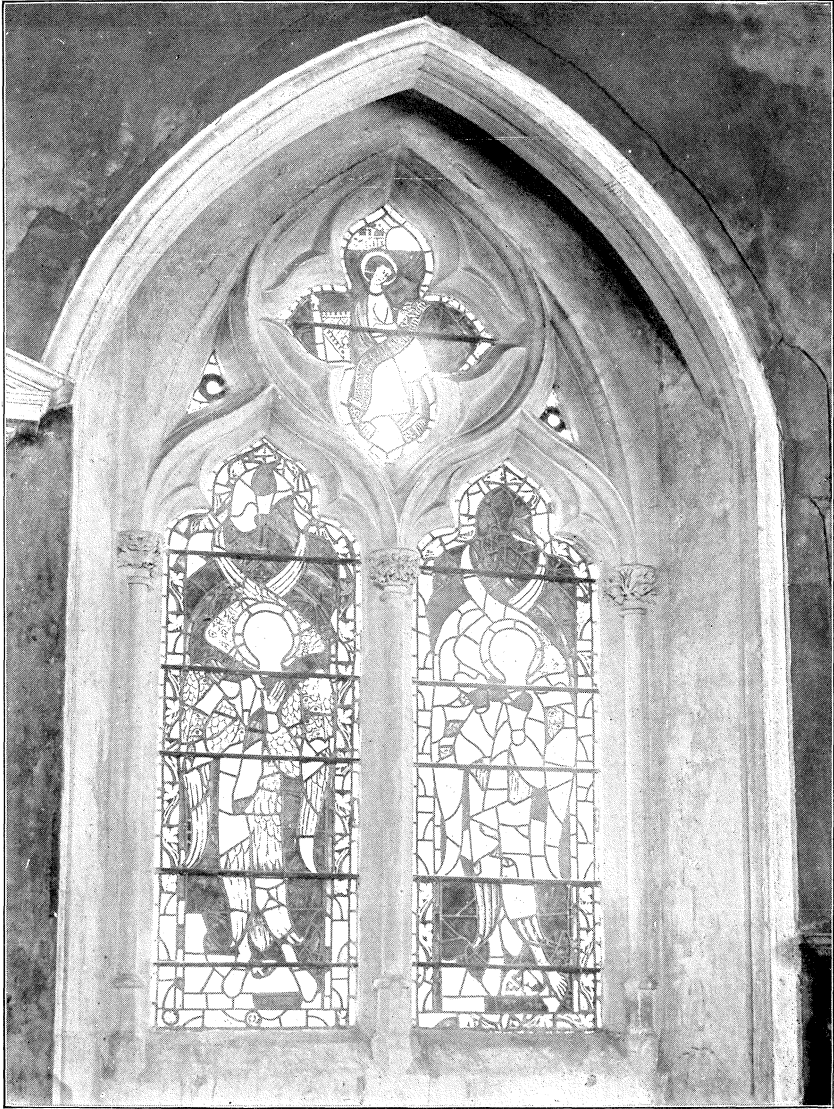
CHURCH OF ST. MARY, HITCHAM.

TWO-LIGHT WINDOW, NORTH SIDE OF CHANCEL,
SHOWING 14TH CENTURY GLASS, AS RE-LEADED.

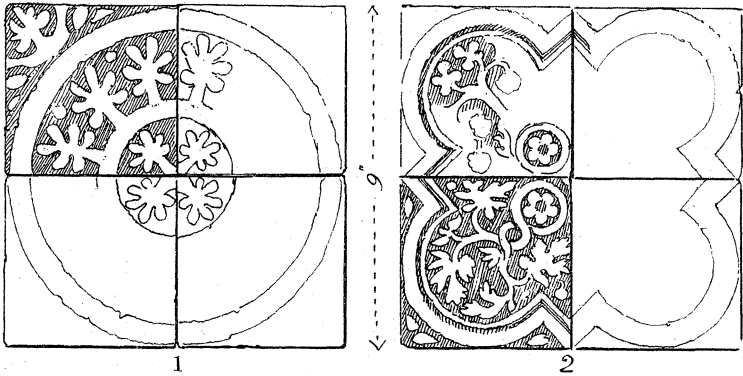
CHURCH OF ST. MARY, HITCHAM.
ENCAUSTIC TILES IN THE CHANCEL.

Many old encaustic tiles remain in the chancel floor, a few of them, perhaps, in their original positions. I have drawn some of the best preserved specimens, which vary considerably in the different examples, and these are illustrated (Pl. VI.). Nos. 6 and 9 occur also at the neighbouring Little Marlow Nunnery; * and No. 9, also at Binfield, within Windsor Forest. On the subject of the three small shields on this tile more will be said when the painted glass is described. Nos. 1, 8, 10, 11, and 13 are, or were,† at Yateley, Hants.
